AIRPROX REPORT No 2025034

Date: 21 Mar 2025 Time: 1519Z Position: 5144N 00010E Location: IVO North Weald

PART A: SUMMARY OF INFORMATION REPORTED TO UKAB

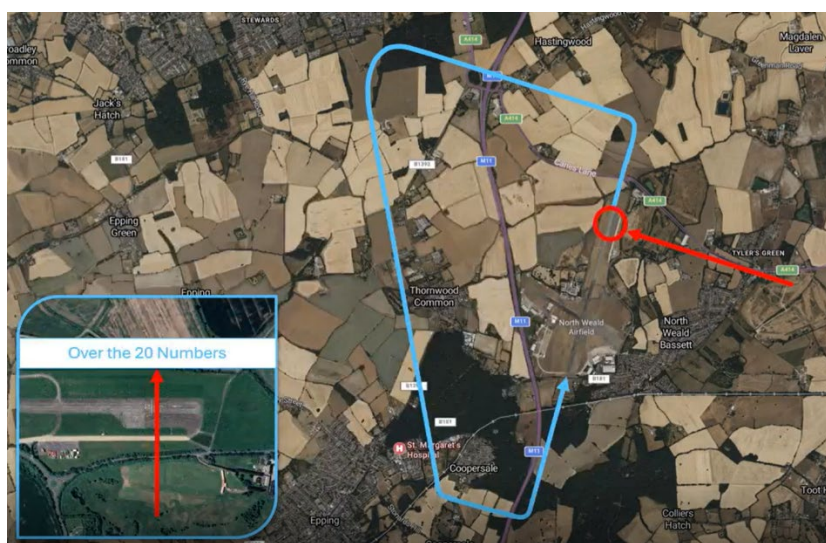
A representative from the North Weald operations team confirmed that there had not been a change to the procedure and that the email and video had been intended to serve as a reminder to pilots of the existing procedure.

Figure 1 – A screenshot from a video showing the correct procedure for joining from the east for RW02

'The January pilot brief outlined the revised safety and noise abatement procedures for joining runway 20. Further to this, the attached video is a reminder of the correct procedure for the crosswind join - runway 02'.

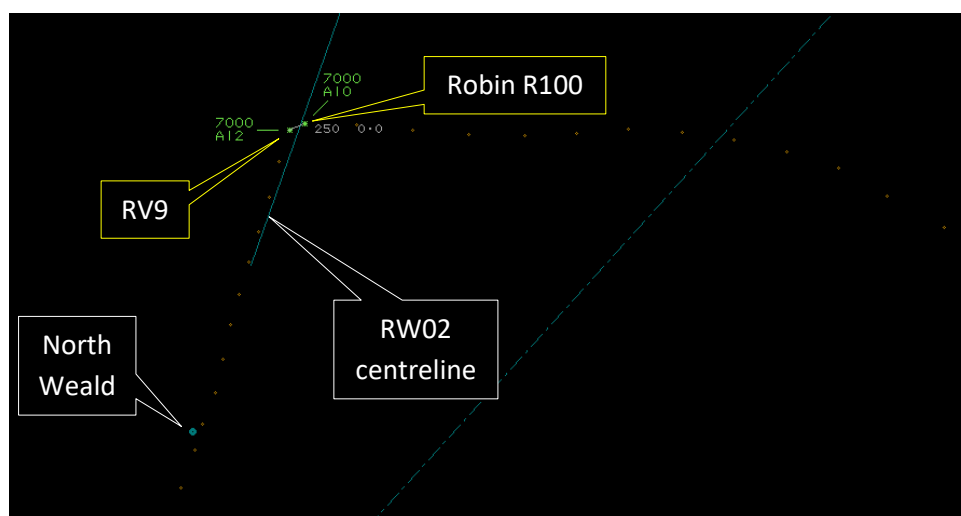
An analysis of the NATS radar replay was undertaken and both aircraft could be positively identified from Mode S data (Figure 2). The aircraft were depicted on the radar replay with altitudes based on 'radar QNH' of 1003hPa. These altitudes have been corrected with reference to the reported QNH from the nearest METAR station and have been shown as approximations in the diagram. The pilot

of the RV9 kindly supplied GPS track data for their flight. The diagram was constructed and the separation determined by combining the data sources.

Figure 2 – CPA at 1518:46

Concluding their discussion, members considered the risk of collision. It was agreed that neither pilot had sighted the other in time to have taken effective avoiding action and that the separation between the aircraft had reduced to the bare minimum. Members were in agreement that providence had played a major part in events and there had been a serious risk of collision (CF7). The Board assigned Risk Category A to this event.
