AIRPROX REPORT No 2025037

Date: 20 Mar 2025 Time: 1606Z Position: 5327N 00252W Location: Croxteth

PART A: SUMMARY OF INFORMATION REPORTED TO UKAB

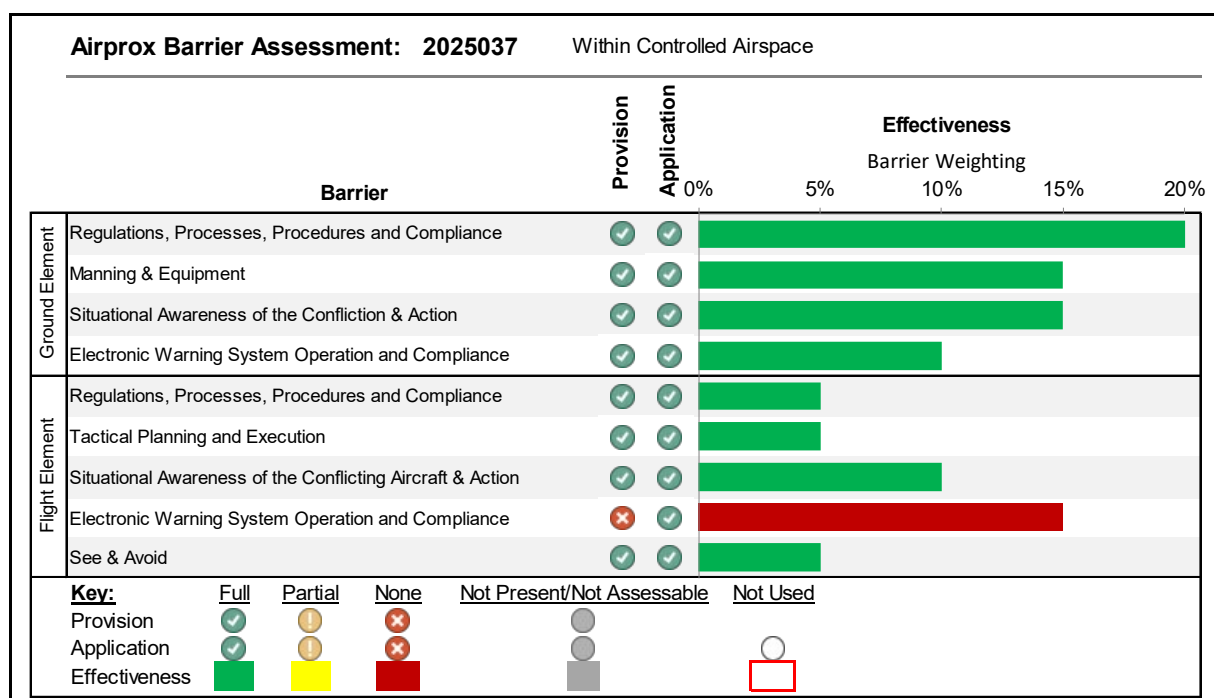
In assessing the effectiveness of the safety barriers associated with this incident, the Board concluded that the key factors had been that:

Flight Elements:

Electronic Warning System Operation and Compliance were assessed as **ineffective** because the EC120 electronic conspicuity output was incompatible with the P68 TAS.
