AIRPROX REPORT No 2025040

Date: 20 Mar 2025 Time: 1556Z Position: 5158N 00004W Location: 2NM NW Buntingford

PART A: SUMMARY OF INFORMATION REPORTED TO UKAB

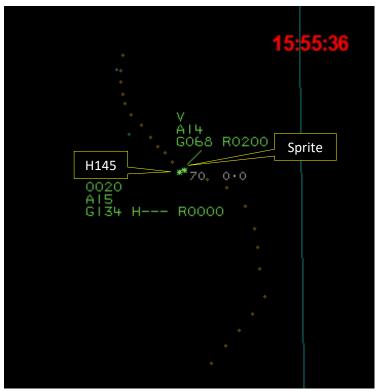
Figure 1 - CPA at 1555:36

The Closest Point of Approach occurred at 1555:36 and was recorded on the multi-track radar as 0.0NM and 100ft (Figure 1).
