AIRPROX REPORT No 2025041

Date: 26 Mar 2025 Time: 1049Z Position: 5417N 00131W Location: RAF Leeming

PART A: SUMMARY OF INFORMATION REPORTED TO UKAB

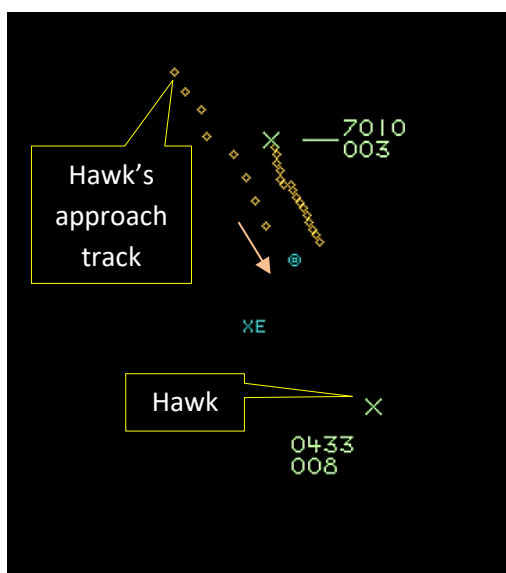
Figure 1 Time 1049:11

An analysis of the NATS radar replay was undertaken and both aircraft were positively identified using Mode S data. The Hawk was seen joining through initial and reappeared upwind at 1049:11 (Figure 1). The uninvolved Tutor in the circuit was in a late left-hand downwind position and the departing Tutor had not yet appeared on radar.

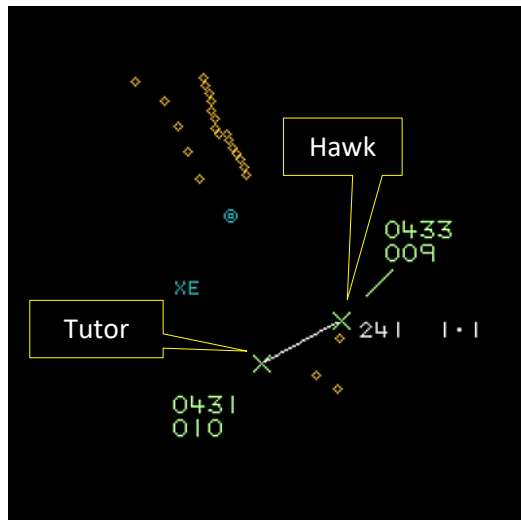
Figure 2 Time 1049:23

The departing Tutor first appeared on the radar replay at 1049:23 and the separation between the Hawk and Tutor was seen as 1.1NM laterally and 100ft vertically (Figure 2).

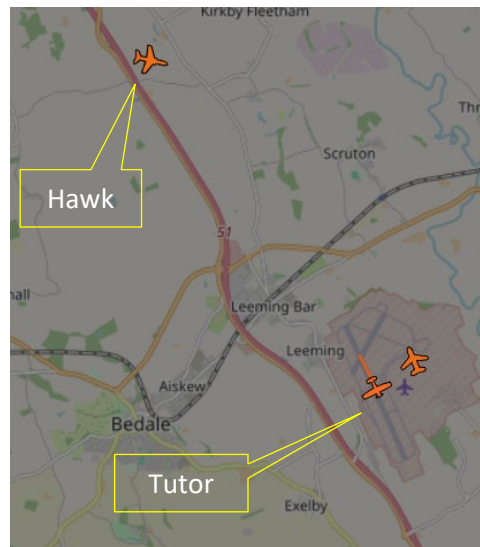
Figure 3 Time 1048:00

Further analysis of flight tracking software was undertaken and both aircraft were positively identified, the Tutor using ADS-B sources and the Hawk using MLAT. The departing Tutor was first seen on RW16 at Leeming at 1048:00 (Figure 3).

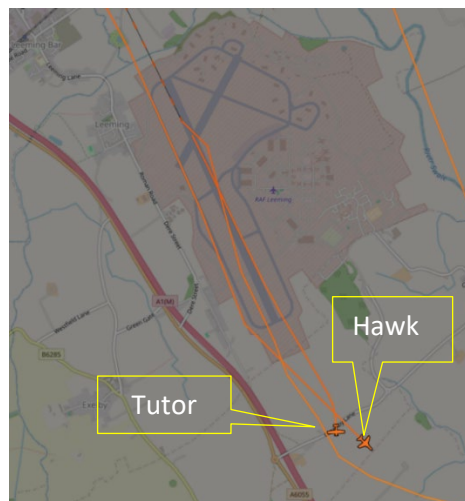
Figure 4 Time 1048:50

The Hawk was seen to have passed behind and beneath the Tutor at 1048:50 (Figure 4).

By interpolation of radar times and ADS-B sourced data, CPA was assessed to have occurred at 1048:47 with approximately 115ft vertical and less than 0.1NM lateral separation.
