**AIRPROX REPORT No 2025043**

Date: 20 Mar 2025 Time: 1622Z Position: 5141N 00020W Location: Elstree

**PART A: SUMMARY OF INFORMATION REPORTED TO UKAB**

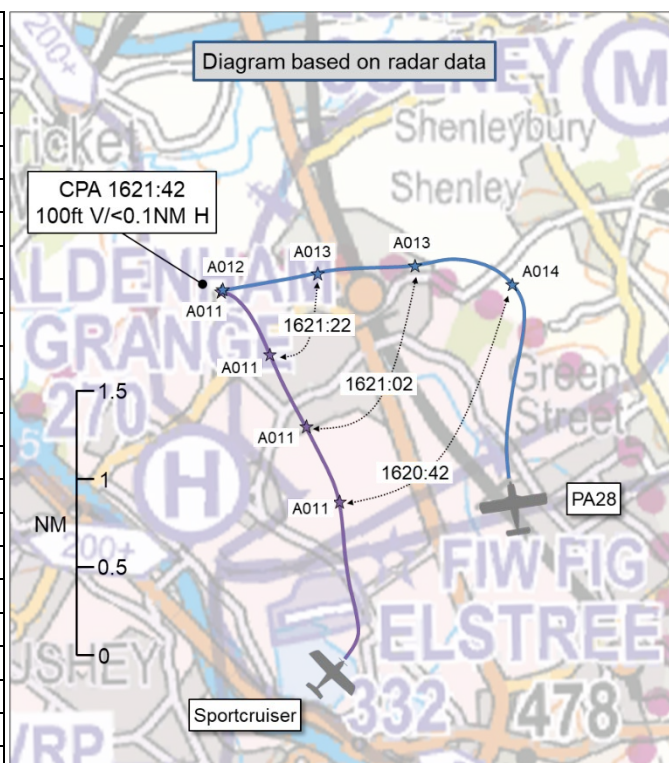
Recorded	Aircraft 1	Aircraft 2
Aircraft	PA28	Sportcruiser
Operator	Civ FW	Civ FW
Airspace	Elstree ATZ	Elstree ATZ
Class	G	G
Rules	VFR	VFR
Service	AFIS	AFIS
Provider	Elstree Information	Elstree Information
Altitude/FL	1200ft	1100ft
Transponder	A, C, S	A, C, S
Reported		
Colours	White, red	Silver, blue
Lighting	Beacon, ldg, nav	Strobes
Conditions	VMC	VMC
Visibility	>10km	>10km
Altitude/FL	1000ft	1000ft
Altimeter	QFE (1006hPa)	QFE (1006hPa)
Heading	225°	360°
Speed	100kt	70kt
ACAS/TAS	SkyEcho	Not fitted
Alert	None	N/A
<b>Separation at CPA</b>		
Reported	0ft V/<0.5NM H	Not seen
Recorded	100ft V/<0.1NM H

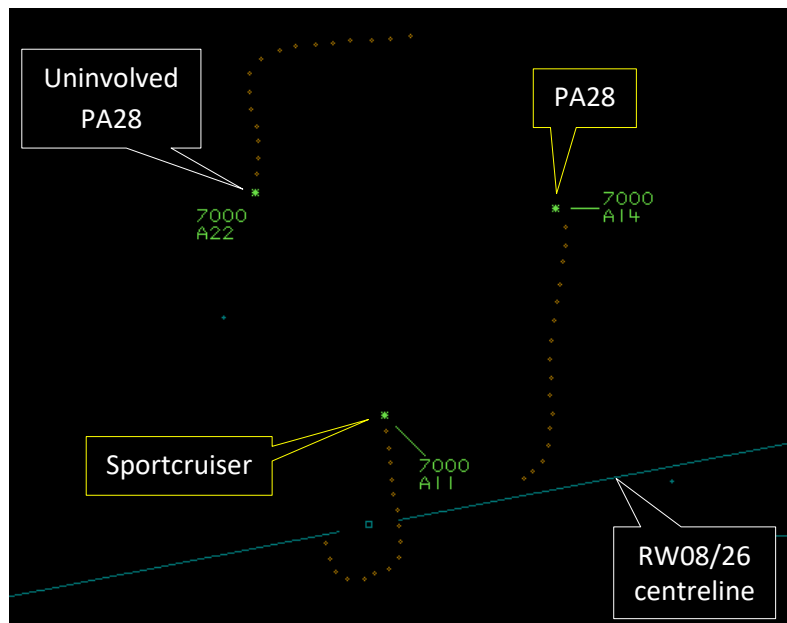
Figure 2 – Aircraft positions at 1620:42

An analysis of the NATS radar replay was undertaken and both aircraft could be positively identified from Mode S data (Figure 2). The PA28 was observed by reference to ADS-B data sources. The diagram was constructed and the separation determined from the radar data.

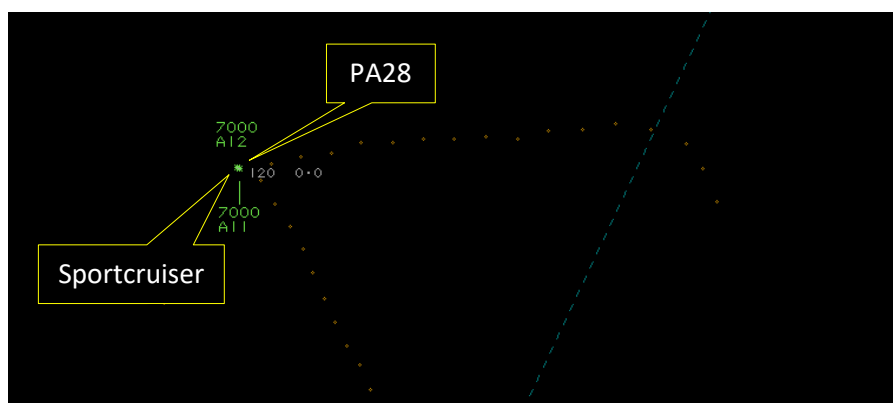
Figure 3 – CPA at 1621:42

The PA28 and Sportcruiser pilots shared an equal responsibility for collision avoidance and not to operate in such proximity to other aircraft as to create a collision hazard.<sup>1</sup> An aircraft operated on or in the vicinity of an aerodrome shall conform with or avoid the pattern of traffic formed by other aircraft in operation.<sup>2</sup>
