AIRPROX REPORT No 2025044

Date: 05 Apr 2025 Time: 1507Z Position: 5158N 00312W Location: Talgarth

PART A: SUMMARY OF INFORMATION REPORTED TO UKAB

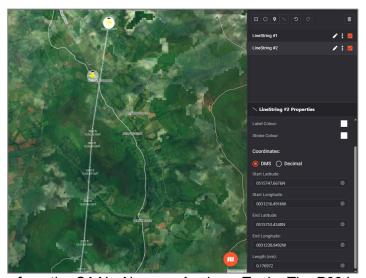
Figure 1: Image taken from the CAA's Airspace Analyser Tool – The P68 had passed across the front of the ASK13 at a distance of ~0.177NM at 1506:32. Note that, due to the P68 showing on the system only at 1506:13 then 1506:49, interpolation puts the CPA at that time and distance.

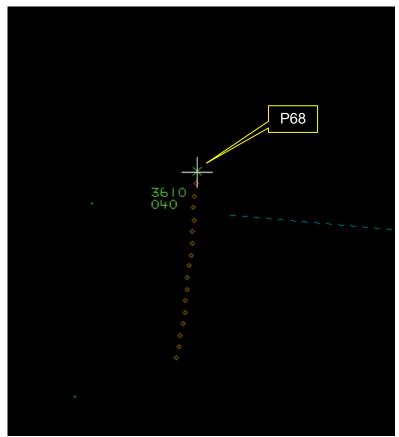
Figure 2: At 1506:32 The white cross is at the reported CPA. The ASK13 did not show on radar.

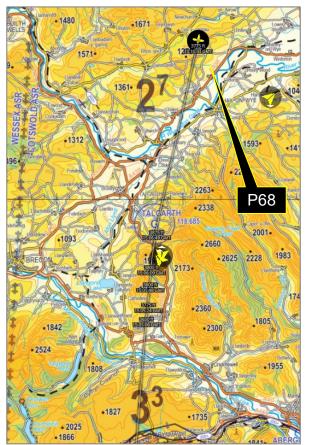
Figure 3: Taken from the CAA's Airspace Analyser Tool showing the south-to-north path of the P68
