**AIRPROX REPORT No 2025047**

Date: 08 Apr 2025 Time: 0947Z Position: 5219N 00018W Location: IVO Grafham Water

**PART A: SUMMARY OF INFORMATION REPORTED TO UKAB**

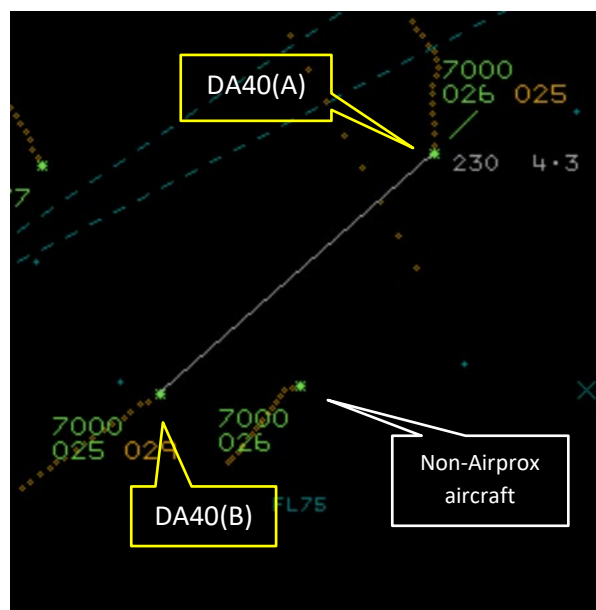
Figure 1 - 0946:09

An analysis of the NATS radar replay was undertaken. Both aircraft could be identified using Mode S data. At Figure 1, DA40(A) can be seen indicating FL026, heading south and DA40(B) indicating FL025 heading northeast. The third aircraft mentioned by both pilots can also be seen at a similar level.

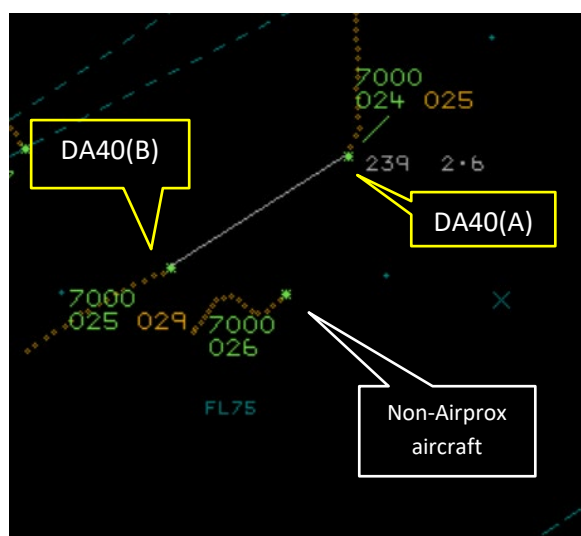
Figure 2 – 0946:38

At Figure 2, the DA40(A) had turned onto a south-westerly heading, as described by the pilot in their report, to avoid the manoeuvring aircraft, the two DA40s were now 2.6NM apart and on reciprocal headings.

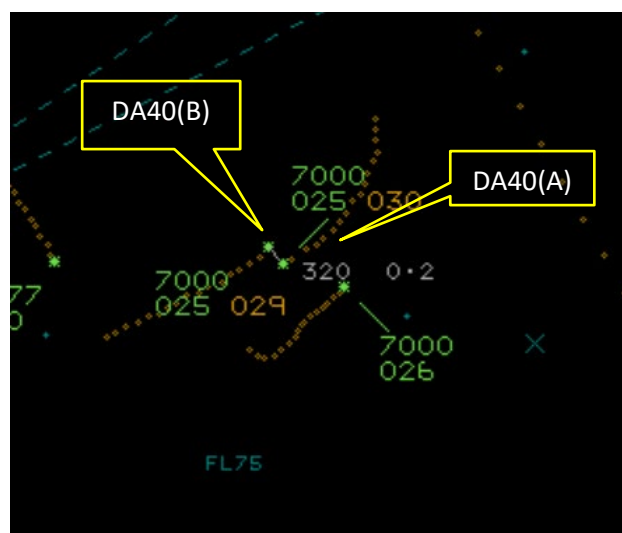
Figure 3 – CPA 0947:18

The two aircraft continued to close until CPA at 0947:18 when they were 0.2NM apart, both aircraft indicated FL025.
