AIRPROX REPORT No 2025050

Date: 11 Apr 2025 Time: 1316Z Position: 5346N 00301W Location: Blackpool Airport.

An Airprox was reported when a C152 and a C172 flew into proximity on the approach to Blackpool Airport at 1316Z on Friday 11th April 2025. Both pilots were operating under VFR in VMC within the Blackpool ATZ and in receipt of an ACS from Blackpool Tower.

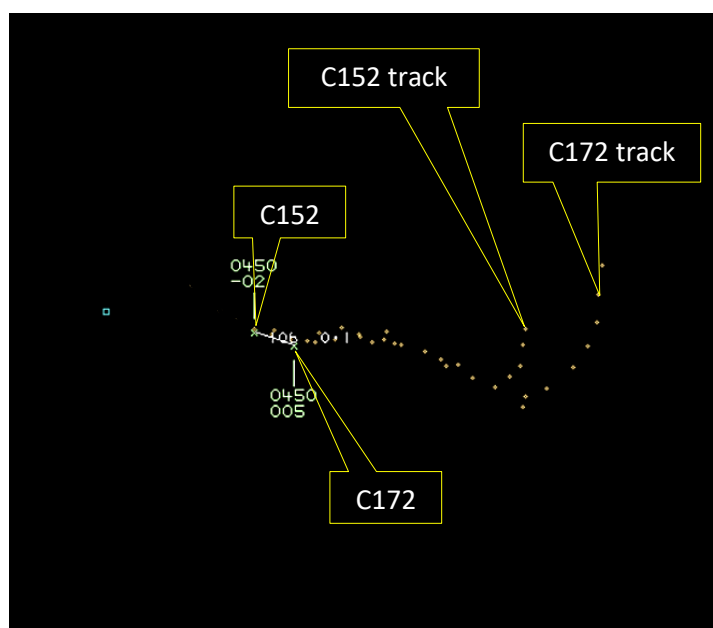
Figure 1 – CPA at 1316:15

An analysis of the NATS radar replay was undertaken and both aircraft were positively identified using Mode S data. The C172 was seen following a similar track to the C152, at a distance of approximately 0.4NM, from their initial reported position east of the Tall Tower towards the base-leg of the approach to Blackpool Airport. The C172 was seen to gradually converge with the C152 on the final approach. CPA was assessed to have occurred at 1316:15 with 0.1NM lateral and 700ft vertical separation (Figure 1).
