**AIRPROX REPORT No 2025054**

Date: 18 Apr 2025 Time: 1222Z Position: 5354N 00046W Location: 1.5NM south of Pocklington

**PART A: SUMMARY OF INFORMATION REPORTED TO UKAB**

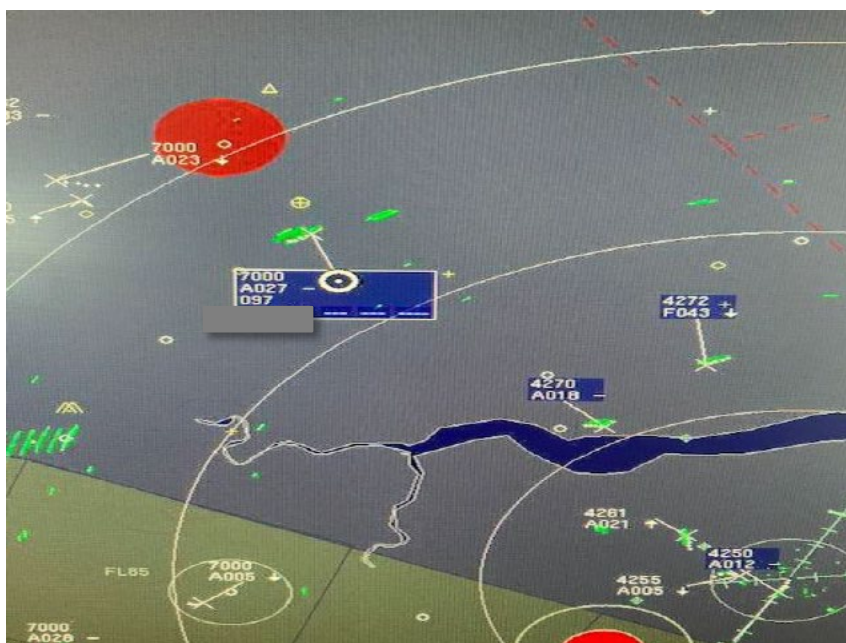
Figure 1: Image taken at 1222:12

1222:12 Mouse cursor was moved over the 7000 squawk, revealing briefly the Mode 'S' data block and callsign.

The aircraft was already in amongst primary returns. The squawk was then highlighted in blue indicating that the ATCO was then aware of the PA28's identity and position.

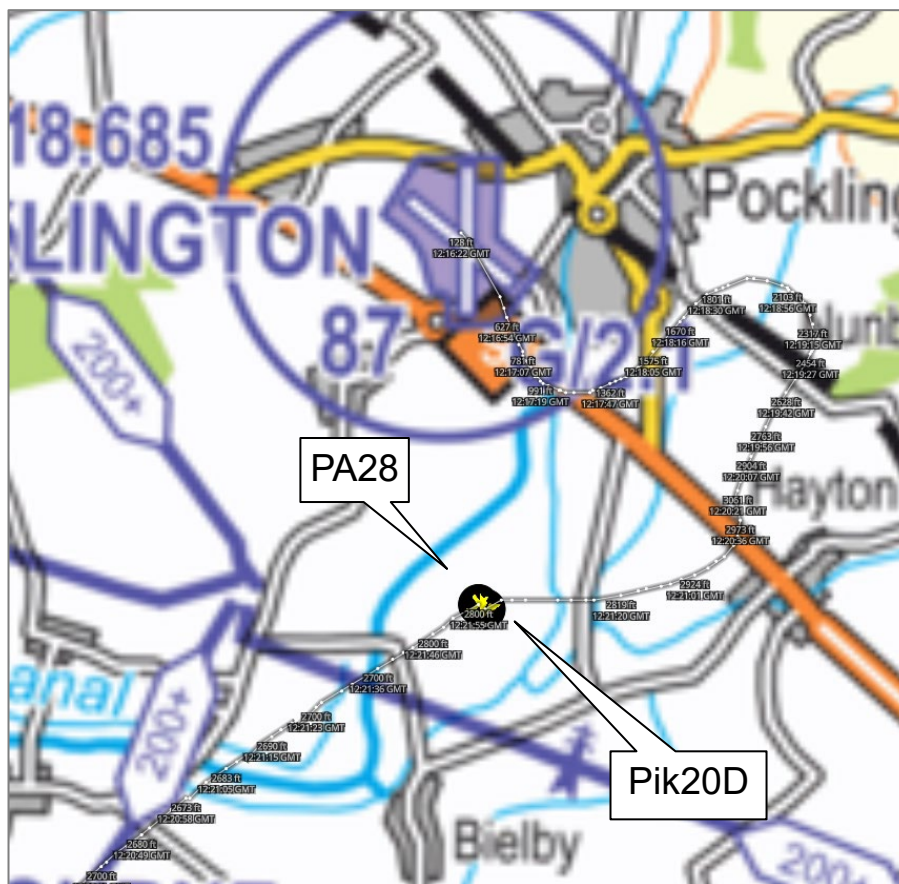
Figure 2: Taken from the CAA's Airspace Analyser Tool at 1221:55 and measured at ~0.04NM H separation. PA28 at 2800ft (SPS)/051°/97kt/0fpm ROC/D. Pik20D 2825ft (SPS)/208°/31kt/474fpm ROD

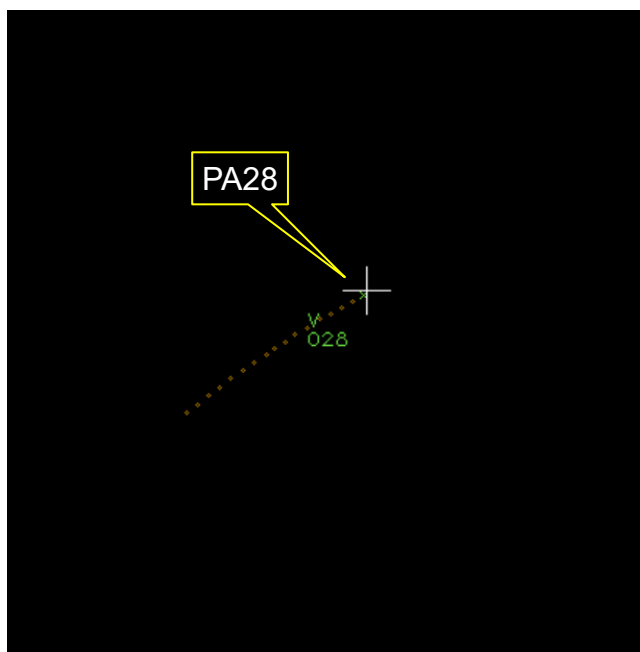
Figure 3: At CPA - 1221:55. The white cross shows the position of the reported CPA. The Pik20D did not show on radar.
