AIRPROX REPORT No 2025062

Date: 01 May 2025 Time: 1113Z Position: 5121N 00103W Location: 1.3NM NNE of Bramley

PART A: SUMMARY OF INFORMATION REPORTED TO UKAB

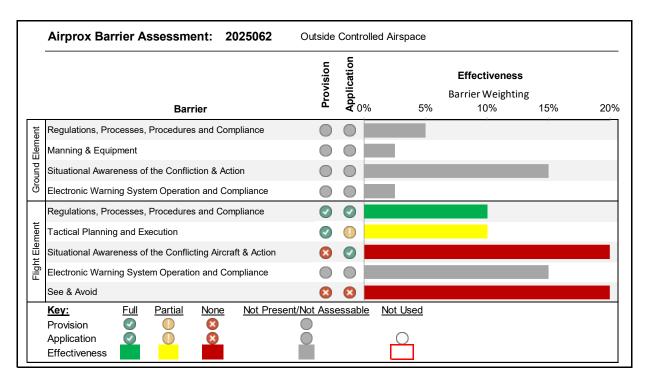
Safety Barrier Assessment⁴

In assessing the effectiveness of the safety barriers associated with this incident, the Board concluded that the key factors had been that:

Tactical Planning and Execution was assessed as **partially effective** because neither pilot had been in receipt of a surveillance-based service where one had been available.

Situational Awareness of the Conflicting Aircraft and Action were assessed as ineffective because neither pilot had situational awareness of the presence of the other aircraft.

See and Avoid were assessed as **ineffective** because neither pilot had seen the other aircraft until at or about the point of CPA.
