AIRPROX REPORT No 2025063

Date: 29 Apr 2025 Time: 1335Z Position: 5319N 00056W Location: Retford/Gamston ATZ

PART A: SUMMARY OF INFORMATION REPORTED TO UKAB

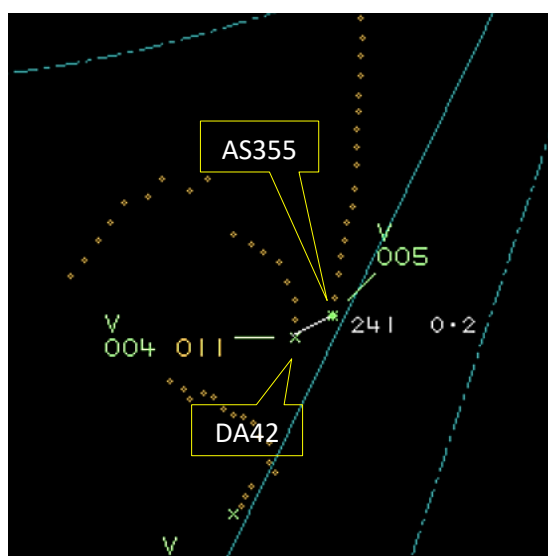
Figure 1 Time 1334:34

An analysis of the NATS radar replay was undertaken and both aircraft were positively identified using Mode S data. The DA42 was seen turning right onto the final approach track for RW20 and the AS355 was seen approaching the same track from a long final position. CPA was assessed to have occurred at 1334:34 with 0.2NM lateral and 100ft vertical separation (Figure 1).

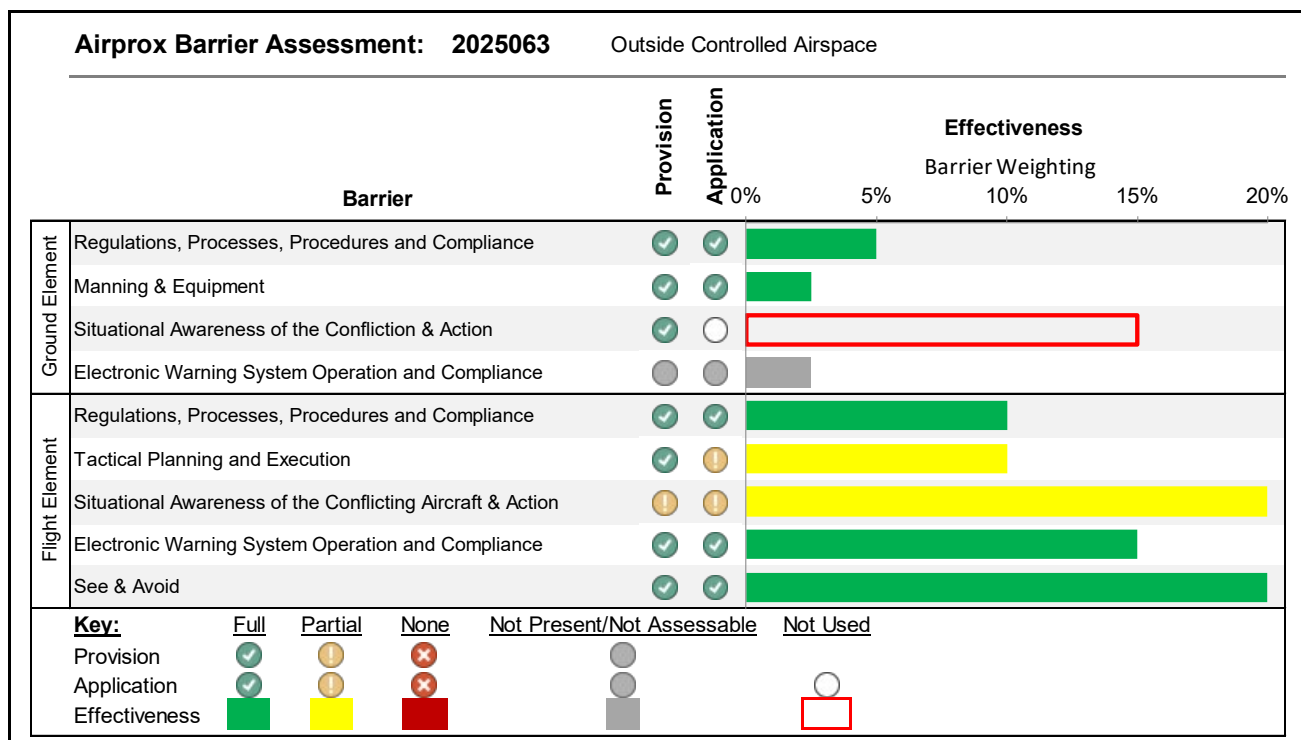
Situational Awareness of the Confliction and Action were assessed as **not used** because the Gamston Air/Ground operator was not required to sequence the traffic in the circuit.

Tactical Planning and Execution was assessed as **partially effective** because the AS355 pilot did not conform with the pattern of traffic already formed by the DA42.

Situational Awareness of the Conflicting Aircraft and Action were assessed as **partially effective** because the AS355 pilot's situational awareness of the DA42's position within the circuit was inaccurate.
