**AIRPROX REPORT No 2025069**

Date: 29 Apr 2025 Time: 1849Z Position: 5114N 00058W Location: Odiham ATZ

**PART A: SUMMARY OF INFORMATION REPORTED TO UKAB**

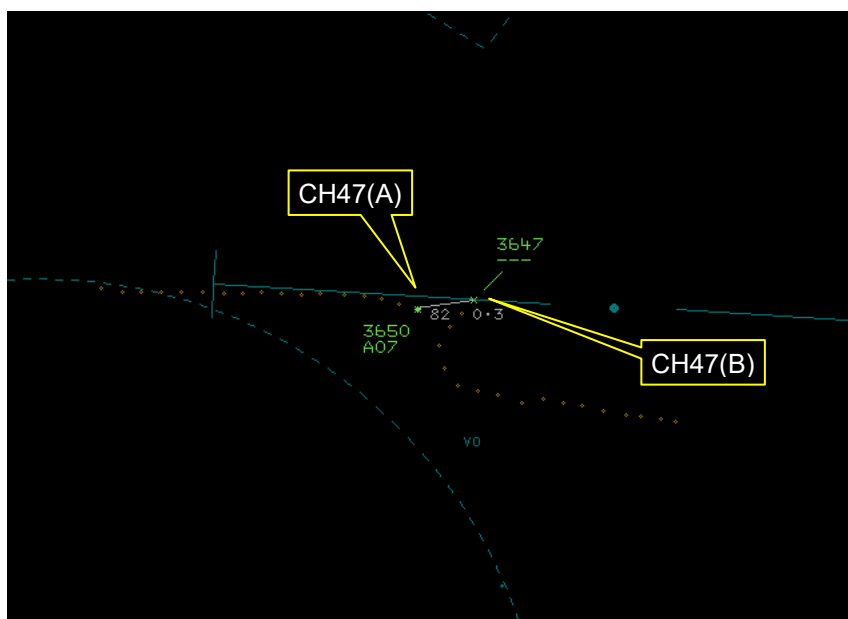
Figure 1: at CPA (1848:34)

Both aircraft were tracked using radar with CH47(A) displaying Mode C to determine their altitude. CH47(B) appeared as a Mode A return only. The altitude displayed on the diagram at page 1 and used for comparison at CPA was that reported by the pilot.

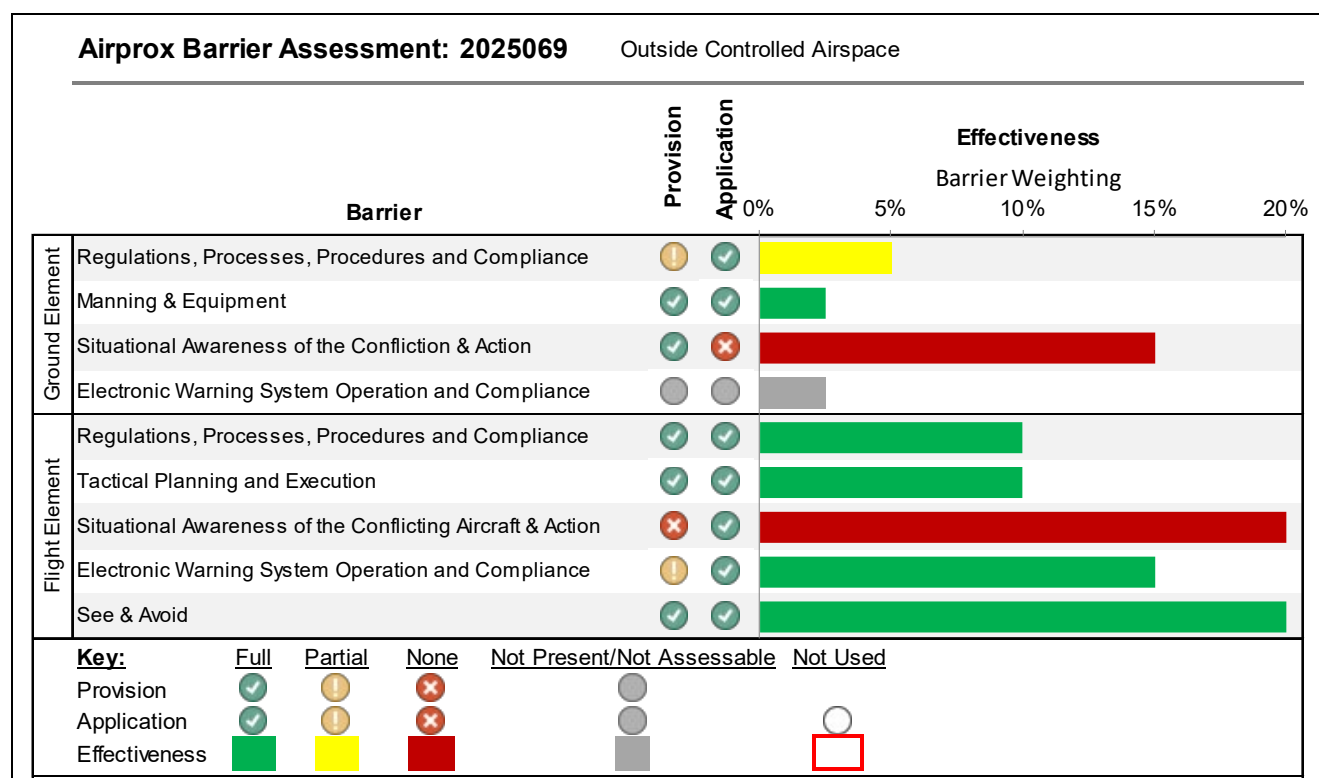
In assessing the effectiveness of the safety barriers associated with this incident, the Board concluded that the key factors had been that:

**Regulations, Processes, Procedures and Compliance** were assessed as **partially effective** because existing airfield documentation had not covered this mixed IFR/VFR traffic operating to simultaneous surfaces scenario.

**Situational Awareness of the Confliction and Action** were assessed as **ineffective** because the Talkdown controller had not corrected the CH47(A) pilot's incorrect readback to their landing clearance.

**Situational Awareness of the Conflicting Aircraft and Action** were assessed as **ineffective** because the CH47(A) pilot had, due to poor radio quality, no situational awareness of the presence of CH47(B) and had incorrectly read back their landing clearance which had then led to inaccurate situational awareness for the CH47(B) pilot.
