**AIRPROX REPORT No 2025073**

Date: 02 May 2025 Time: 1644Z Position: 5416N 00118W Location: 0.5NM NNW of Felixkirk

**PART A: SUMMARY OF INFORMATION REPORTED TO UKAB**

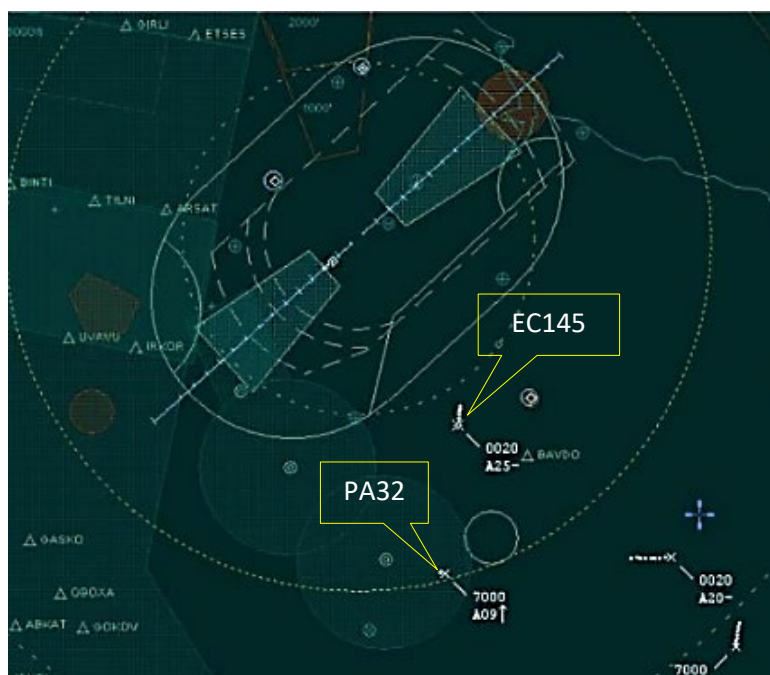
[The EC145 pilot] had left [their departure point] and was returning to base. The pilot elected to continue en-route whilst approximately 12NM south of Teesside and approximately 9NM north of Bagby, where a contact had just got airborne by the end of the transmission with what initially looked to be a south easterly track (Figure 1).

Figure 1 – Time 1641:17 EC145 changed frequency from Teesside.

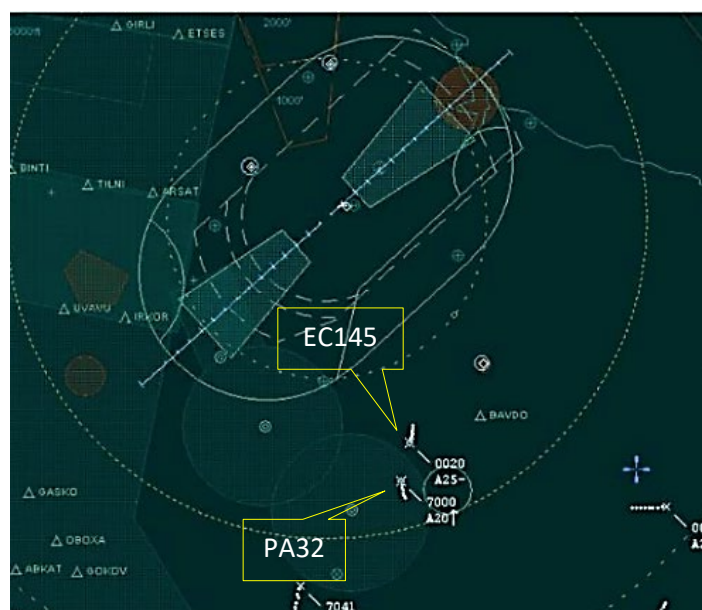
[The PA32], believed to be the primary [sic] contact out of Bagby, then turned north and [the pilot] called [Teesside Approach] with details of their flight. Traffic Information was passed to the pilot as “believed to be” as it was prior to identification, whereupon the pilot reported visual and continued northbound (Figure 2).

Figure 2 – Time 1642:56 PA32 pilot requested Traffic Service and transit.

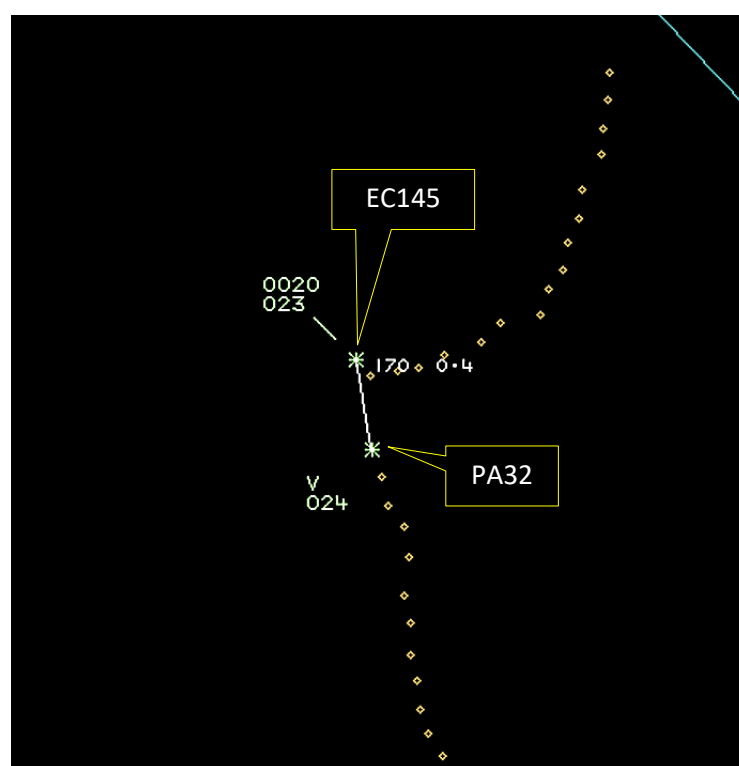
CPA was assessed to have occurred at 1643:38 with 100ft vertical and 0.4NM lateral separation (Figure 3).

Figure 3 - Time 1643:38
