**AIRPROX REPORT No 2025074**

Date: 04 May 2025 Time: 0852Z Position: 5048N 00011E Location: IVO Polegate

**PART A: SUMMARY OF INFORMATION REPORTED TO UKAB**

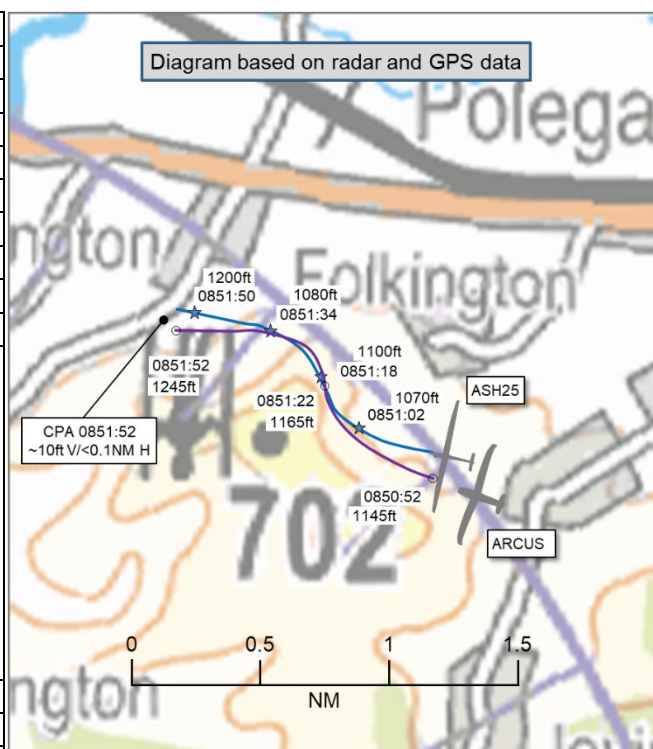
| Recorded | Aircraft 1 | Aircraft 2 |
|---|---|---|
| Reported | 30ft V/10m H | Not reported |
| Recorded | ~10ft V/<0.1NM H | |

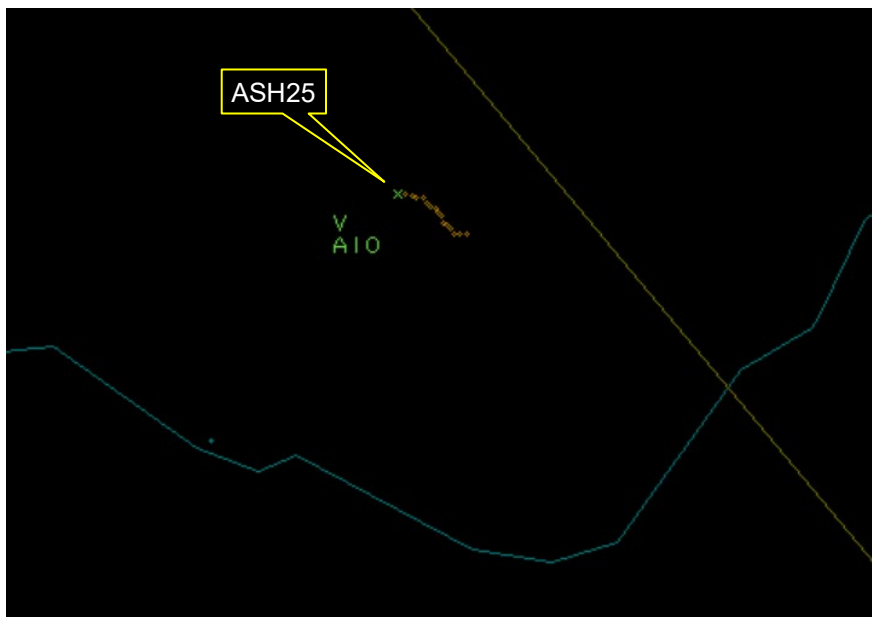
Figure 1: At CPA – 0851:52. The Arcus did not show on radar.

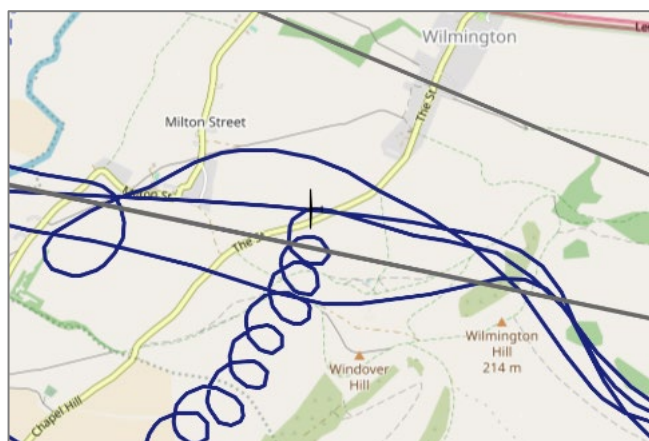
Figure 2: ASH25 at CPA from the pilot-provided IGC file.

Five seconds before CPA, at 0851:47, the ASH25 was flying at a ground speed of 72kt on a track of 285°, 570ft above the top of the adjacent ridge, when it encountered a strong thermal. With a 1.5NM gap in the ridge immediately ahead, whose crossing could incur significant height loss, the ASH25 pilot had apparently decided to use that thermal to gain extra height, and had begun rolling the glider left, towards the ridge, to begin a continuous thermalling turn. At that moment the Arcus was 100m astern of the ASH25 at the same level and in the latter's 7 o'clock position, flying at a similar speed on a gently diverging track of 270°. As the ASH25 turned across the Arcus' path, the latter's pilot had had little time to react. GNSS data indicate a minimum horizontal separation of 30m between the two gliders at CPA.

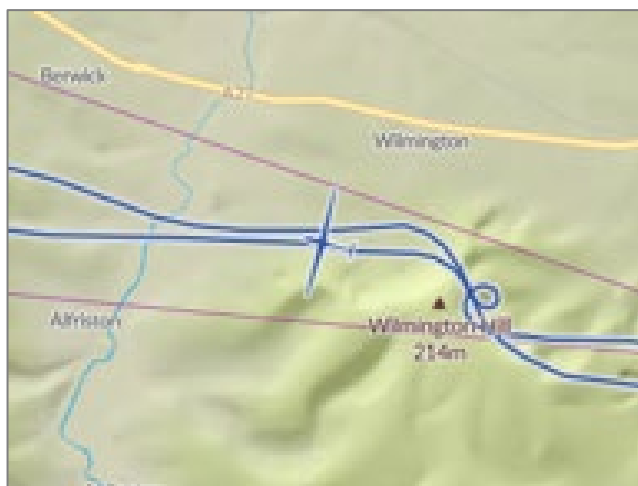
Figure 3: The Arcus at CPA. Image taken from an open source
