**AIRPROX REPORT No 2025075**

Date: 02 May 2025 Time: 1312Z Position: 5143N 00211W Location: 2NM SE Stroud

**PART A: SUMMARY OF INFORMATION REPORTED TO UKAB**

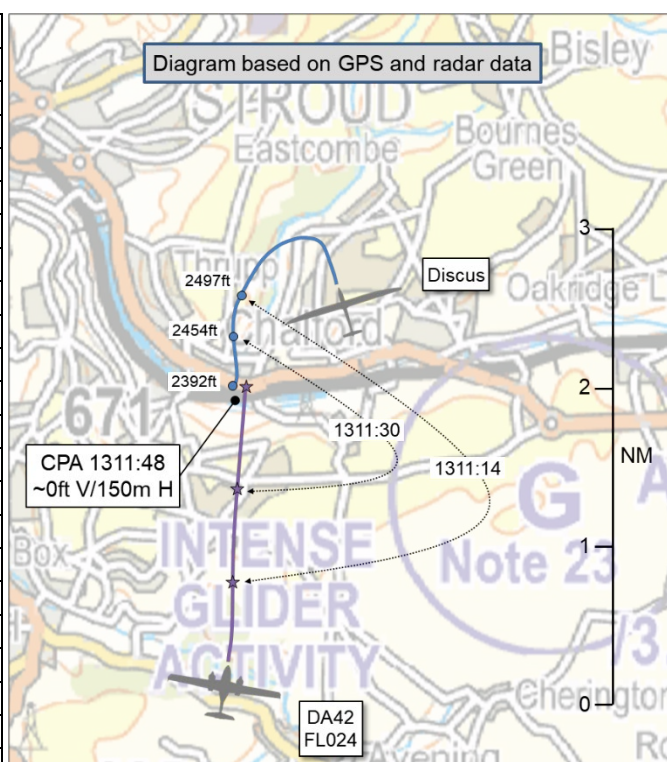
Both pilots kindly supplied GPS data for their respective flights. The diagram was constructed and the separation determined by combining the data sources. The aircraft are displayed in the diagram with altitudes based on standard pressure.

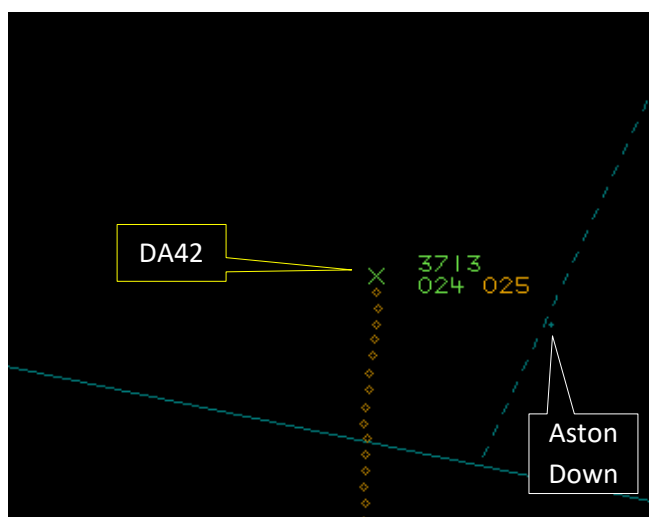
Figure 1 - 1311:42

An analysis of the NATS radar replay was undertaken and the DA42 could be positively identified from Mode S data. The Discus was not observed (Figure 1).

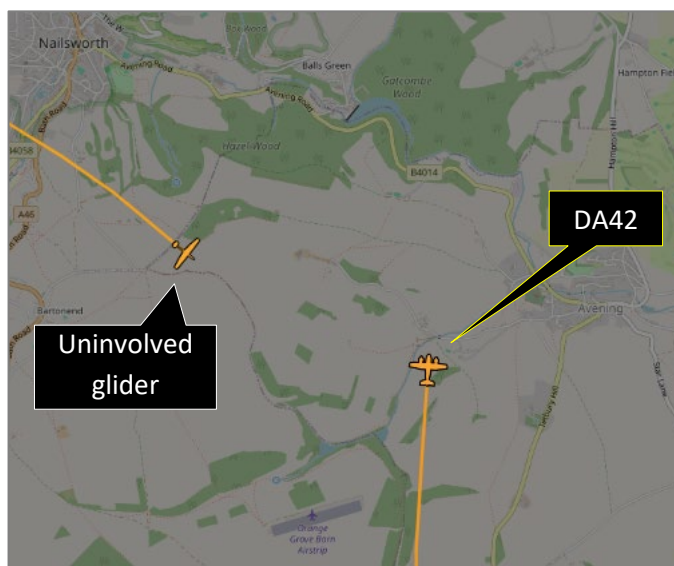
Figure 2 – 1310:30

The pilot of the DA42 had referred in their narrative report to a glider, sighted at 1310, that had been above them by 300ft and tracking south-east. That glider is believed to have been the glider shown in Figure 2 that was not involved in the Airprox encounter.
