**AIRPROX REPORT No 2025080**

Date: 10 May 2025 Time: 1016Z Position: 5058N 00210W Location: final RW08 Compton Abbas

**PART A: SUMMARY OF INFORMATION REPORTED TO UKAB**

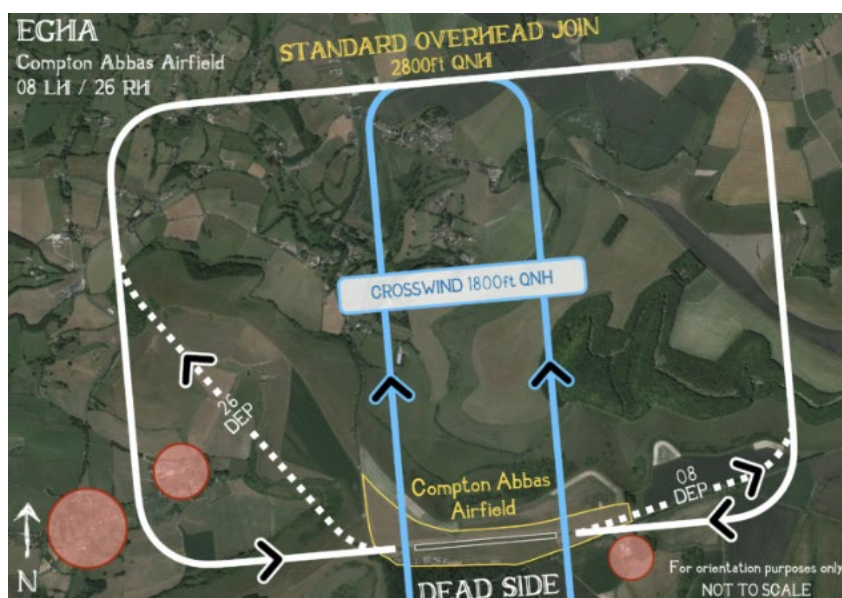
Figure 1 – Compton Abbas circuit procedures

As a noise abatement measure, pilots on the base and final legs for RWY 08 are asked to avoid flying over the built up areas of Compton Abbas and East Compton, as highlighted by the red circles. In particular, please avoid using the church at the western edge of Compton Abbas as a waypoint or turn-point. On the downwind leg, pilots are asked to remain to the North of Cann Common.

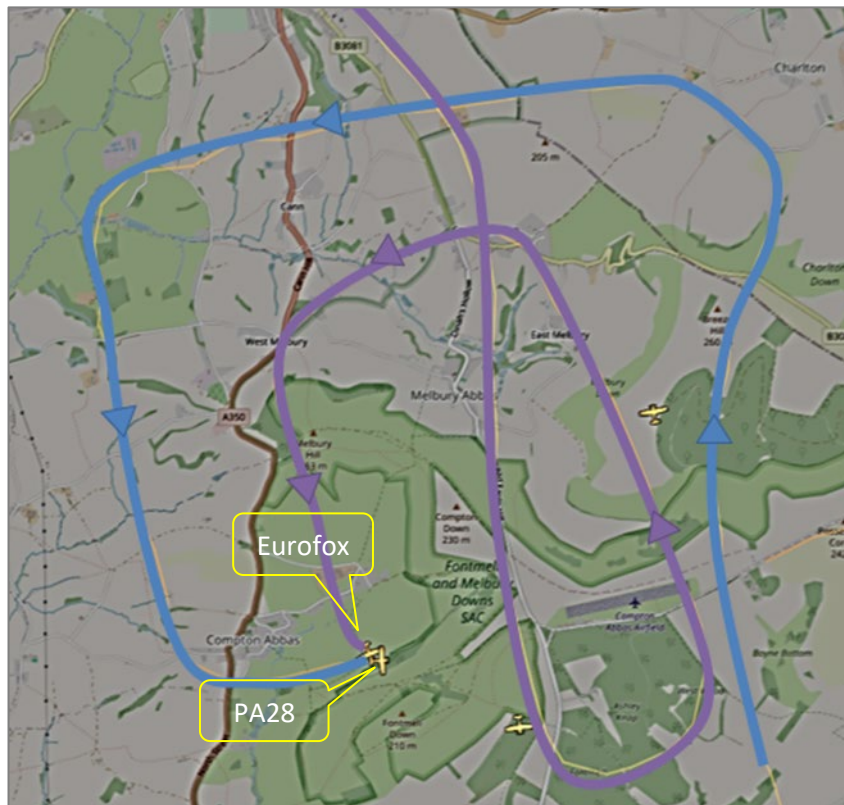
Figure 2 – Time 1015:30

Figure 2, above depicts the flight paths and joining pattern flown by each aircraft, as depicted by ADS-B data. The Eurofox track was coincident with the navigation track data provided by the pilot.

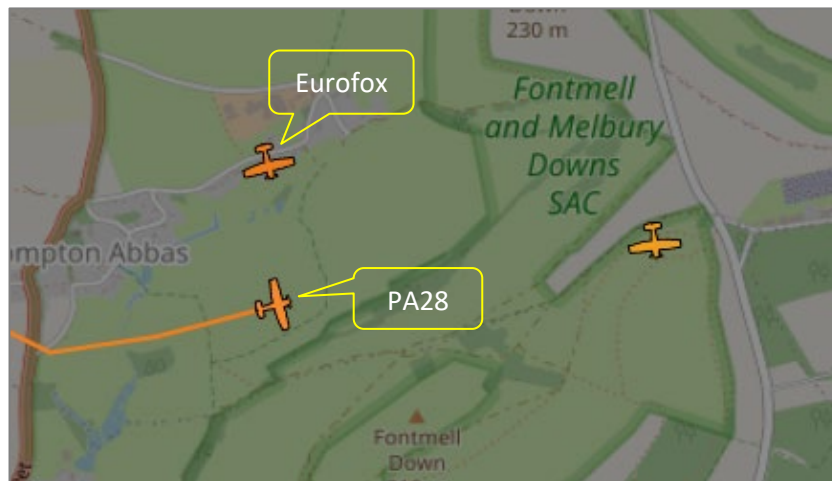
Figure 3 – Time 1015:20

At 1015:20 the Eurofox could be seen on a base leg for RW08, heading towards the PA28 which was established on the final approach for RW08. Separation at this time was approximately 100ft vertically and 0.23NM laterally (Figure 3).

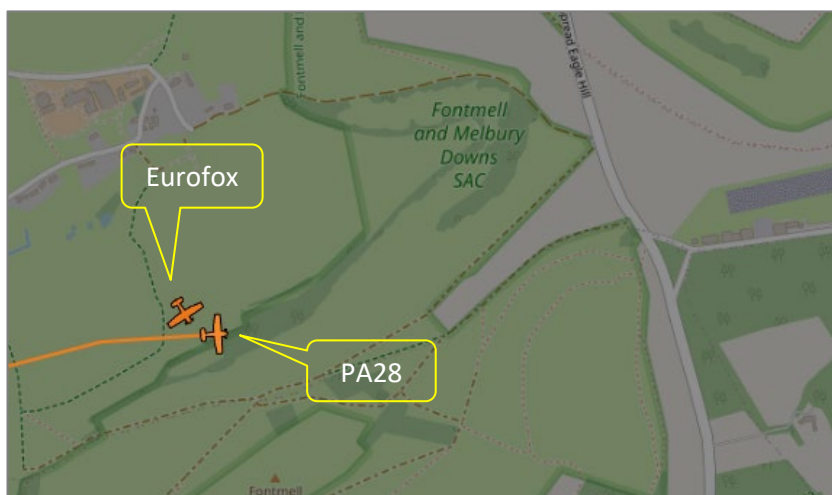
Figure 4 – Time 1015:30

After analysis and interpolation of available data sources, CPA was assessed to have occurred at 1015:30 when the Eurofox was seen to initiate a turn from left base onto final for RW08, with vertical separation approximately 10ft and lateral separation less than 0.1NM (Figure 4).
