AIRPROX REPORT No 2025081

Date: 09 May 2025 Time: 1113Z Position: 5609N 00247W Location: 4.5NM SE Elie

PART A: SUMMARY OF INFORMATION REPORTED TO UKAB

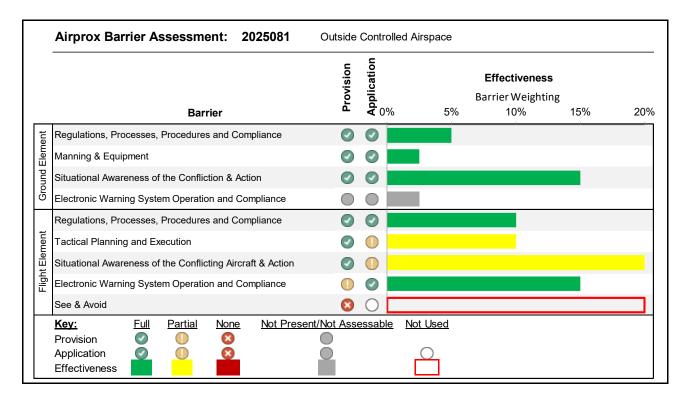
Safety Barrier Assessment⁴

Tactical Planning and Execution was assessed as **partially effective** because the Long-EZ pilot had not assimilated NOTAM H2317/25 during their pre-flight planning and the BE200 pilot had not briefed the Leuchars controller on their task requirement of a non-deviating track.

Situational Awareness of the Conflicting Aircraft and Action were assessed as partially effective because the BE200 pilot was concerned by the proximity of the Long-EZ.

See and Avoid was assessed as **not used** because the BE200 pilot reacted on the basis of their TAS information, without seeing the Long-EZ, and the Long-EZ pilot did not see the BE200 but separation at CPA was such that safety was maintained.
