**AIRPROX REPORT No 2025082**

Date: 09 May 2025 Time: 1322Z Position: 5319N 00144W Location: IVO Camphill

**PART A: SUMMARY OF INFORMATION REPORTED TO UKAB**

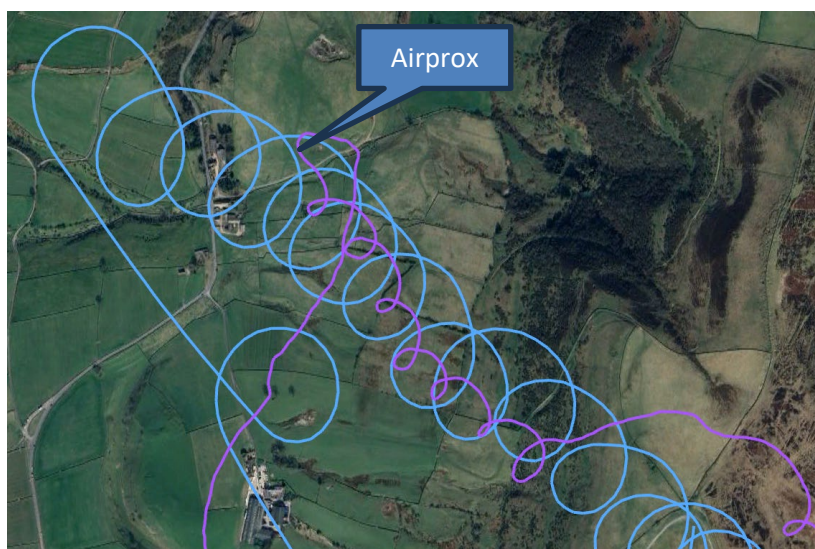
An analysis of the NATS radar replay was undertaken. Neither aircraft was observed on the replay. Both pilots kindly supplied GPS track data for their respective flights (Figure 1).

Figure 1 – The tracks of the Discus (blue) and paraglider (purple)

The diagram was constructed and the separation at CPA determined from the GPS data.
