**AIRPROX REPORT No 2025083**

Date: 14 May 2025 Time: 1552Z Position: 5156N 00055W Location: 5NM SE Buckingham

**PART A: SUMMARY OF INFORMATION REPORTED TO UKAB**

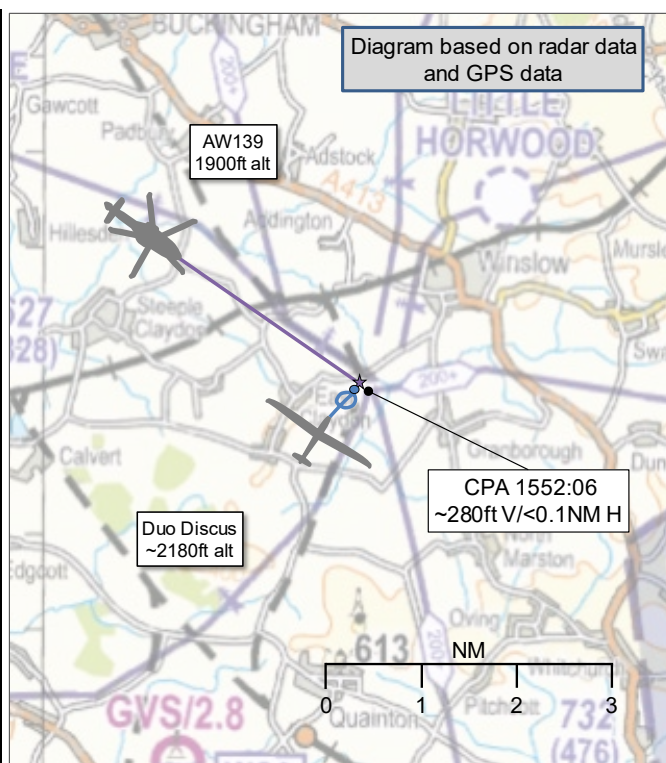
| Recorded | Aircraft 1 | Aircraft 2 |
|---|---|---|
| Recorded | ~280ft V/<0.1NM H | |

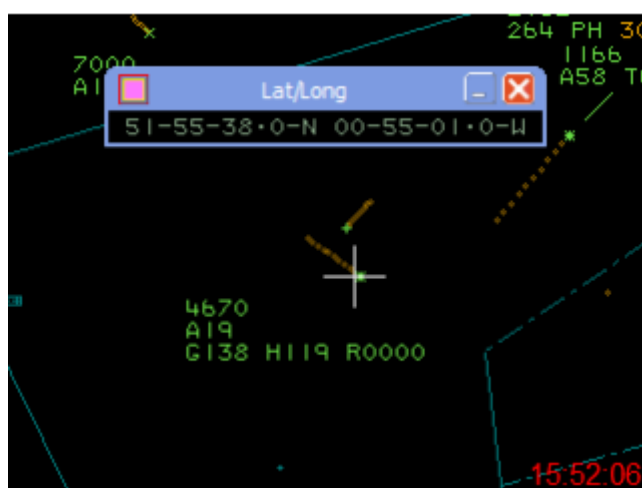
Figure 1

The notification of the Airprox from UKAB included a time and Lat/Long position. [The AW139] was passing the Lat/Long position coincident with the GW APP controller informing them they were identified and issuing a Basic Service, at 1552:06 (Figure 1).
