AIRPROX REPORT No 2025085

Date: 15 May 2025 Time: 1346Z Position: 5328N 00223W Location: Barton ATZ

PART A: SUMMARY OF INFORMATION REPORTED TO UKAB

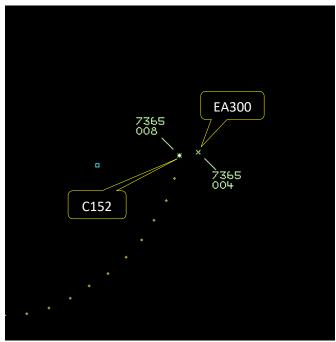
Figure 1 Time 1345:51 CPA

An analysis of the NATS radar replay was undertaken and both aircraft were positively identified using Mode S data. The EA300 first appeared on the radar replay at 1345:51 during its climb-out from Barton. The separation at that time was 400ft vertically and 0.1NM laterally, and was the closest recorded point of approach (Figure 1).

The EA300 continued to climb straight ahead while the C152 continued to join the circuit pattern. The two aircraft became co-altitude at 1346:03, at which point they were 0.4NM apart.

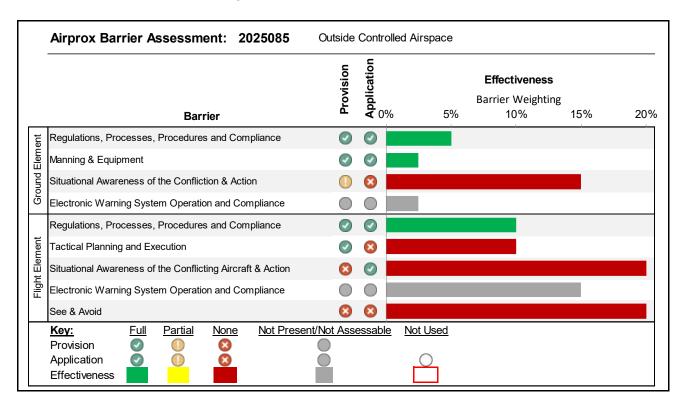
Situational Awareness of the Confliction and Action were assessed as ineffective because the Barton AFISO did not pass specific Traffic Information to either the C152 or the EA300 pilots.

Tactical Planning and Execution was assessed as ineffective because the EA300 pilot had neither communicated their intentions nor considered adjusting their departure profile for joining traffic.

Situational Awareness of the Conflicting Aircraft and Action were assessed as ineffective because the EA300 pilot had no situational awareness of the presence of the C152, having neither been informed of it nor requested pertinent local Traffic Information.

See and Avoid were assessed as ineffective because the C152 pilot had not seen the EA300 until it passed beneath and to the right of them, and the EA300 pilot had not seen the C152.
