**AIRPROX REPORT No 2025090**

Date: 08 May 2025 Time: 1501Z Position: 5357N 00034W Location: 4NM S Wetwang

**PART A: SUMMARY OF INFORMATION REPORTED TO UKAB**

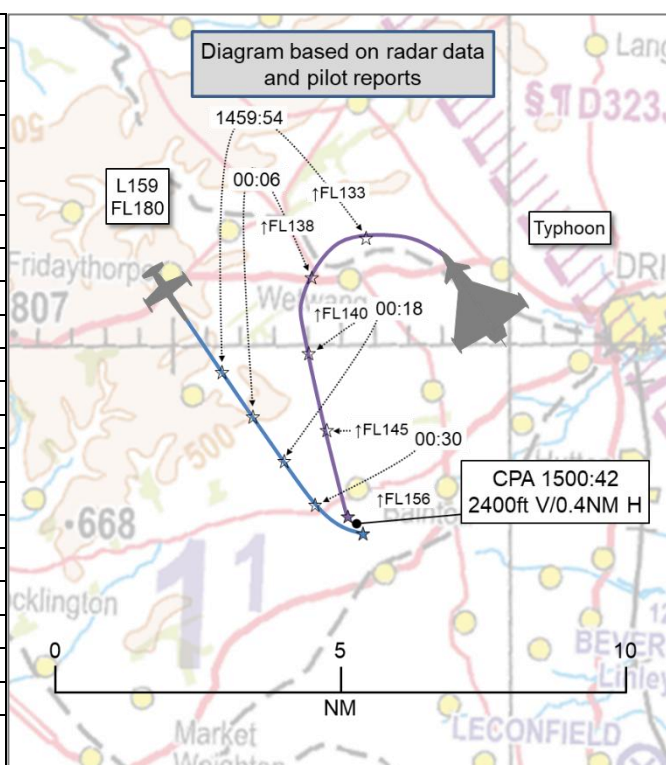
Recorded	Aircraft 1	Aircraft 2
Aircraft	Aero L159	Typhoon
Operator	Civ Comm	HQ Air (Ops)
Airspace	London FIR	London FIR
Class	G	G
Rules	VFR	VFR
Service	Traffic	Traffic
Provider	Boulmer	Swanwick Mil
Altitude/FL	FL180	FL156
Transponder	A, C, S	A, C, S
Reported		
Colours	NR	NR
Lighting	NR	NR
Conditions	VMC	NR
Visibility	NR	NR
Altitude/FL	FL180	NR
Altimeter	NR	NR
Heading	144°	NR
Speed	220kt	NR
ACAS/TAS	TAS	Not fitted
Separation at CPA		
Reported	'1-2NM in the 6 o'clock'	Not Seen
Recorded	2400ft V/0.4NM H

CPA occurred at 1500:43, with a separation of 0.4NM laterally and 2400ft vertically.
