**AIRPROX REPORT No 2025092**

Date: 20 May 2025 Time: 1412Z Position: 5155N 00150W Location: IVO Upper Harford

**PART A: SUMMARY OF INFORMATION REPORTED TO UKAB**

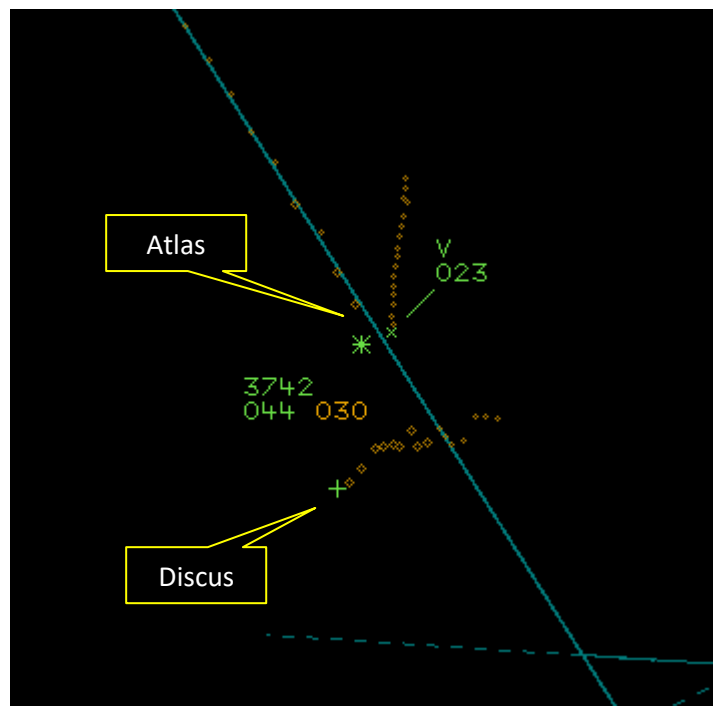
Figure 1 - NATS radar 1412:02

An analysis of the NATS radar replay was undertaken, the Atlas could be seen and identified using Mode S data (Figure 1). The Discus could not be identified, however, a primary-only contact could be seen. The Discus pilot provided a GPS data file which matched the profile of the primary-only track on the NATS radar (Figure 2). The diagram at the top of the report was compiled by amalgamating the GPS data file and the radar data to provide an approximate separation. The Discus has been shown in the diagram with altitudes based on standard pressure. The primary-only track faded from radar at 1412:10, just before CPA. Note, the Brize Radar controller would not have been using the NATS radar and therefore probably had a different radar picture.
