AIRPROX REPORT No 2025093

Date: 20 May 2025 Time: 1543Z Position: 5144N 00217W Location: ivo Nympsfield glider site

PART A: SUMMARY OF INFORMATION REPORTED TO UKAB

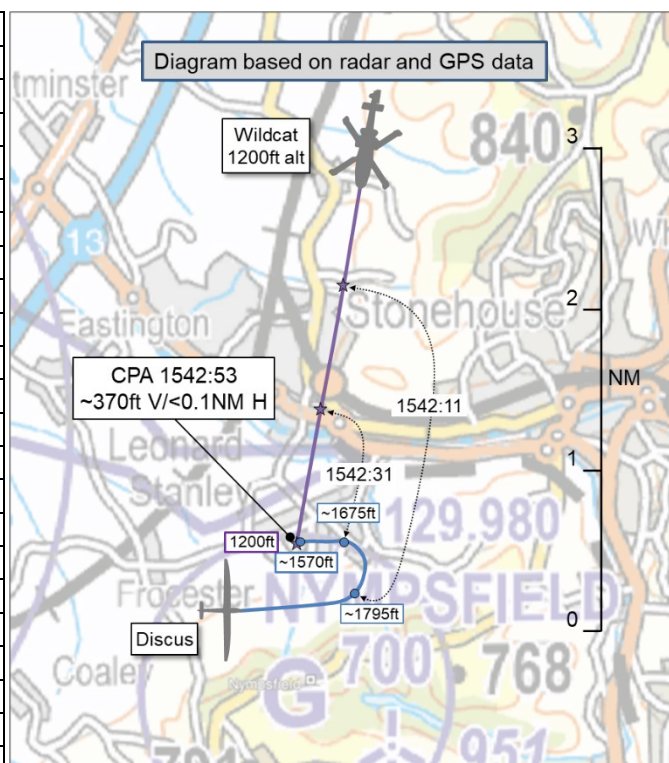
An analysis of the NATS radar replay was undertaken and the Wildcat was positively identified using Mode S data but the Discus was not detected.

CPA was assessed to have been at 1542:53 by interpolation of radar and GPS data, with approximately 370ft vertical and less than 0.1NM lateral separation.

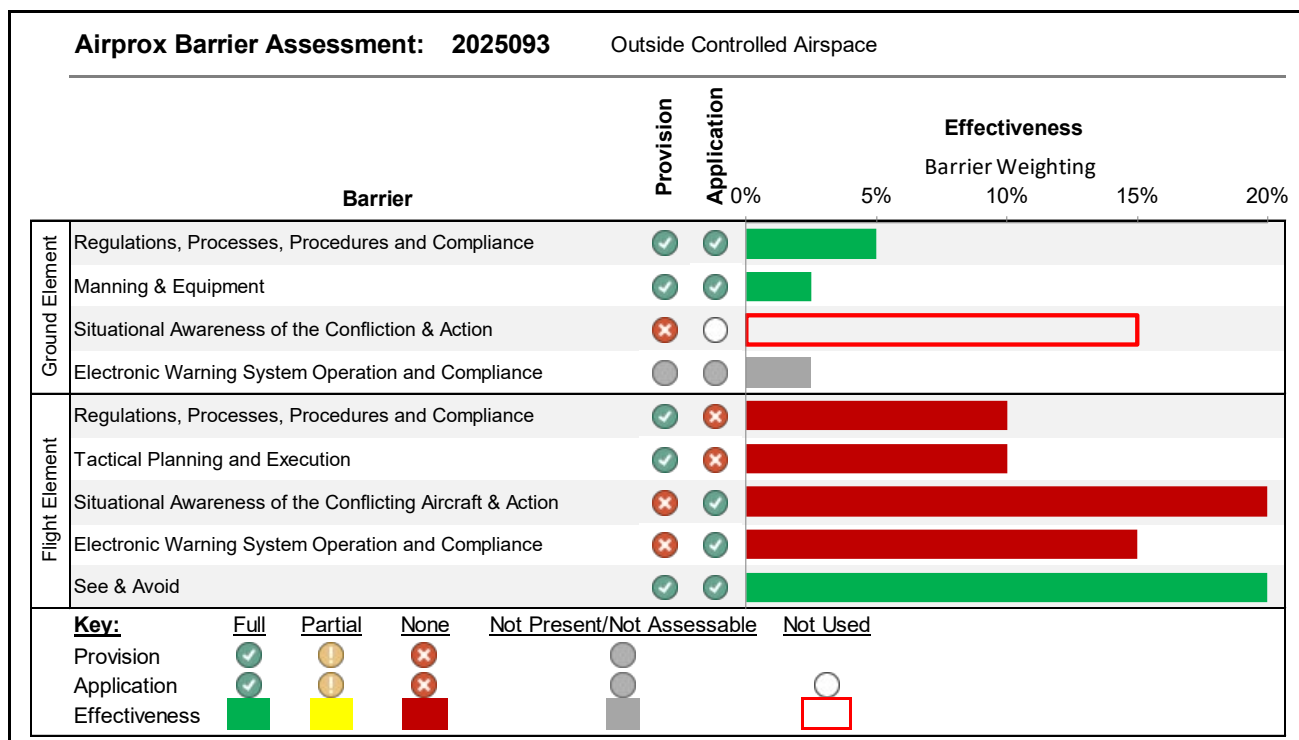
Safety Barrier Assessment⁴

Situational Awareness of the Confliction and Action were assessed as **not used** because the London FISO was not required to monitor the Wildcat under the terms of a Basic Service.

Regulations, Processes, Procedures and Compliance were assessed as **ineffective** because the Wildcat pilot had not complied with regulations pertaining to avoidance of circuit traffic.

Tactical Planning and Execution was assessed as **ineffective** because the Wildcat pilot's ineffective preflight planning led them to mistakenly overfly an active glider site.

Situational Awareness of the Conflicting Aircraft and Action were assessed as **ineffective** because neither pilot had any situational awareness of the presence of the other aircraft.

Electronic Warning System Operation and Compliance were assessed as **ineffective** because the EC equipment fitted in the Discus was unable to detect that of the Wildcat, and the TAS fitted in the Wildcat was unable to detect the signals emitted by the EC equipment fitted in the Discus.
