**AIRPROX REPORT No 2025100**

Date: 25 May 2025 Time: 1203Z Position: 5109N 00017E Location: NE Tunbridge Wells

**PART A: SUMMARY OF INFORMATION REPORTED TO UKAB**

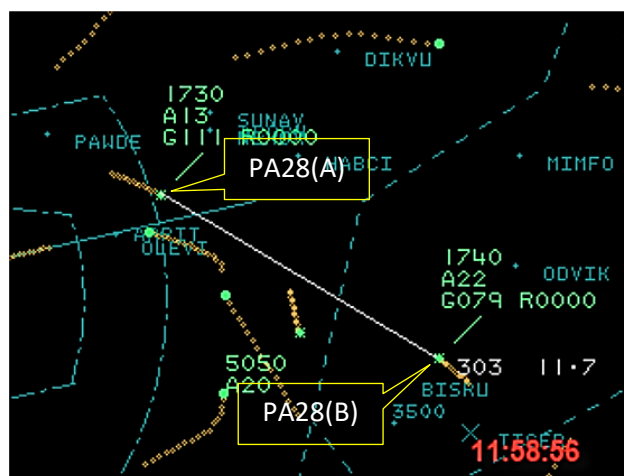
Figure 1

The pilot of [PA28(B)], outbound from [departure point], contacted the Farnborough LARS East (LF-LARS) at 1131:08 (all times UTC) and requested a Basic Service which was agreed. The pilot of [PA28(A)] contacted the LF-LARS frequency at 1158:15 and requested a Basic Service. The pilot reported they were overhead Bough Beech Reservoir at altitude 1300ft, on QNH 1010hPa. SSR code 1730 was issued with a Basic Service agreed. The SSR code 1730 was input to the aircraft Mode-A at 1158:56 with [PA28(A)], tracking beneath the lateral boundary of the Gatwick CTA, 11.3NM from [PA28(B)], on an opposite direction track (Figure 1).

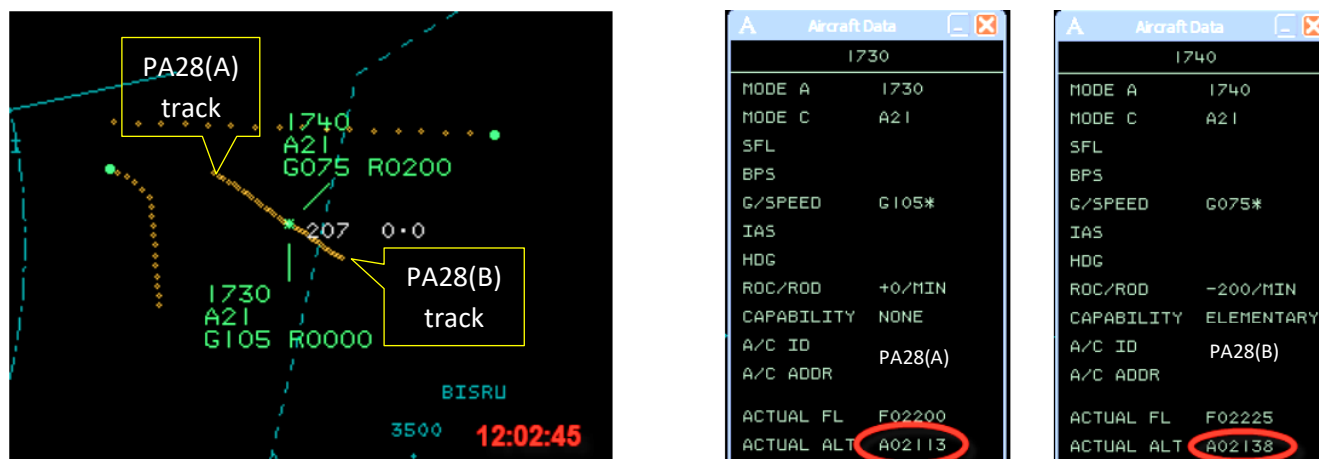
[PA28(A)] then commenced an unreported climb to maintain altitude of 2200ft. This was potentially in conflict with [PA28(B)] that was maintaining 2200ft on an opposite direction track, inbound to [destination]. The two aircraft crossed at 1202:45 (Figure 2).

Figure 2: CPA Time 1202:45 and altitude read-outs.

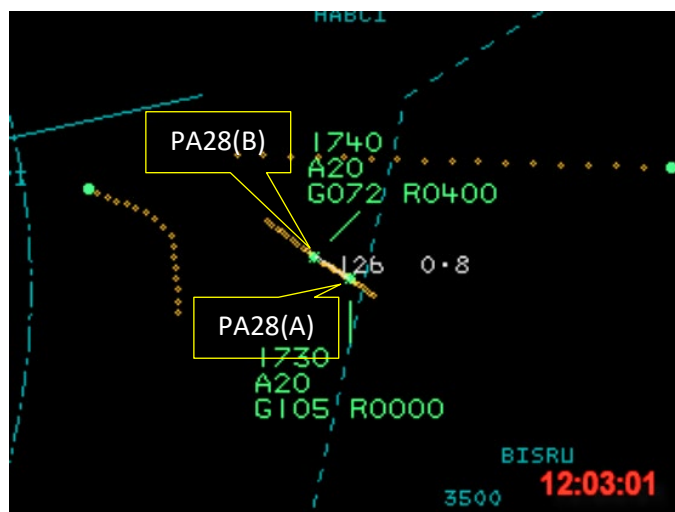
The closest point of approach between [PA28(A)] and [PA28(B)] occurred at 1202:45 and was displayed on NODE multi-track radar as 0.0NM and 0ft. NODE Radar aircraft data displayed the 'actual altitude' of [PA28(A)] as 2113ft, with the 'actual altitude' of [PA28(B)] displayed as 2138ft, which indicated the vertical separation was approximately 25ft. Although the Mode C of both aircraft changed from A21 (2100ft) to A20 (2000ft), neither aircraft displayed any form of lateral or vertical avoidance manoeuvre on radar (Figure 3).

Figure 3 – after CPA.

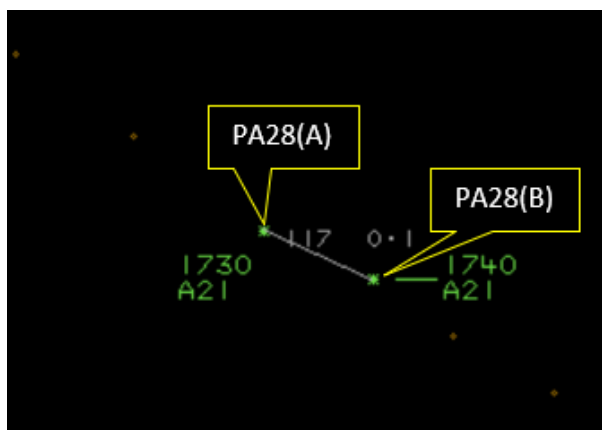
Figure 4 – Time 1202:46 co-altitude at 0.1NM

Figures 4 and 5, above depict that the aircraft were separated laterally by 0.1NM immediately before and after CPA. Therefore, CPA was assessed by interpolation to have been at 1202:48, co-altitude and less than 0.1NM lateral separation.

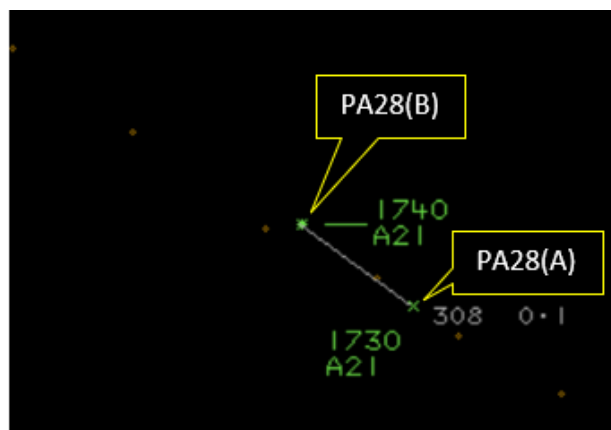
Figure 5 – Time 1202:50 co-altitude at 0.1NM
