AIRPROX REPORT No 2025101

Date: 17 May 2025 Time: 1352Z Position: 5231N 00252W Location: Long Mynd

PART A: SUMMARY OF INFORMATION REPORTED TO UKAB

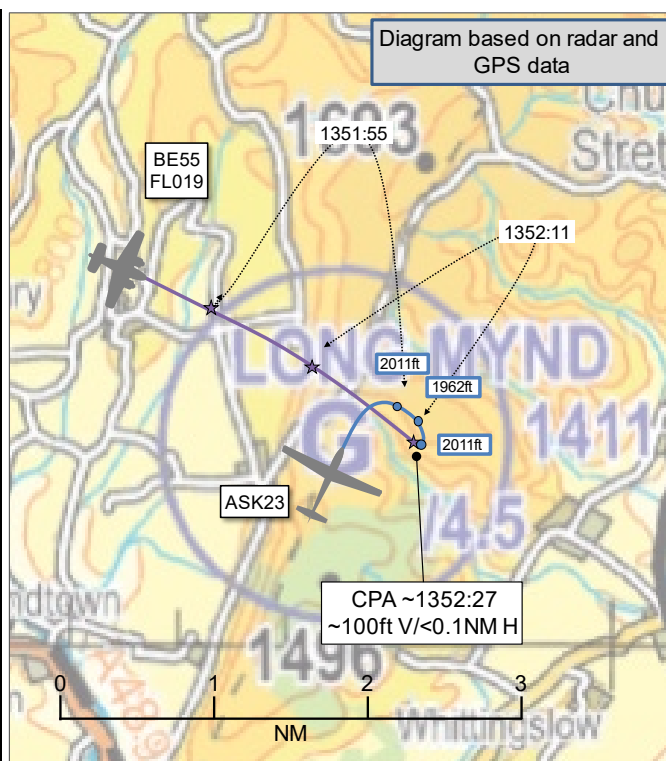
Recorded	Aircraft 1	Aircraft 2
Aircraft	ASK23	BE55
Operator	Civ Gld	Civ FW
Airspace	London FIR	London FIR
Class	G	G
Rules	VFR	VFR
Service	None	Basic
Provider	N/A	London Information
Altitude/FL	2011ft (1013hPa)	FL019
Transponder	Not fitted	A, C, S
Reported		
Colours	White	White
Lighting	None	
Conditions	VMC	VMC
Visibility	>10km	5-10km
Altitude/FL	7-800ft	NK
Altimeter	QFE	NK
Heading	Southerly	134°
Speed	NK	160kt
ACAS/TAS	FLARM	SkyEcho
Alert	None	None
Separation at CPA		
Reported	100ft V/100ft H	300ft V/1000m H
Recorded	~100ft V/<0.1NM H

An analysis of the NATS radar replay was undertaken and the BE55 could be seen indicating FL019; the ASK23 could not be seen on the radar. However, the ASK23 pilot provided a GPS log file, from which the diagram at the top of the report could be compiled. The glider was flying at approximately 2011ft (SPS) when the BE55 transited past at FL019.

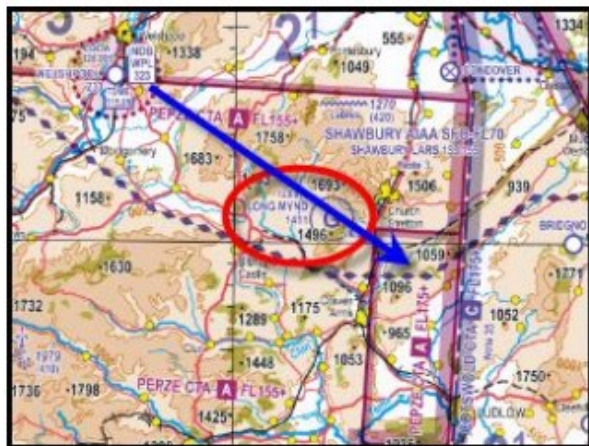
Figure 1

Figures 1 and 2 display the location of the confliction and approximate track of [the BE55]. The ASK23 was not displayed on NODE Radar.

The VFR Chart (Figure 1) displayed Long Mynd elevation as 1411ft AMSL with associated glider winch activity up to altitude 4500ft. There was no primary or secondary contact on radar representing the glider, therefore, based on the pilot report of an estimated height of 700ft, it was calculated, using the RPS (1019hPa) at the time, that [the ASK23] was at an estimated altitude of 2111ft. [The BE55] Mode-C displayed FL020 (converting to 2157ft using 1019hPa) at the approximate time of the confliction.

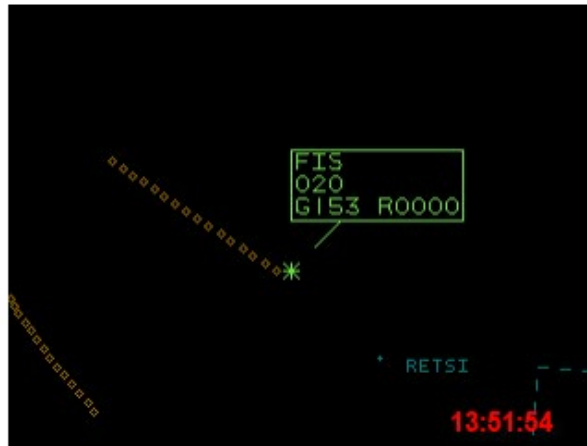
Figure 2

The BE55 was previously maintaining FL021, however had descended to FL020 whilst approaching Long Mynd. NODE radar displayed a minor lateral change to the track of the BE55 at 1351:54 (Figure 2/Figure 3). The pilot of the BE55 did not report a confliction on the London FIS frequency.

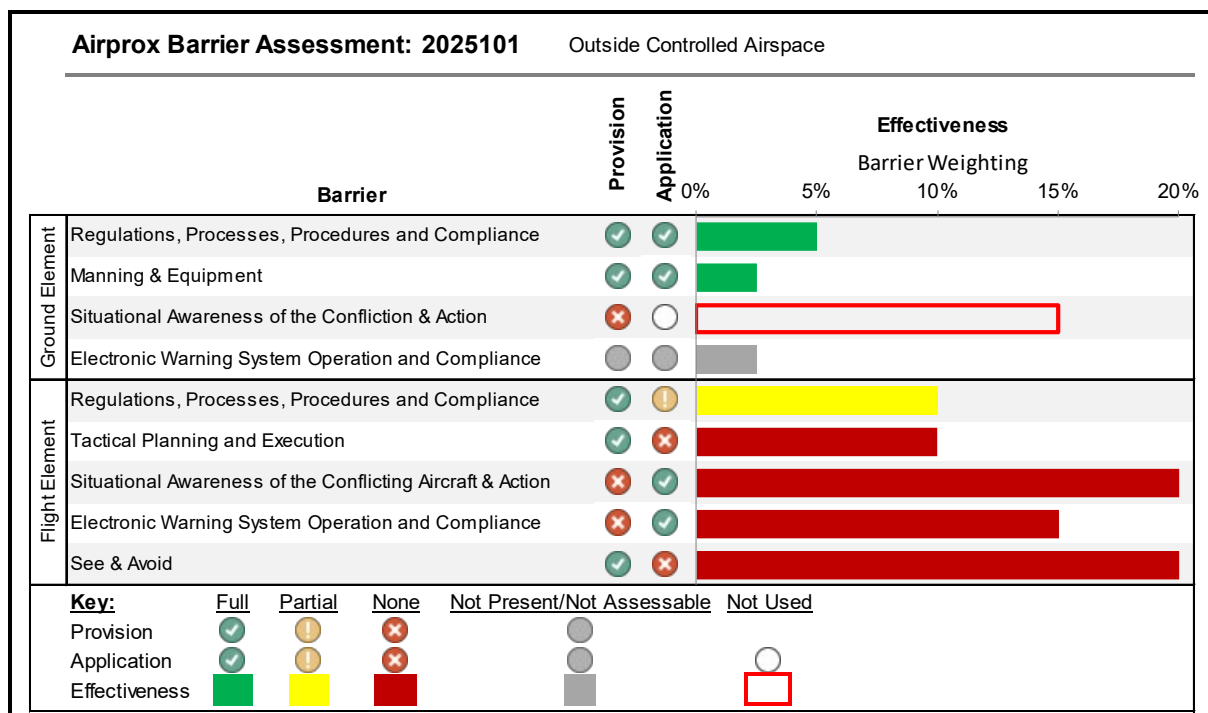
In assessing the effectiveness of the safety barriers associated with this incident, the Board concluded that the key factors had been that:

Situational Awareness of the Confliction and Action were assessed as **not used** because the London FISO was not required to monitor the flight of the BE55.

Regulations, Processes, Procedures and Compliance were assessed as **partially effective** because the BE55 pilot had overflown the gliding site, at or around circuit height.

Tactical Planning and Execution was assessed as **ineffective** because the BE55 had not sufficiently briefed pre-flight in order to be aware of the Long Mynd gliding site, and subsequently had not remained clear of the glider in the circuit.

Situational Awareness of the Conflicting Aircraft and Action were assessed as **ineffective** because neither pilot had received any situational awareness that the other aircraft had been in the vicinity, until they became visual.

Electronic Warning System Operation and Compliance were assessed as **ineffective** because the EWS on the glider could not have detected the BE55 and the EWS on the BE55 had been unserviceable at the time of the Airprox.

See and Avoid were assessed as **ineffective** because the glider pilot had not seen the BE55 until CPA and the BE55 pilot had probably been visual with a different glider.
