AIRPROX REPORT No 2025104

Date: 11 May 2025 Time: 0952Z Position: 5709N 00203W Location: Aberdeen

PART A: SUMMARY OF INFORMATION REPORTED TO UKAB

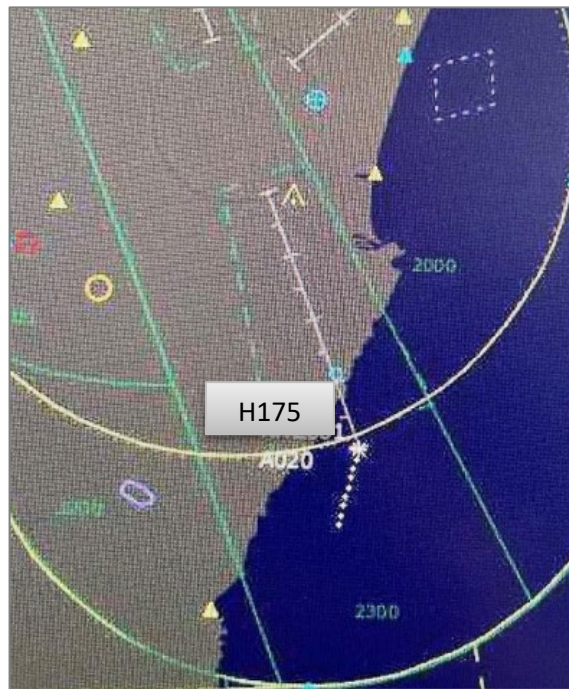
Figure 1

At this time [H175 C/S] entered the CTR at the southern boundary, offshore on the Stonehaven Lane with Mode C indicating 2000ft (Figure 1).

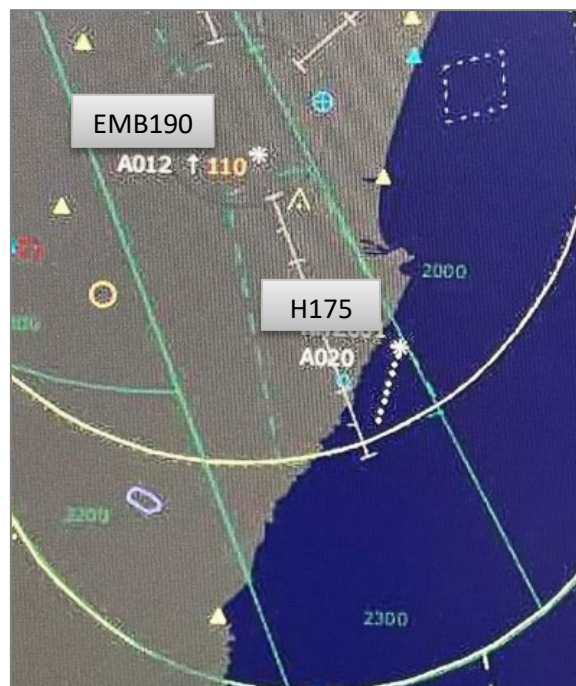
Figure 2

0950:37 – [EMB190 C/S] appeared in surveillance coverage with Mode C indicating the aircraft was climbing through 1200ft (Figure 2).

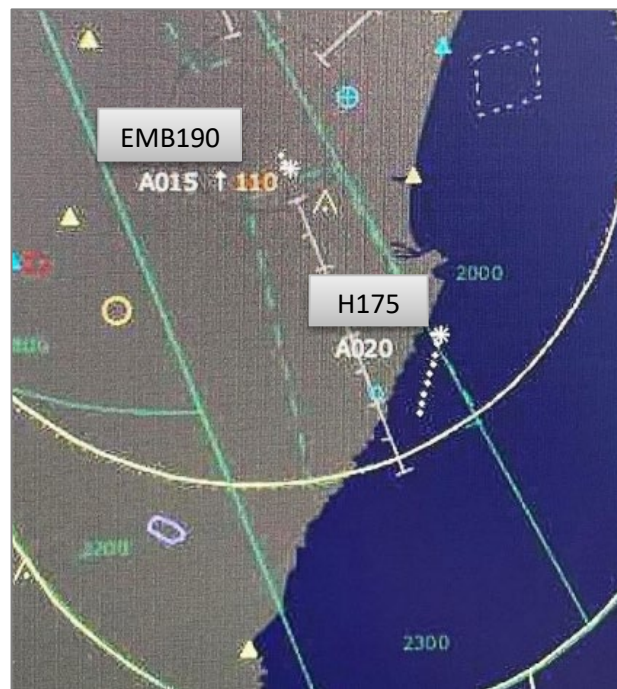
Figure 3

0950:49 – [EMB190 C/S] commenced a left turn towards RIVOT (Figure 3).

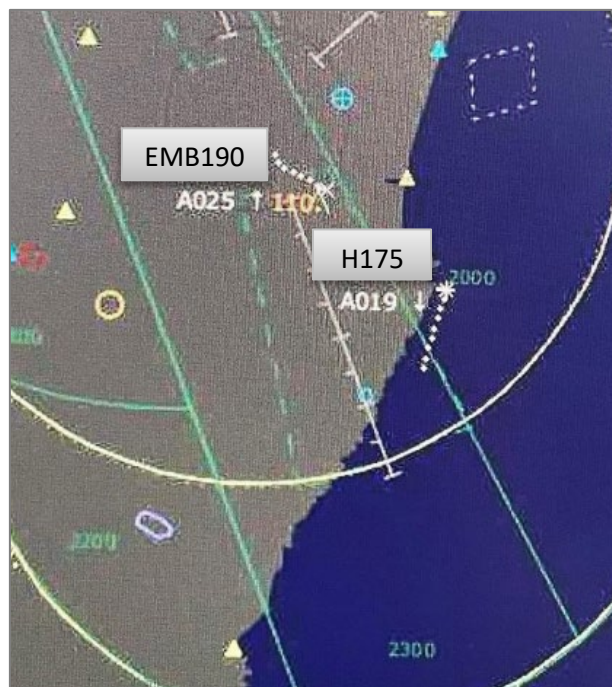
Figure 4

0951:18 – EMB190: “[C/S] *is there any traffic information...one o'clock?*”

RIT: “[EMB190 C/S] *there is a helicopter inbound to the field, VFR 1900ft.*”

This was acknowledged by the EMB190 pilot (Figure 4).

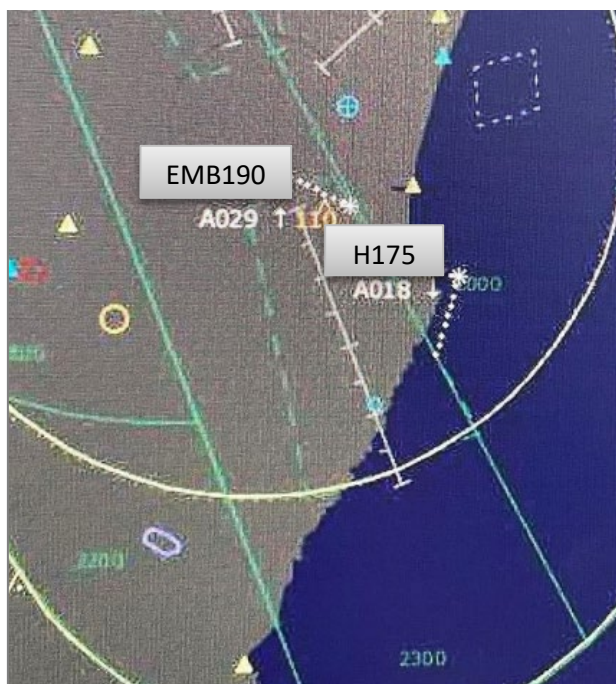
Figure 5

0951:31 - 1000ft vertical separation was achieved, based on Mode C responses. This point is also the closest [vertical] point of approach (Figure 5).

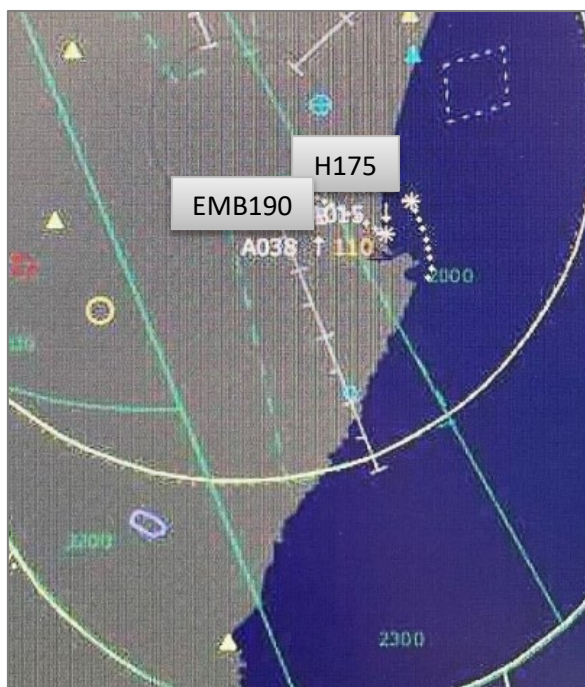
Figure 6

0952:14 - Minimum lateral separation of 1.16NM (Figure 6).

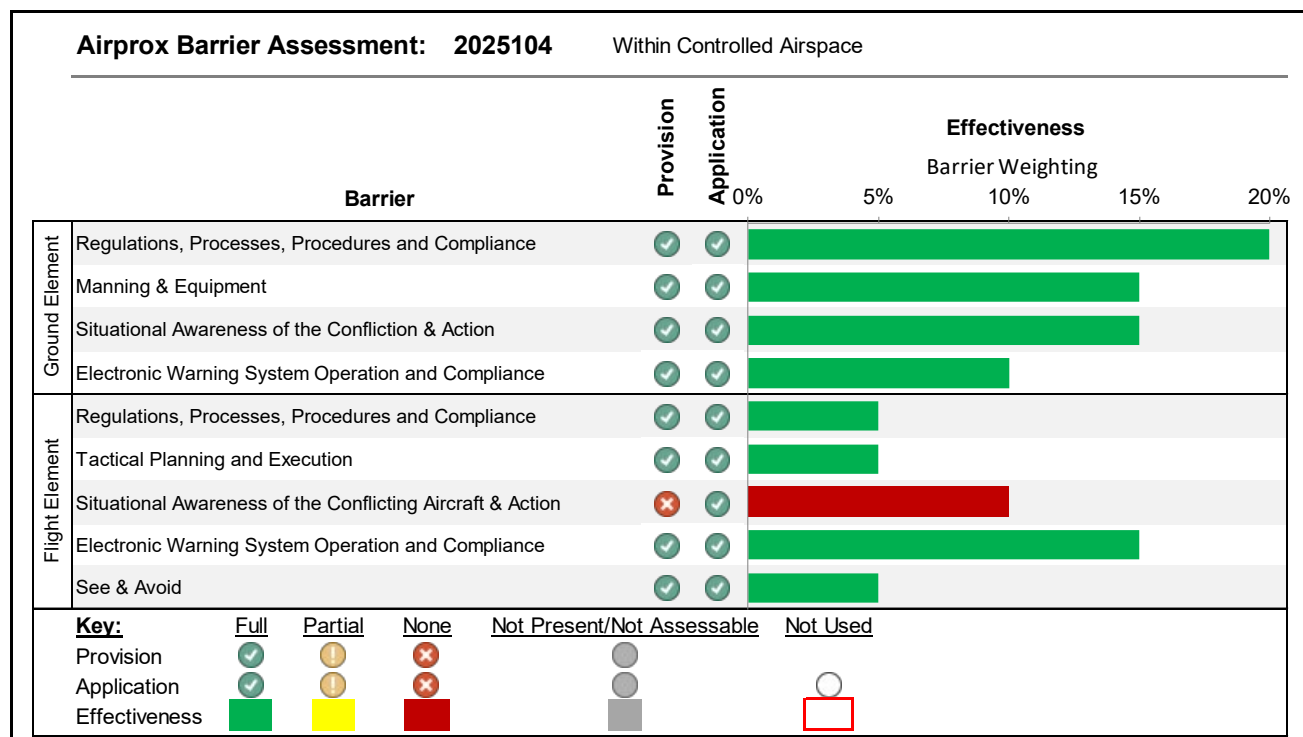
Situational Awareness of the Conflicting Aircraft and Action were assessed as **ineffective** because the EMB190 pilot had not received any prior situational awareness on the presence of the H175.
