AIRPROX REPORT No 2025105

Date: 23 May 2025 Time: 1549Z Position: 5145N 00057W Location: Thame

PART A: SUMMARY OF INFORMATION REPORTED TO UKAB

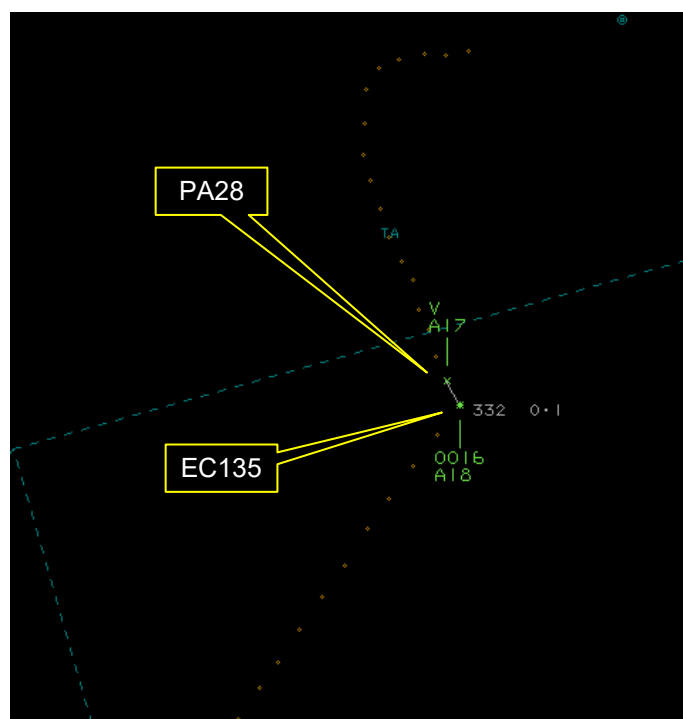
CPA occurred at 1548:59, with a separation of 0.1NM laterally and 100ft vertically.

Figure 1:1548:58 (CPA minus 1 sec) 100ftV/<0.1NM H
