AIRPROX REPORT No 2025108

Date: 15 Jun 2025 Time: 1423Z Position: 5303N 00029W Location: IVO Cranwell North

PART A: SUMMARY OF INFORMATION REPORTED TO UKAB

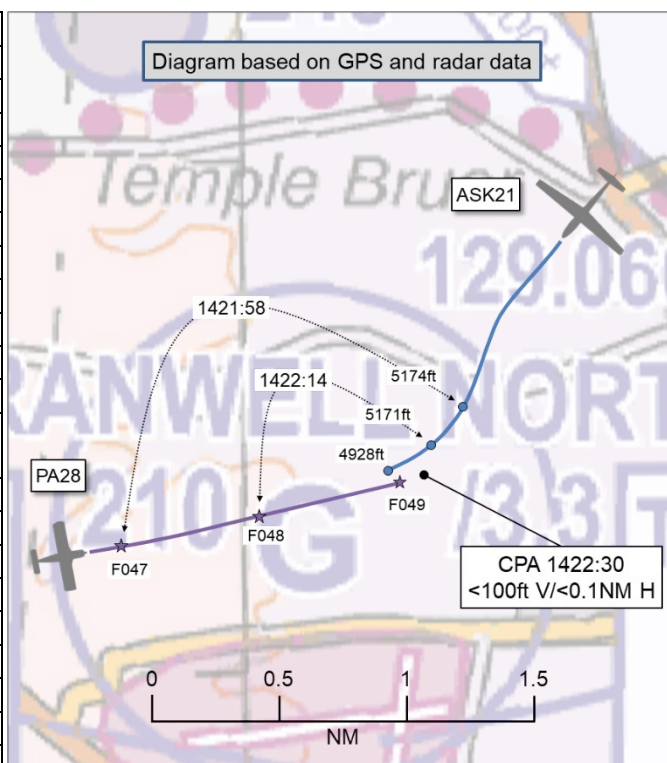
Permanent glider launch sites are listed in UK AIP ENR 5.5 and labelled on CAA VFR charts with a "G" symbol, as shown in the chart segment in Part A. Routine activity at these sites that falls within the schedule listed in ENR 5.5 does not merit a NOTAM. A greater density of gliders may be expected nearby during these scheduled periods, and at any altitude up to cloudbase.

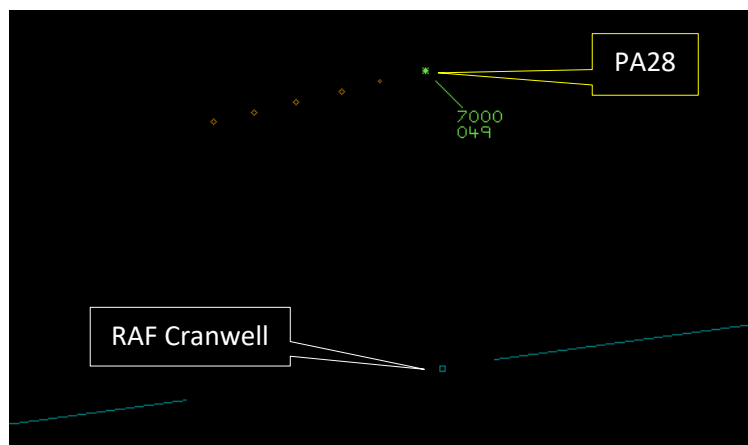
Figure 1 – CPA at 1422:30

An analysis of the NATS radar replay was undertaken and the PA28 could be positively identified from Mode S data (Figure 1). The ASK21 was not observed on the replay and was not observed by reference to ADS-B data sources.

The pilot of the ASK21 kindly supplied GPS track data for their flight. It was by combining the data sources that the diagram was constructed and the separation at CPA determined.
