**AIRPROX REPORT No 2025109**

Date: 14 Jun 2025 Time: 1305Z Position: 5224N 00058W Location: 4NM SE of Husbands Bosworth

**PART A: SUMMARY OF INFORMATION REPORTED TO UKAB**

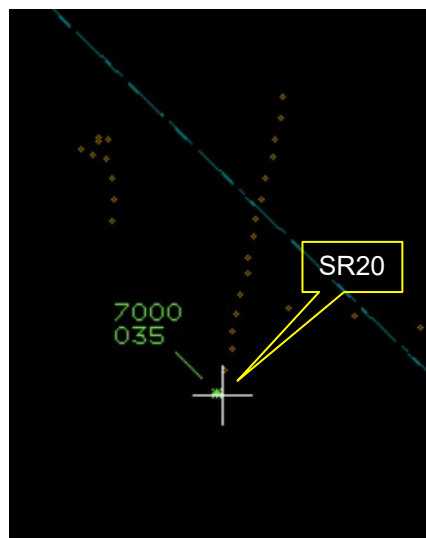
Figure 1: At CPA (1305:08) The ASW20 did not show on radar. White cross shows location of reported CPA.

The SR20 was tracked and identified using Mode S data. The ASW20 did not appear on radar at or around CPA. Both aircraft could be tracked using a number of open-source tracking tools and, in correlation with the GPS data file provided by the ASW20 pilot, the separation at CPA could be estimated at 0.1NM horizontally and ~20ft vertically. The SR20 could be seen to have initiated descent rapidly from approximately CPA minus 1sec and appeared to 'bottom out' approximately 300ft below the ASW20's altitude.

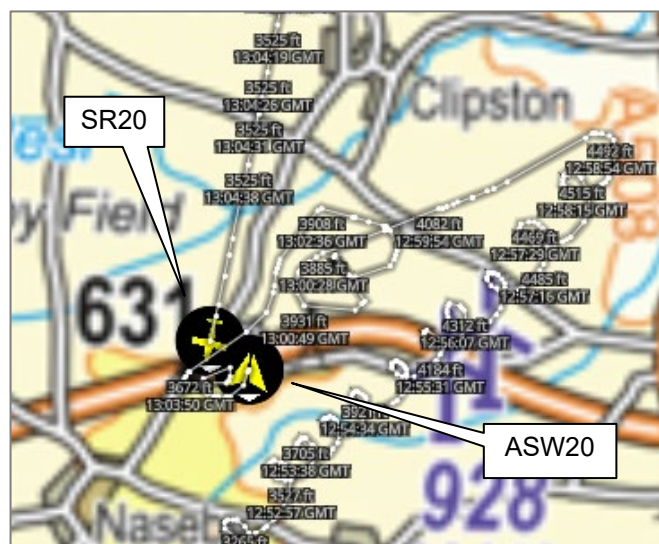
Figure 2: From the Airspace Analyser Tool at CPA minus 3sec (1305:05)

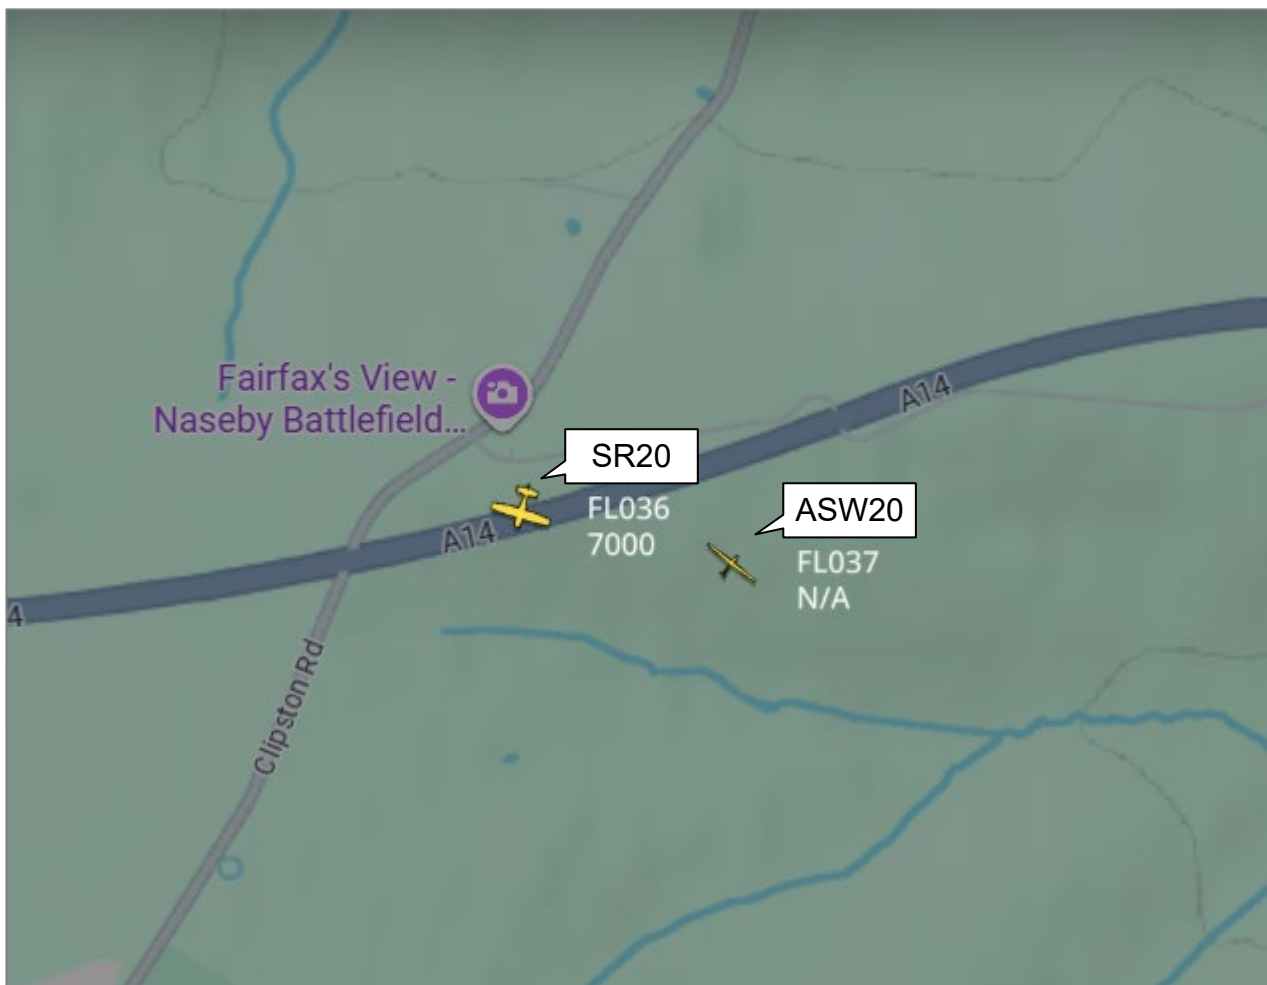
Figure 3: from an open-source aircraft tracking system at 1305:08
