**AIRPROX REPORT No 2025118**

Date: 20 Jun 2025 Time: 0943Z Position: 5145N 00121W Location: Farmoor Reservoir

**PART A: SUMMARY OF INFORMATION REPORTED TO UKAB**

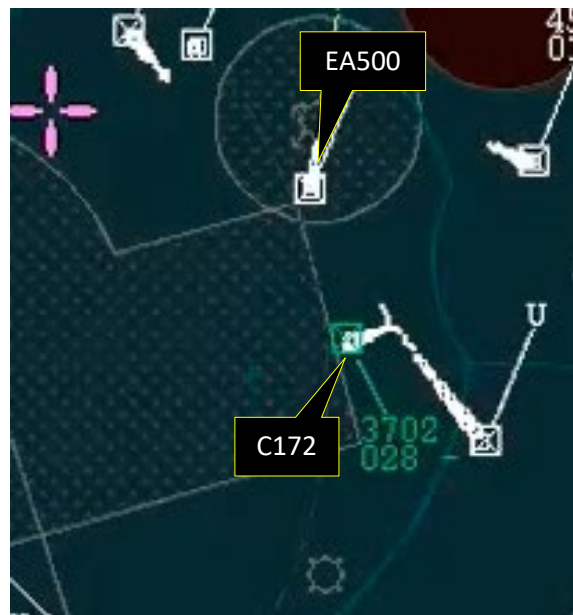
At 0941:31, the C172 entered the CTR, the controller issued Radar Control and instructed the pilot to remain VMC (Figure 1).

Figure 1 0941:31 C172 entering CTR

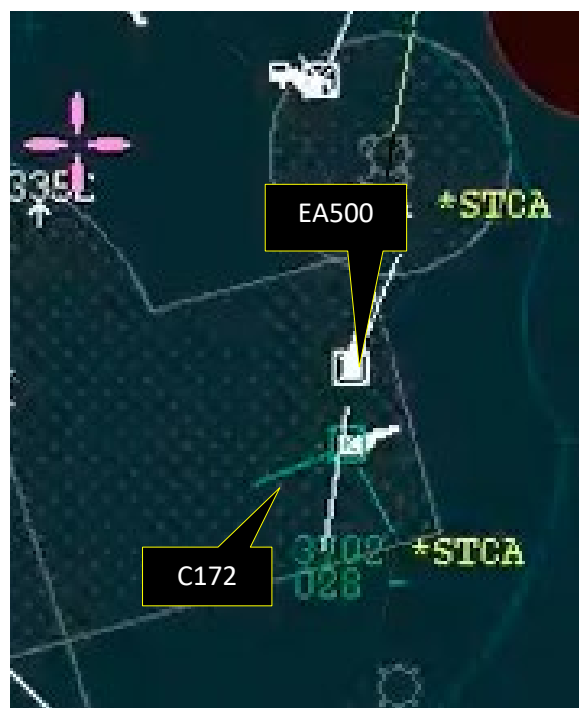
At 0942:08, the Brize Norton Zone controller provided the C172 [pilot with] Traffic Information regarding the EA500 *“traffic north, 2-miles, tracking south indicating 500ft below climbing.”* The C172 [pilot] responded with *“copied”* (Figure 2).

Figure 2 – Time 0942:08 Traffic information passed to C172 pilot.

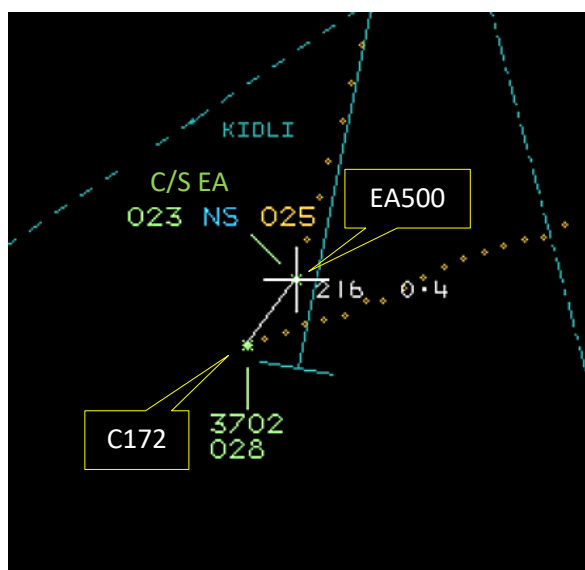
An analysis of the NATS radar replay was undertaken and both aircraft were positively identified using Mode S data. The C172 GPS navigation data provided by the pilot correlated with the radar tracks. CPA was assessed to have been at 0942:30 with 500ft vertical and 0.4NM lateral separation (Figure 3).

Figure 3 CPA at 0942:30
