AIRPROX REPORT No 2025143

Date: 08 Jul 2025 Time: 1331Z Position: 5202N 00039W Location: ivo Cranfield

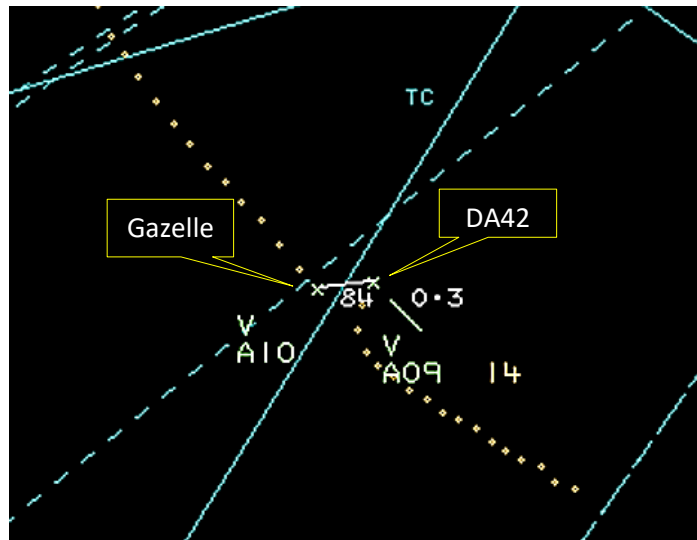
Figure 1- Time 1330:39

An analysis of the NATS radar replay was undertaken and both aircraft were positively identified using Mode S data. The DA42 was seen to join right-hand downwind for RW03, and the Gazelle on a left-hand downwind for RW03. The 2 aircraft were seen converging from opposite base-leg positions (Figure 1).

CPA was assessed to have occurred at 1330:39 as the Gazelle passed behind the DA42 turning onto the final approach for RW03, with 0.3NM lateral and 100ft vertical separation.

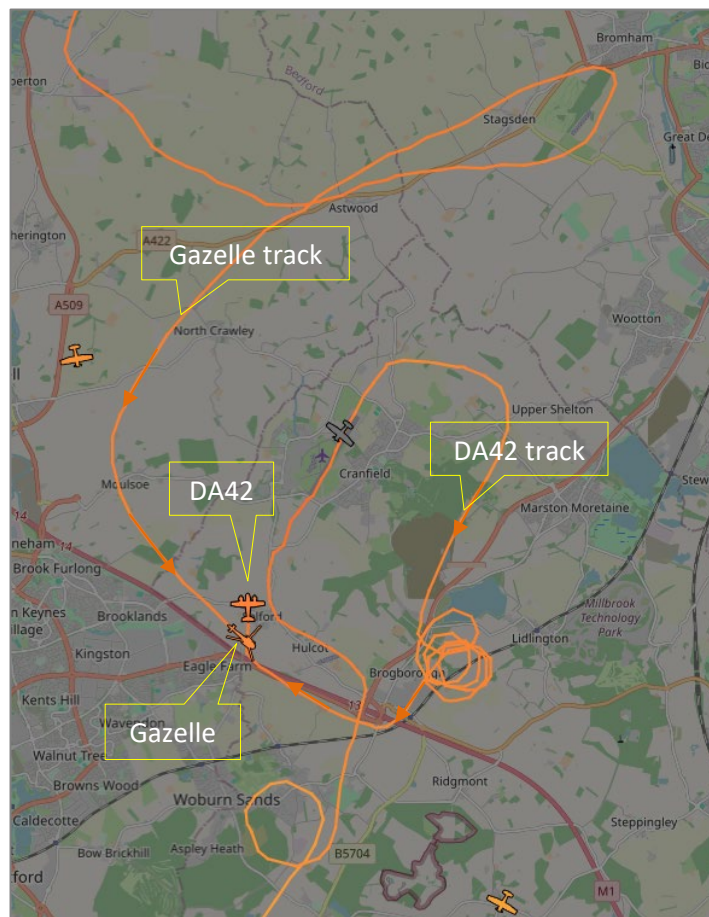
Figure 2 – Time 1330:40 Aircraft positions and tracks.

Analysis of aircraft tracking sources detected both aircraft using MLAT data, confirming their tracks and positions. The DA42 was seen to have orbited downwind before continuing towards a right-base for RW03, and the Gazelle was seen to join from the northwest to make a non-standard join for a left-hand downwind position for RW03 (Figure 2).

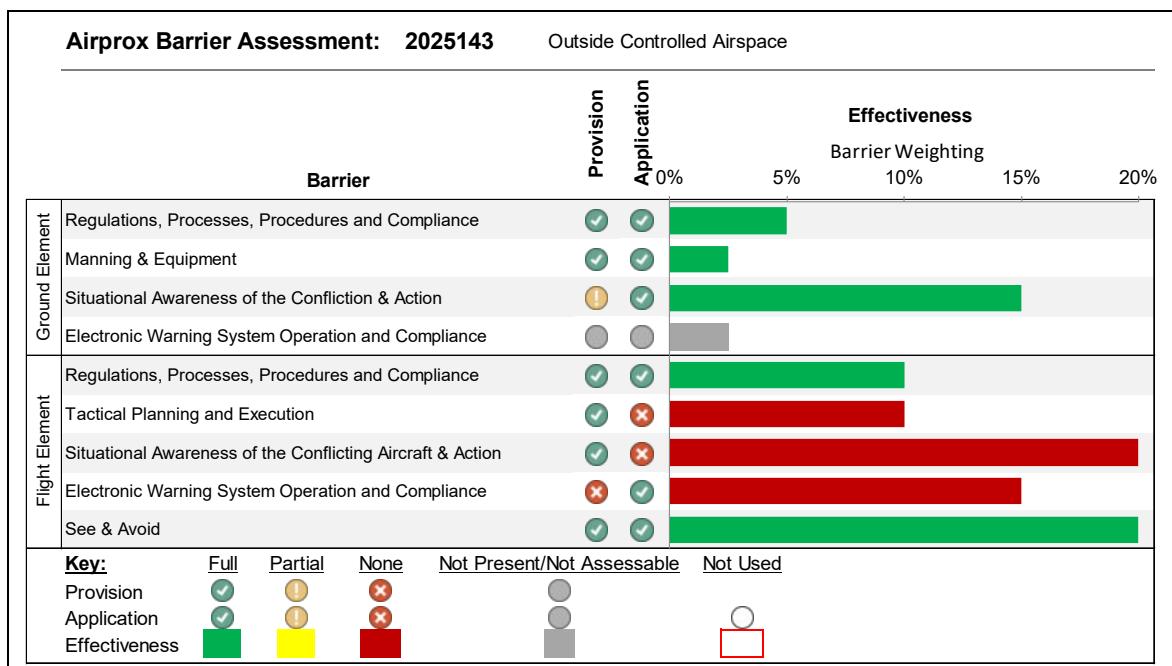
Tactical Planning and Execution was assessed as **ineffective** because the Gazelle pilot did not conform with the circuit pattern of traffic already formed in the circuit having incorrectly executed the join.

Situational Awareness of the Conflicting Aircraft and Action were assessed as **ineffective** because the Gazelle pilot either did not respond or responded incorrectly to ATC instructions and had not assimilated the potential conflict with the DA42.

Electronic Warning System Operation and Compliance were assessed as **ineffective** because the electronic conspicuity equipment fitted in the Gazelle had been unable to detect the transmissions from the DA42.
