AIRPROX REPORT No 2025147

Date: 28 Jun 2025 Time: 1538Z Position: 5214N 00100E Location: 3NM N Stowmarket

PART A: SUMMARY OF INFORMATION REPORTED TO UKAB

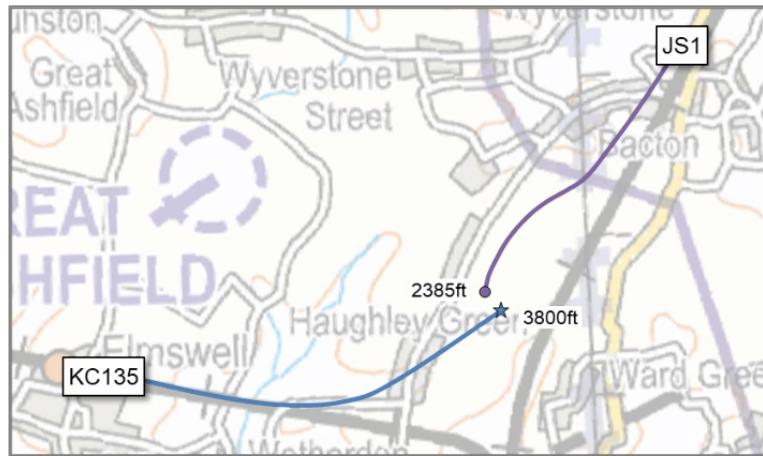
Figure 2 – 1529:48

During a holding pattern (the hold before the reported Airprox occurred) at 1529:48, the KC135 passed within 0.15NM horizontally and approximately 1400ft above the JS1 (Figure 2).

Members considered the situation at 1529:48, when the KC135 had passed within 0.15NM of the JS1 (albeit 1400ft above it). The JS1 had been observed on the NATS radar replay as a primary-only target at that time. However, approximately 2min later, secondary radar returns were observed. It was not clear to members whether the transponder fitted to the JS1 had been operated continuously throughout the period or had been switched on in response to the JS1 pilot observing nearby military traffic. Whilst that could not be determined, it was clear to members that the secondary returns had been sporadic on the NATS radar replay and no primary or secondary returns had been observed on the Lakenheath radar display.

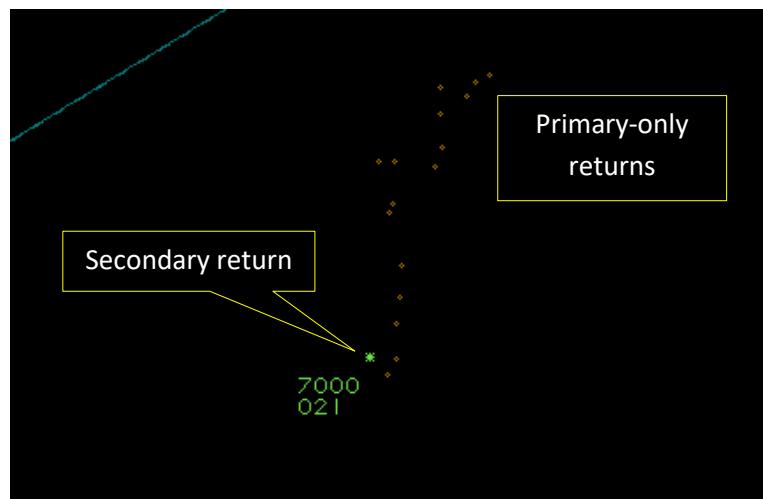
Figure 3 – The first secondary return from the JS1 appeared at 1531:38

No secondary-radar returns were observed from the JS1 until 1531:38, from which moment the JS1 could be positively identified from Mode S data (Figure 3).

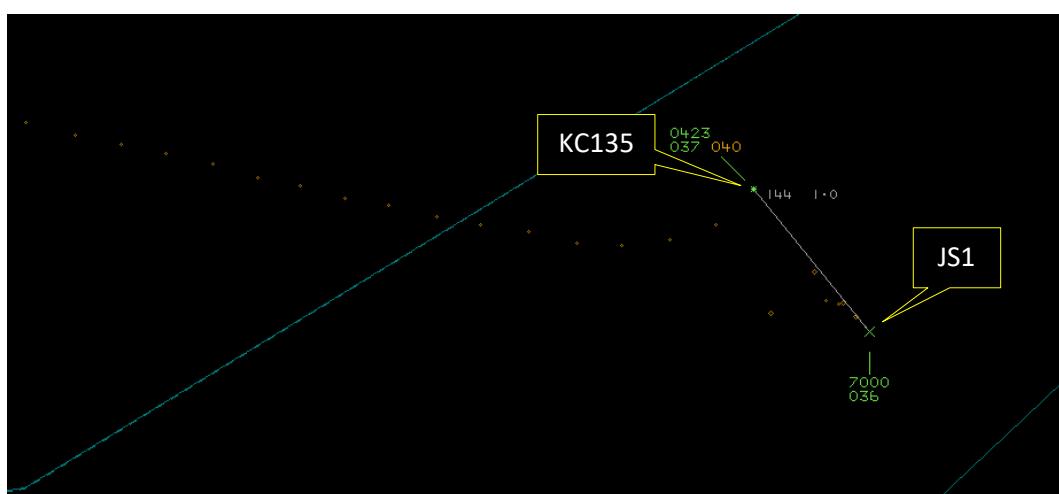
Figure 4 – CPA at 1537:38 (Mode C data)

The JS1 disappeared from the radar replay after a few sweeps and did not reappear until 1536:06 when it was observed sporadically for a few sweeps before disappearing again. The JS1 reappeared at 1537:26 and persisted until CPA (Figure 4).

The diagram was constructed and the CPA determined by combining the data sources. The separation between the aircraft was determined from the radar data for the KC135 and the GPS data for the JS1. The altitudes for both aircraft are shown in the diagram with reference to standard pressure.

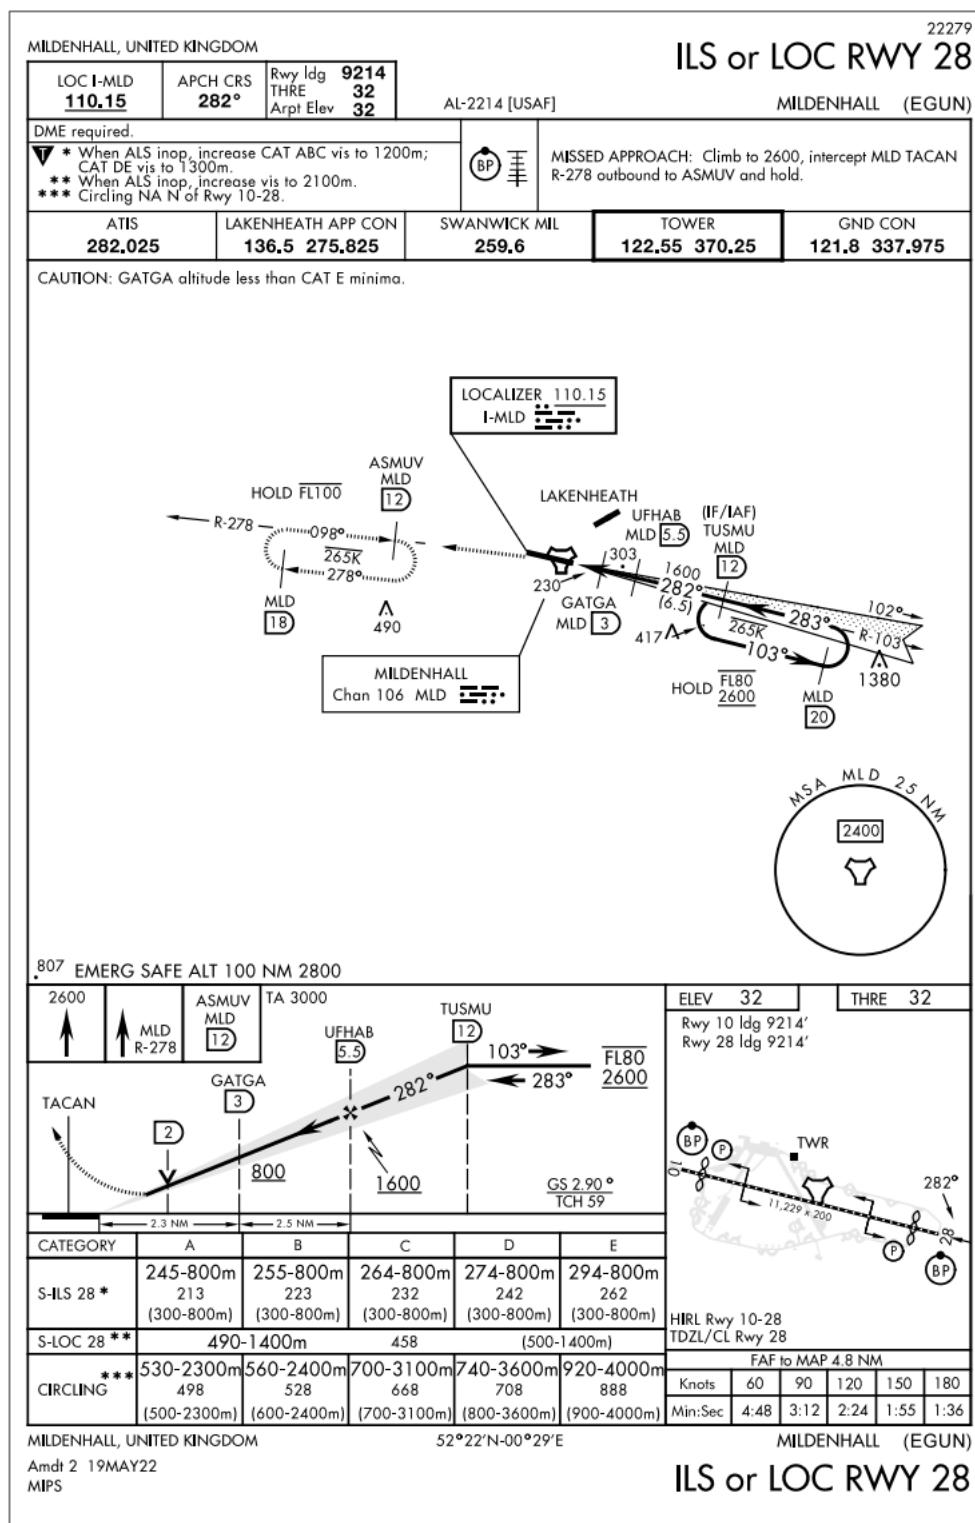
Figure 5 – The ILS/LOC approach to RAF Mildenhall RW28

At the time of this incident, no Instrument Approach Procedures for RAF Mildenhall (or nearby RAF Lakenheath) were publicly available via either the Civil or Military AIP. This denied non-military pilots the opportunity to plan routes that would avoid traffic using those procedures.

Members concluded their discussion and were heartened to learn that the approach plate for RW28 at Mildenhall (Figure 5), as well as other approach plates, are to become available on the UK military AIP website.⁴ The matter of the risk of collision was considered, and some members proffered that the sighting of the JS1 by the KC135 pilot had been early enough that effective avoiding action had been taken and that there had not been a reduction of normal safety margins for an encounter in Class G airspace. Other members pointed out that several safety barriers had either not been present or had not been fully effective. A vote was conducted and the latter view, that normal safety parameters had been eroded, prevailed. Notwithstanding, members were satisfied that there had not been a risk of collision and assigned Risk Category C to this event.
