AIRPROX REPORT No 2025149

Date: 17 Jul 2025 Time: ~1642Z Position: 5435N 00102W Location: Marske-by-the-Sea

PART A: SUMMARY OF INFORMATION REPORTED TO UKAB

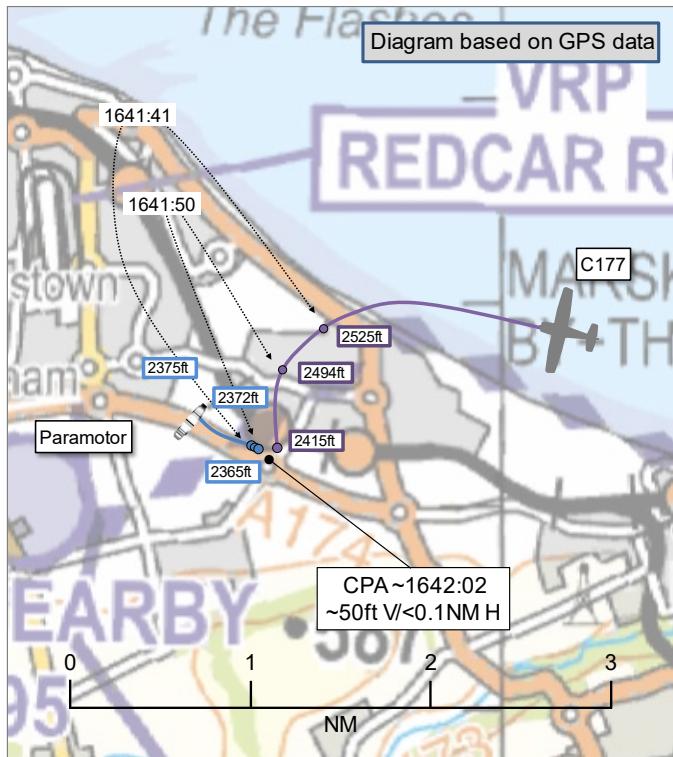
Recorded	Aircraft 1	Aircraft 2
Aircraft	Paramotor	C177
Operator	Civ Hang	Civ FW
Airspace	London FIR	London FIR
Class	G	G
Rules	VFR	VFR
Service	None	Basic
Provider	N/A	Teesside
Altitude/FL	~2365ft	~2415ft
Transponder	Not fitted	A, C, S
Reported		
Colours	Pink, Blue	White
Lighting	Nil	Landing, Nav, Anti-cols, Strobe
Conditions	VMC	VMC
Visibility	>10km	>10km
Altitude/FL	2250ft	2500ft
Altimeter	QFE	QNH
Heading	110°	NK
Speed	20kt	108kt
ACAS/TAS	Not fitted	Not fitted
Separation at CPA		
Reported	0ft V/100m H	Not Seen
Recorded	~50ft V/<0.1NM H

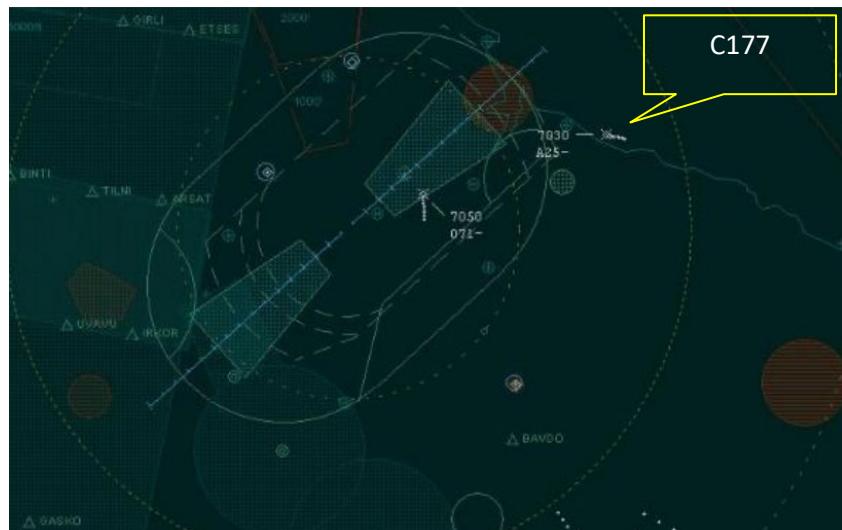
Figure 1 - C177 squawking 7030 at 2500ft approaching Marske-by-the-Sea prior to the time of the reported incident.

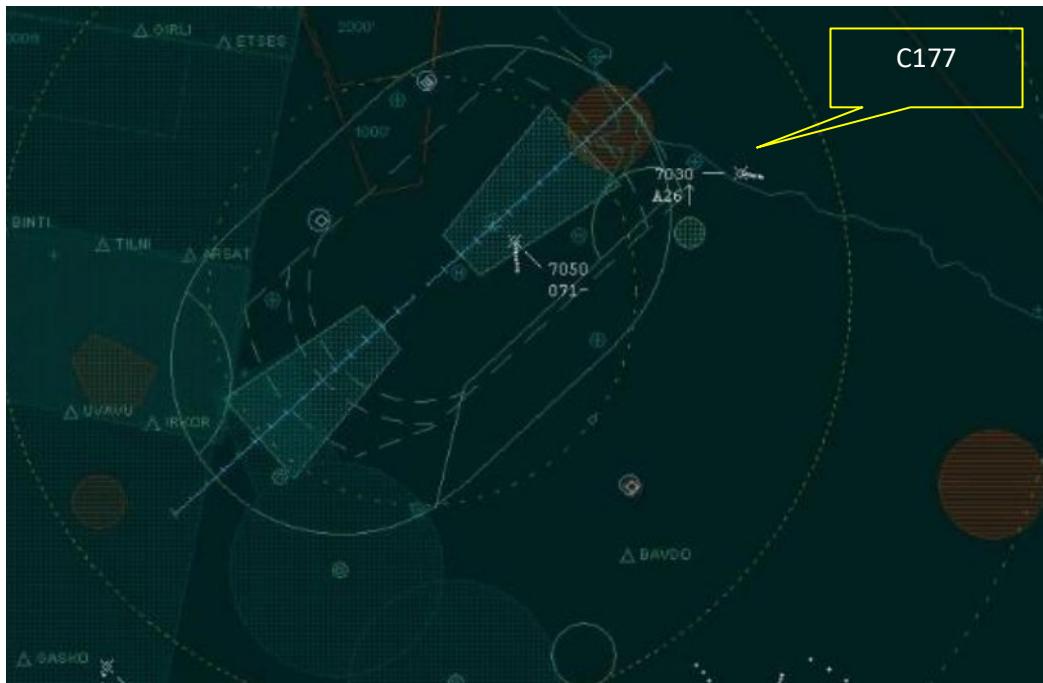
Figure 2 - C177 squawking 7030 at 2600ft overhead Marske-by-the-Sea at the time of the reported incident.

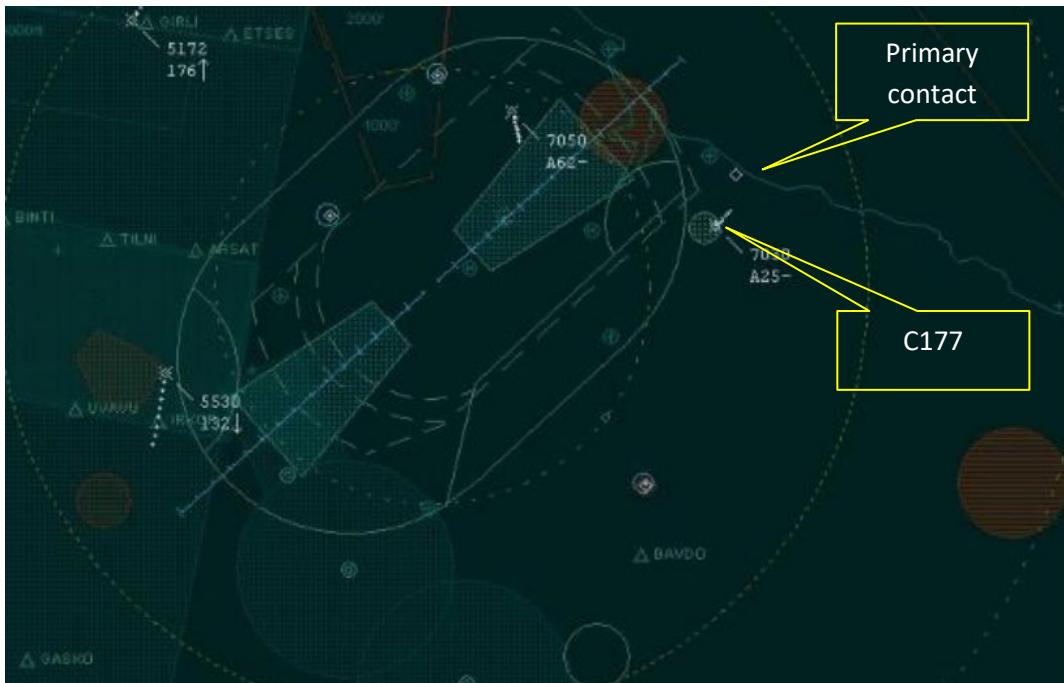
Figure 3 - C177 squawking 7030 at 2500ft overhead Guisborough heading south-west several minutes after the reported incident.

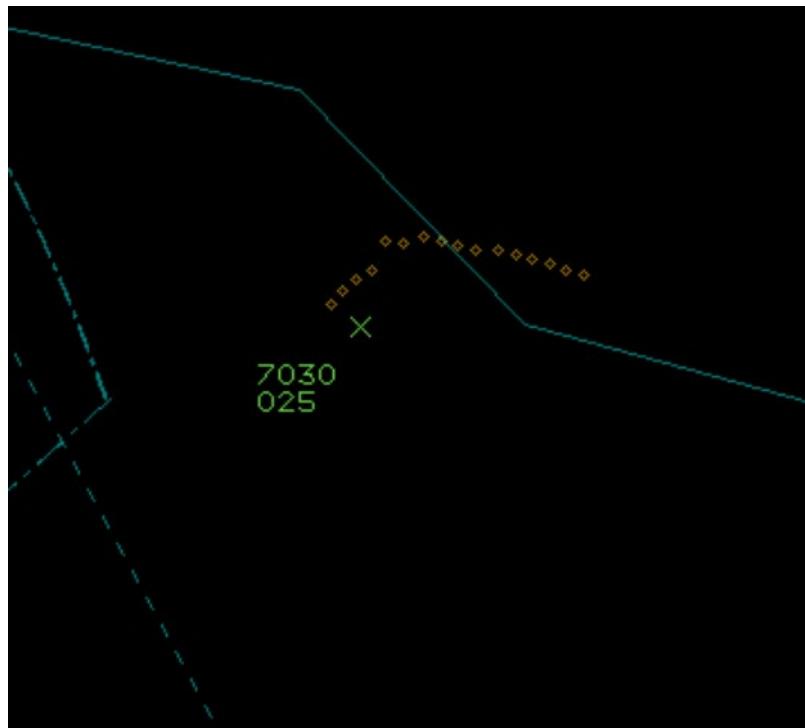
Figure 4 – 1642:03 approximate CPA

An analysis of the NATS radar replay was undertaken, the C177 could be seen and identified via Mode S data, however the radar track was jittery (Figure 4). The paramotor could not be seen on the radar. Neither aircraft could be observed by reference to ADS-B data sources.

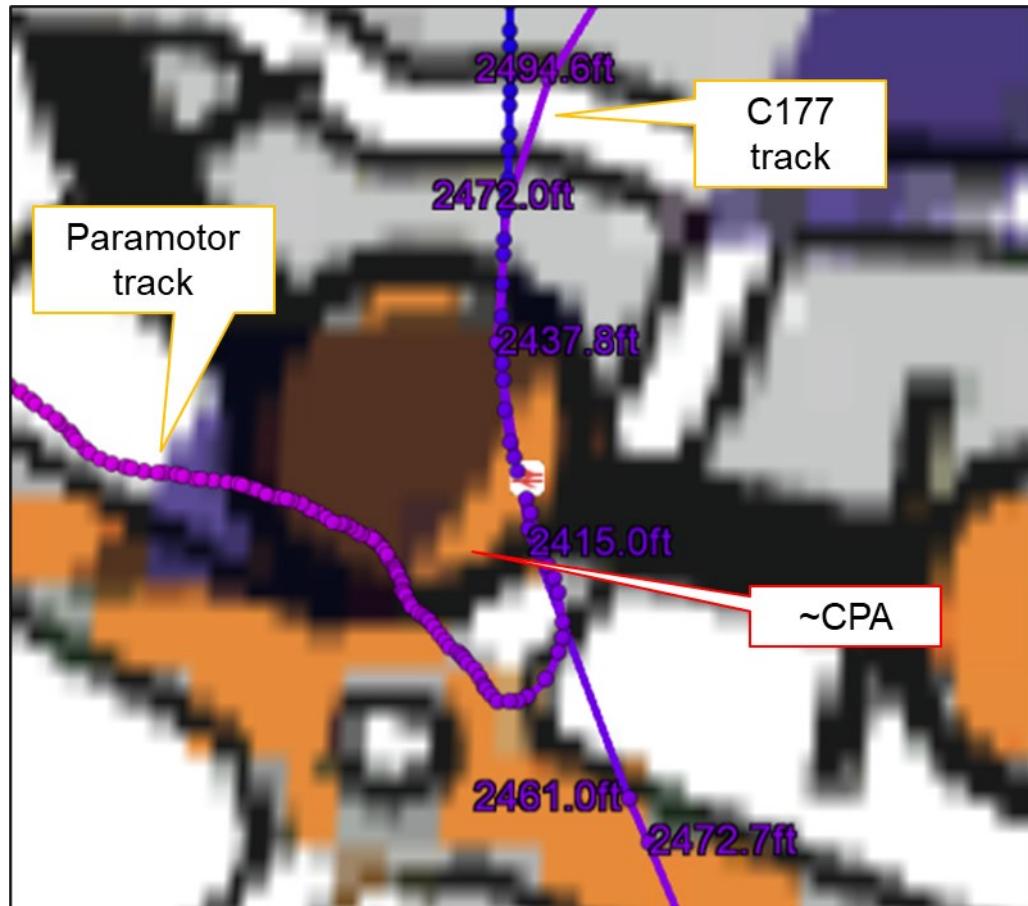
Figure 5 – GPS tracks from both pilots

Fortunately, both pilots provided GPS data, which could be compared using the closest data points, and the diagram at the top of the report was compiled using this data.
