**AIRPROX REPORT No 2025153**

Date: 16 Jul 2025 Time: 1441Z Position: 5357N 00113W Location: 1.5NM northwest of Rufforth

**PART A: SUMMARY OF INFORMATION REPORTED TO UKAB**

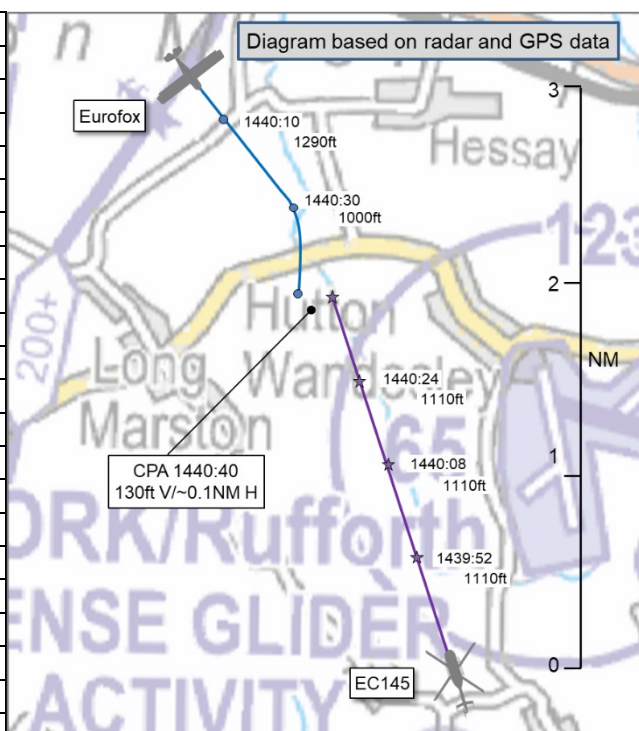
Recorded	Aircraft 1	Aircraft 2
Aircraft	Eurofox	EC145
Operator	Civ FW	Civ Comm
Airspace	London FIR	London FIR
Class	G	G
Rules	VFR	VFR
Service	Listening Out	Unknown
Provider	Rufforth	Unknown
Altitude/FL	~980ft	1110ft
Transponder	Not fitted	A, C, S
<b>Reported</b>		
Colours	Yellow	Yellow
Lighting	Nav, ldg	'Standard'
Conditions	VMC	VMC
Visibility	>10km	>10km
Altitude/FL	~970ft	1000ft
Altimeter	QFE	QNH
Heading	~150°	350°
Speed	~90kt	120kt
ACAS/TAS	FLARM	TCAS I
Alert	None	None
<b>Separation at CPA</b>		
Reported	400ft V/50ft H	100ft V/300m H
Recorded	~130ft V/0.1NM H

The EC145 was tracked via radar and identified through Mode S. The Eurofox did not carry a transponder and did not show on radar as a 'primary only' track. The diagram at page 1 was constructed by combining radar data and the GPS track file provided by the Eurofox pilot. Relative altitudes have been converted to a common pressure setting to allow direct comparison.

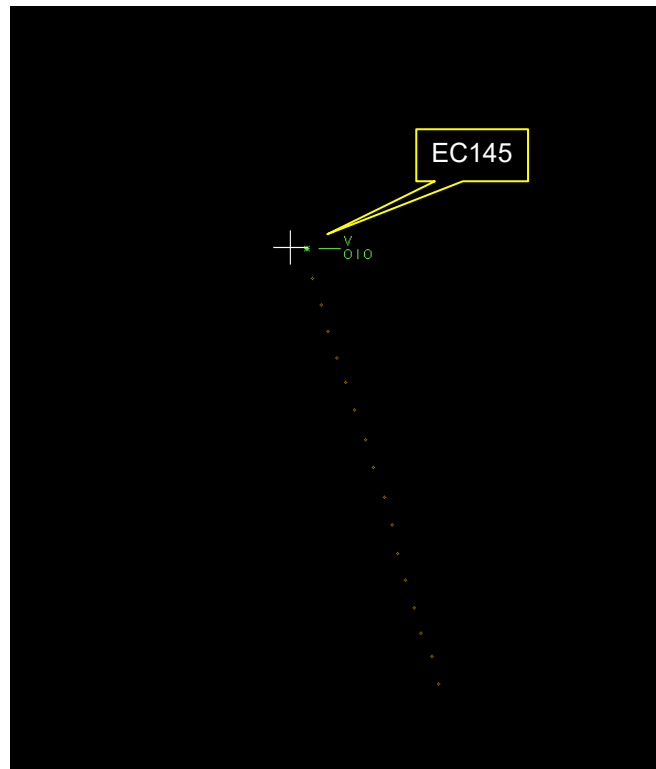
Figure 1: at CPA (1440:40) Eurofox not seen on radar. White cross marks CPA.

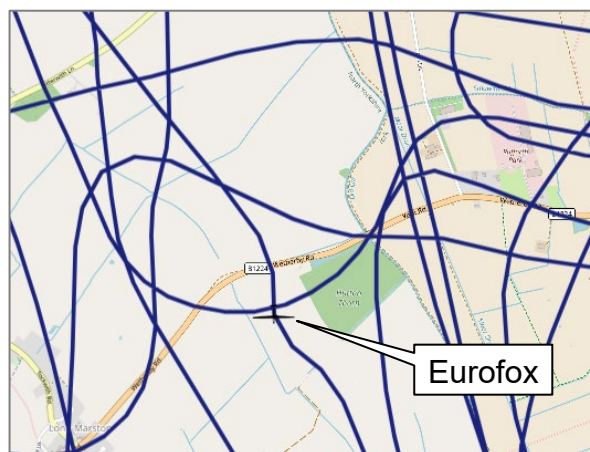
Figure 2: Taken from the Eurofox pilot-provided IGC file at 1440:40

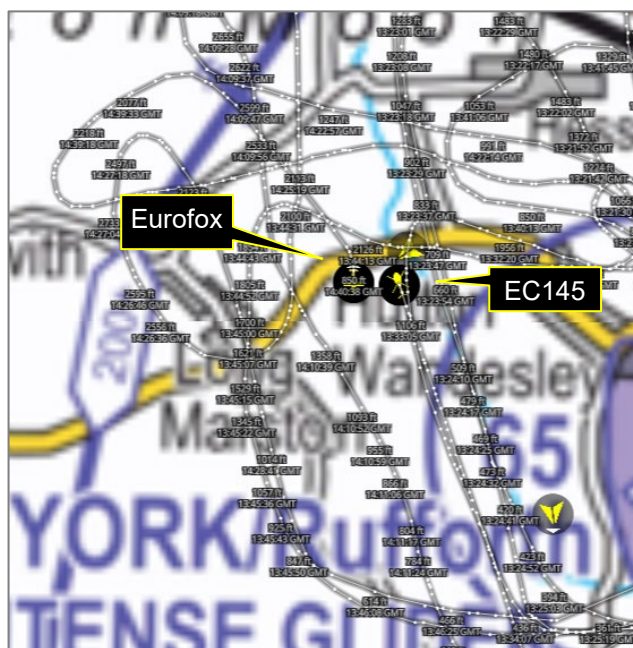
Figure 3: Taken from the Airspace Analyser Tool at 1440:40

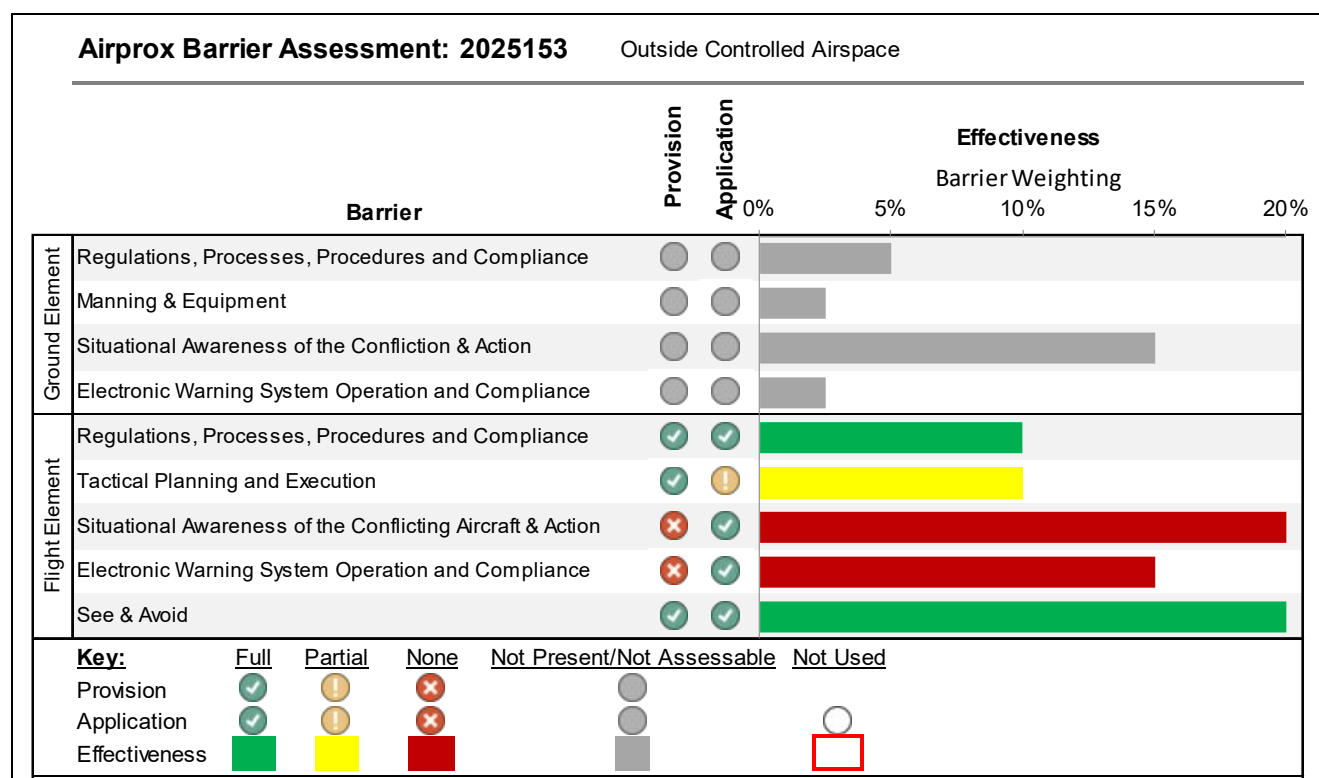
**Tactical Planning and Execution** was assessed as **partially effective** because the EC145 pilot, having planned to fly adjacent to Rufforth and whilst flying through that promulgated airspace, could have made an awareness call on the published Rufforth frequency.

**Situational Awareness of the Conflicting Aircraft and Action** were assessed as **ineffective** because neither pilot had any situational awareness of the proximity of the other aircraft.

**Electronic Warning System Operation and Compliance** were assessed as **ineffective** because the equipment carried by both aircraft had been unable to register electronic emissions from the other aircraft.
