**AIRPROX REPORT No 2025154**

Date: 18 Jul 2025 Time: ~1250Z Position: 5249N 00042W Location: Saltby

**PART A: SUMMARY OF INFORMATION REPORTED TO UKAB**

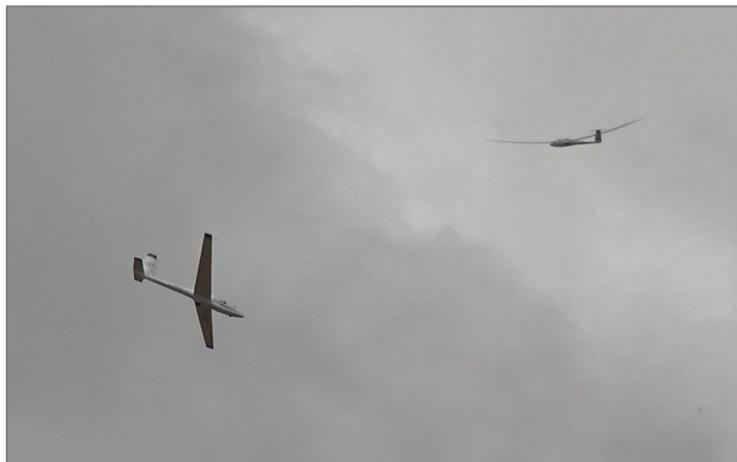
Figure 1 – An image from a video taken by a witness on the ground. The Perkoz is shown at the bottom-left during an aerobatic manoeuvre. The Nimbus is shown at the top-right.

It has been determined that the image shown in Figure 1 had captured a moment a few seconds after CPA when the Nimbus pilot had turned to the left to enter a thermal, and the Perkoz pilot had descended after having completed an Immelmann manoeuvre. The exact geometry of the Airprox encounter could not be verified. The diagram has been constructed with the track of the Perkoz shown as a dotted line to indicate a probable track. The exact moment of CPA and the separation between the aircraft could not be determined.

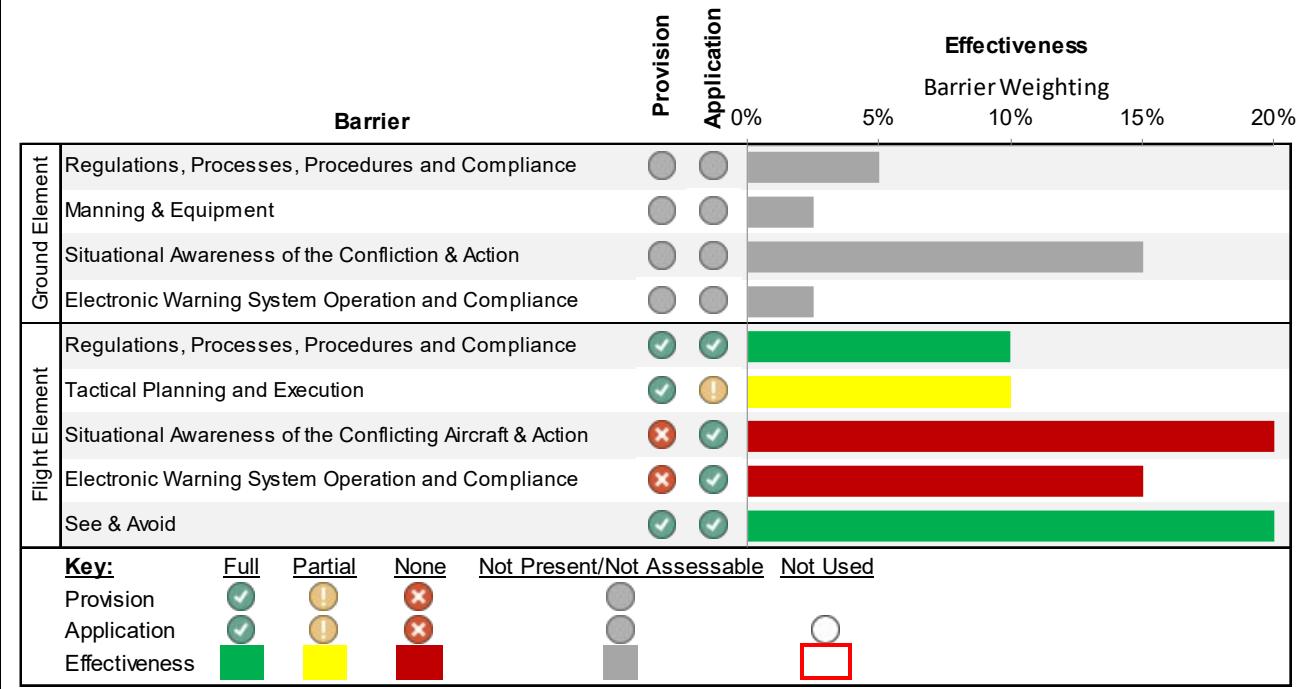
## Airprox Barrier Assessment: 2025154 Outside Controlled Airspace

**Tactical Planning and Execution** was assessed as **partially effective** because it may have been prudent for the pilot of the Nimbus to have relayed their intentions on the Saltby Traffic frequency.

**Situational Awareness of the Conflicting Aircraft and Action** were assessed as **ineffective** because neither pilot had situational awareness of the presence of the other aircraft.

**Electronic Warning System Operation and Compliance** were assessed as **ineffective** because the EC device fitted to the Nimbus would not have been expected to have detected the presence of the Perkoz.
