AIRPROX REPORT No 2025156

Date: 23 Jul 2025 Time: 1513Z Position: 5110N 00131W Location: 2.9NM NE of Middle Wallop

PART A: SUMMARY OF INFORMATION REPORTED TO UKAB

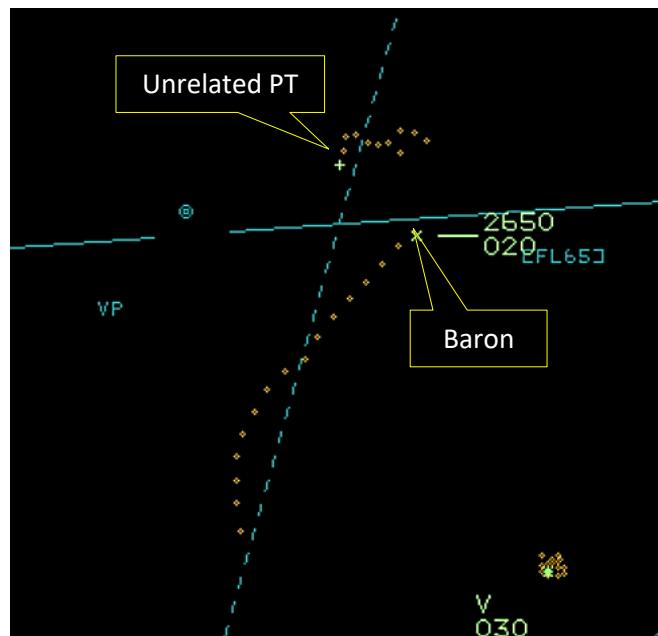
Figure 1 - Time 1512:11 Baron passed unknown primary track

An analysis of the NATS radar replay was undertaken and the Baron was identified using Mode S data. There was an unknown primary track detected in the vicinity of Middle Wallop which was not in the position of the Rallye tug with a glider on tow. Neither the Rallye nor glider on tow were detected on radar. The Baron was seen transiting the Boscombe/Middle Wallop CMATZ, passing the unknown primary target at 1512:11 with 0.8NM lateral separation.
