**AIRPROX REPORT No 2025162**

Date: 30 Jul 2025 Time: 1353Z Position: 5211N 00116W Location: 1NM NNW Byfield Daventry

**PART A: SUMMARY OF INFORMATION REPORTED TO UKAB**

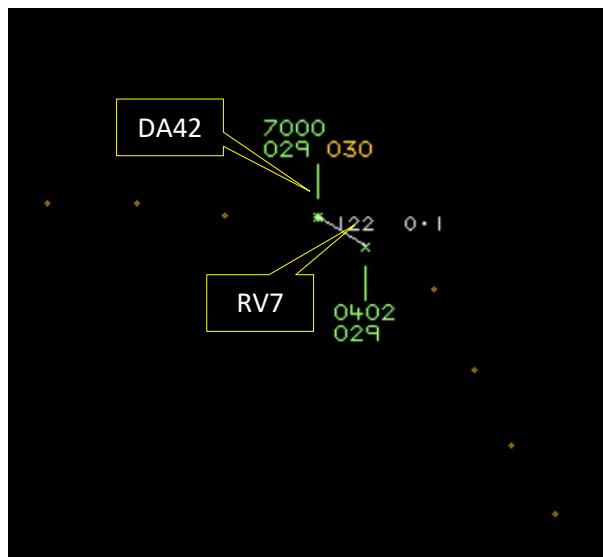
Figure 1 – Time 1353:26 just prior to CPA.

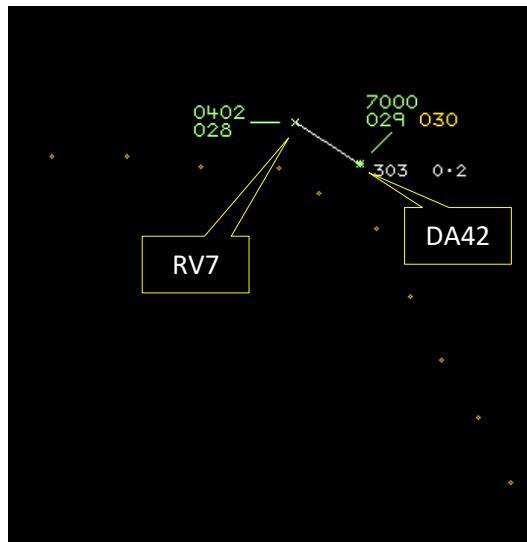
Figure 2 – Time 1353:30 post CPA - aircraft tracks have crossed.

Based on interpolation of the radar tracks, CPA was assessed to have occurred at 1353:27 with 0ft vertical and less than 0.1NM lateral separation.
