AIRPROX REPORT No 2025164

Date: 28 Jul 2025 Time: 1416Z Position: 5341N 00136W Location: Ossett, Wakefield

PART A: SUMMARY OF INFORMATION REPORTED TO UKAB

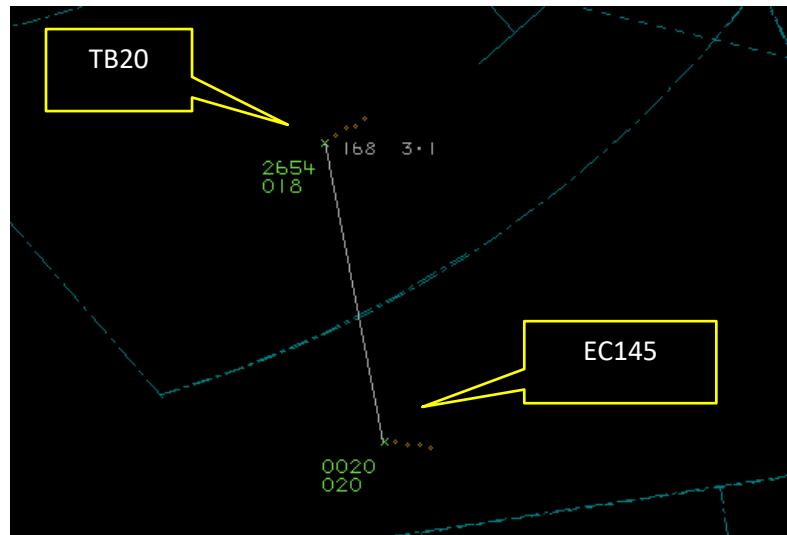
Figure 1 – 1414:17

An analysis of the NATS radar replay was undertaken. Both aircraft could be seen in SSR only and identified using Mode S data, with the EC145 indicating FL020 and the TB20 FL018, see Figure 1. Proprietary ADS-B data sources were assessed, on which the EC145 could be seen using ADS-B data sources, but the TB20 in MLAT only.

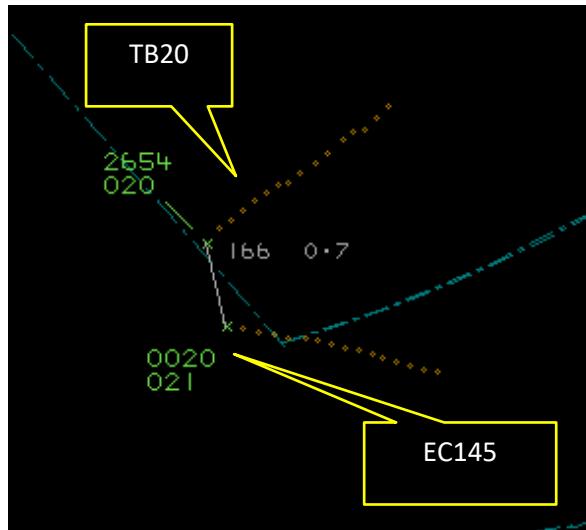
Figure 2 - 1415:52

The two aircraft continued on track , both climbing slightly, see Figures 2 and 3.

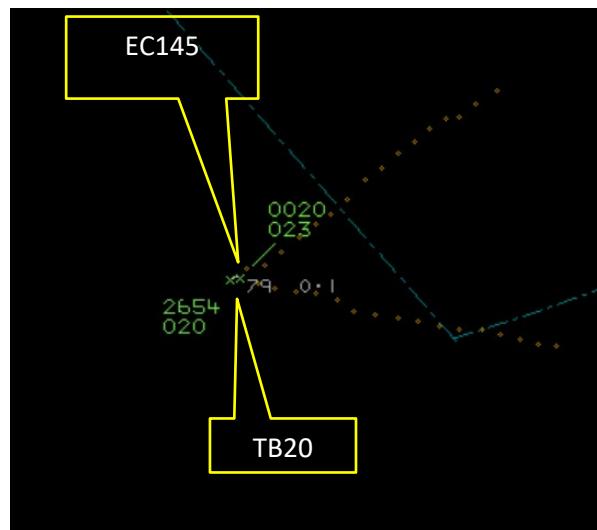
Figure 4 – CPA 1416:19

CPA occurred at 1416:19 when the EC145 appeared to climb 100ft and turn behind the TB20.

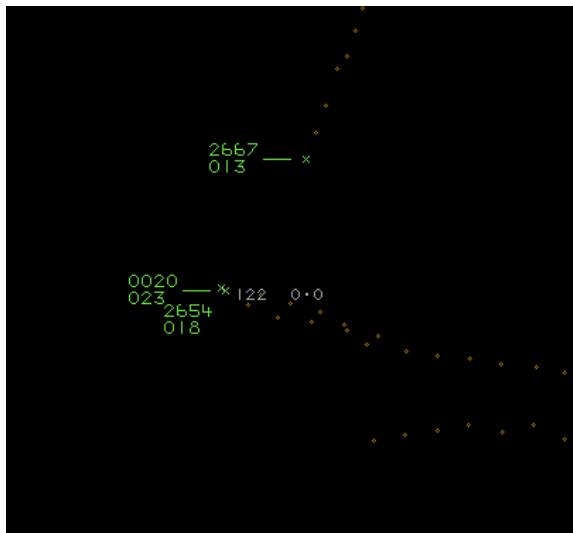
Figure 5 - 1417:23

After the CPA, the two aircraft continued on a similar track with the TB20 directly below the EC145, with 500ft vertical separation, see Figure 5. The situation described by the EC145 pilot in their report with another aircraft at a similar level occurred at 1419:39 (Figure 6), by which stage the TB20 was 0.4NM behind the helicopter.

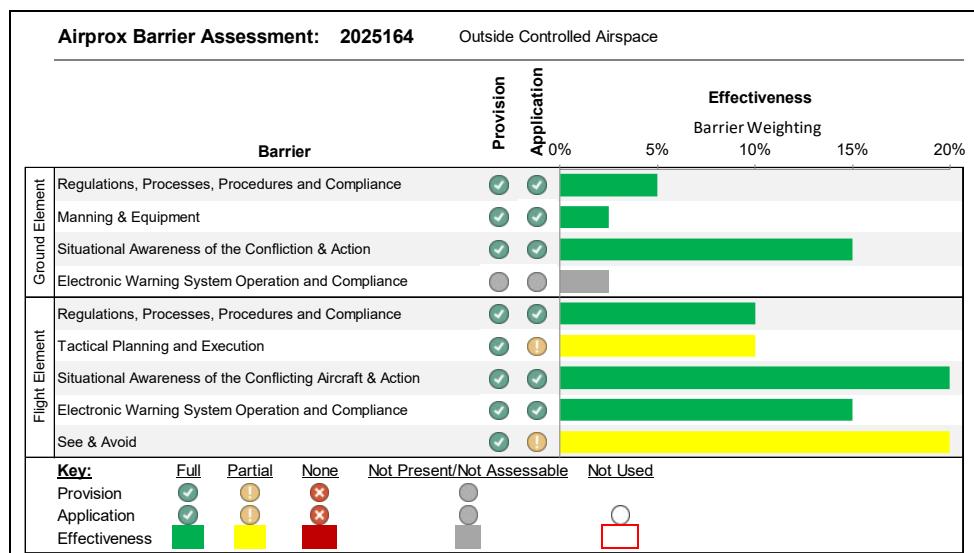
Safety Barrier Assessment⁴

In assessing the effectiveness of the safety barriers associated with this incident, the Board concluded that the key factors had been that:

Tactical Planning and Execution was assessed as **partially effective** because the TB20 pilot could have taken earlier action to have allowed the EC145 more room, in order to avoid causing the other pilot concern.

See and Avoid were assessed as **partially effective** because the TB20 pilot flew close enough to cause concern to the EC145 pilot.
