AIRPROX REPORT No 2025168

Date: 02 Aug 2025 Time: 0954Z Position: 5058N 00042E Location: 1.5NM NW Rye

PART A: SUMMARY OF INFORMATION REPORTED TO UKAB

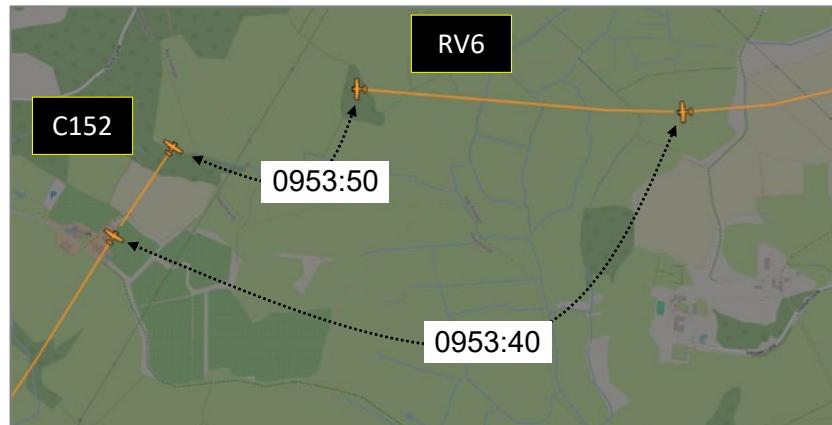
Figure 1 - Aircraft tracks (MLAT data for the C152 and ADS-B data for the RV6)

An analysis of the NATS radar replay was undertaken and both aircraft could be positively identified from Mode S data. The RV6, but not the C152, was observed by reference to ADS-B data sources.

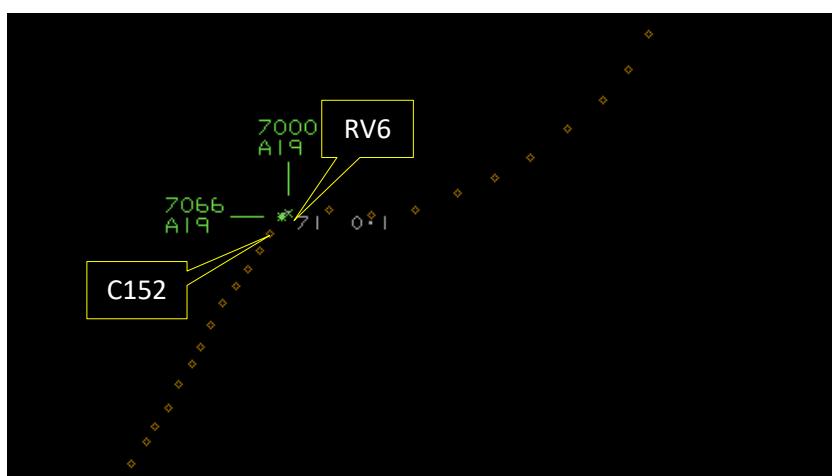
Figure 2 - CPA at 0953:58 (radar data)

The diagram was constructed and the separation determined from the radar data.
