AIRPROX REPORT No 2025169

Date: 02 Aug 2025 Time: 1544Z Position: 5355N 00105W Location: Naburn Marina VRP

PART A: SUMMARY OF INFORMATION REPORTED TO UKAB

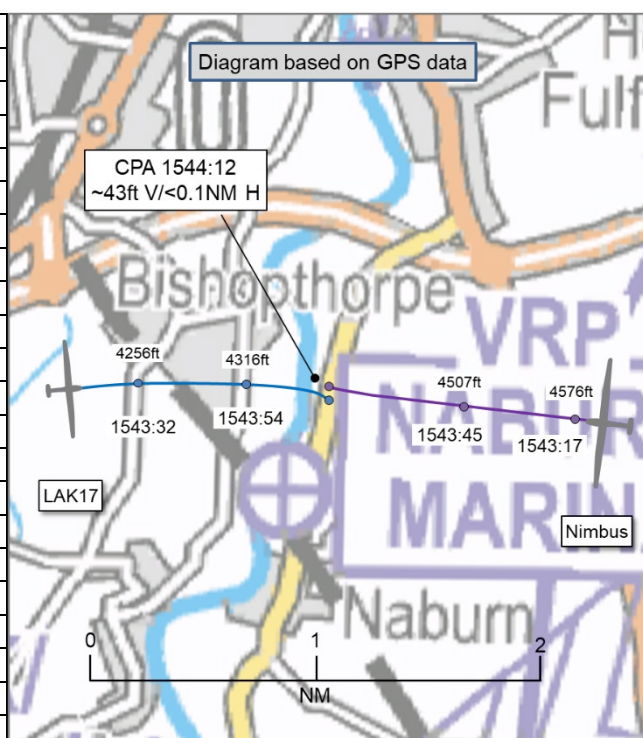
Neither aircraft appeared on radar. Both pilots provided a GPS file which allowed construction of the diagram at page 1 and a direct comparison of relative altitudes.

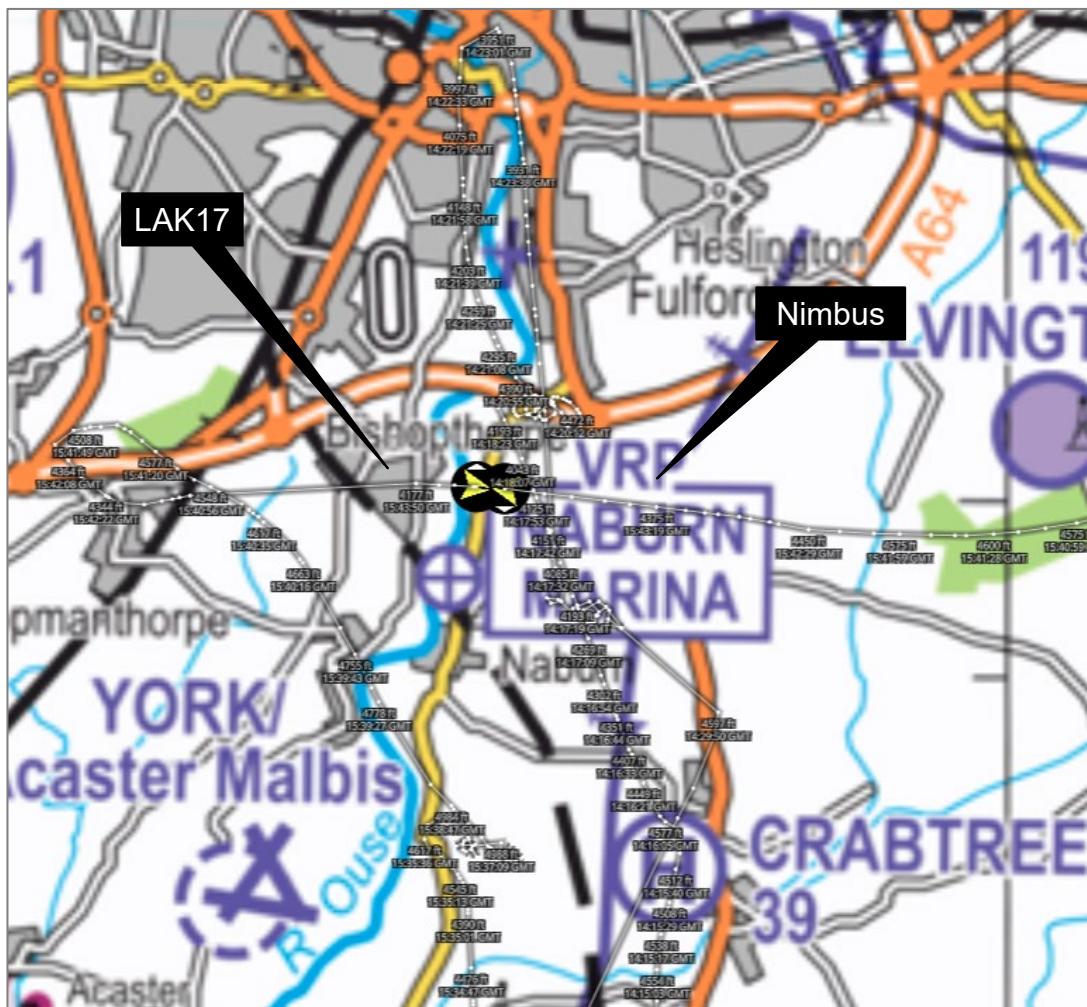
Figure 1: From the Airspace Analyser Tool at CPA minus 2sec.

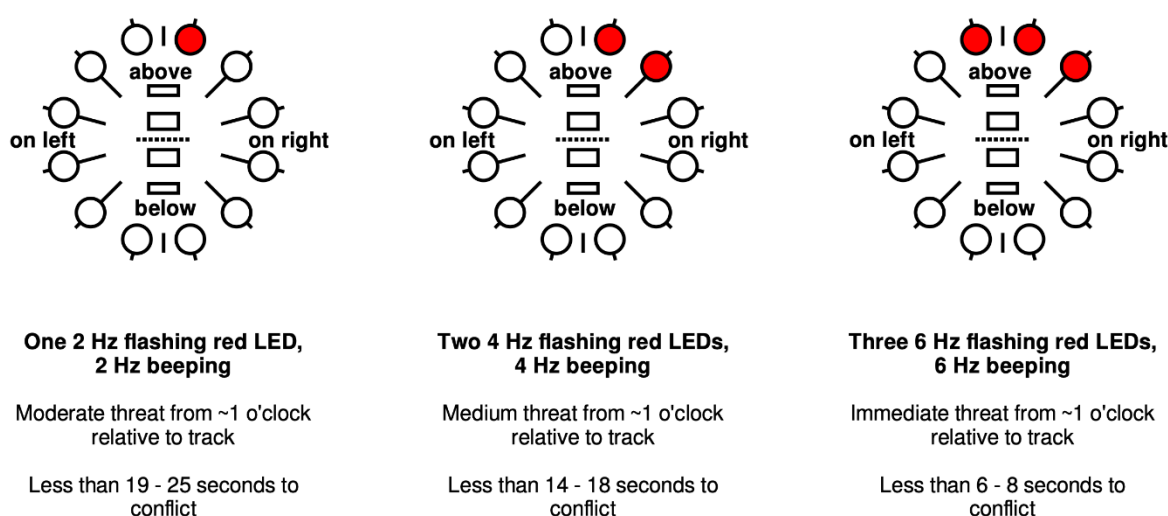
Figure 2: Proximity indicators as used in the LAK17 cockpit.

Both pilots report having received a warning from this system some seconds before sighting the other aircraft. On hearing an audio warning, the LAK17 pilot reports having used their LED display to inform the direction of their lookout. After a couple of seconds, they faintly saw the forward-facing "canopy flasher" (strobe) on the other glider, but initially not the aircraft itself. When the glider became visible a few seconds after that, the LAK17 pilot promptly initiated a right turn to avoid as the audio warning escalated to the highest level (conflict predicted in "less than 6 - 8sec"). This account is consistent with the GNSS flight recorder traces from both gliders, which show the LAK17 turning right at or shortly after 1544:07 (5sec before CPA). With the two aircraft approaching at a relative speed of about 130kt, their horizontal separation at this point would have been about 400m.

The BGA encourages owners of aircraft operating at its member club sites to equip with the electronic collision-warning system (CWS) fitted to both gliders in this incident. To ensure that their CWS antenna installation is as effective as possible, operators are further advised to routinely check its detection range. Further information available at this BGA web page:
