AIRPROX REPORT No 2025179

Date: 12 Aug 2025 Time: 1153Z Position: 5301N 00032W Location: Cranwell

PART A: SUMMARY OF INFORMATION REPORTED TO UKAB

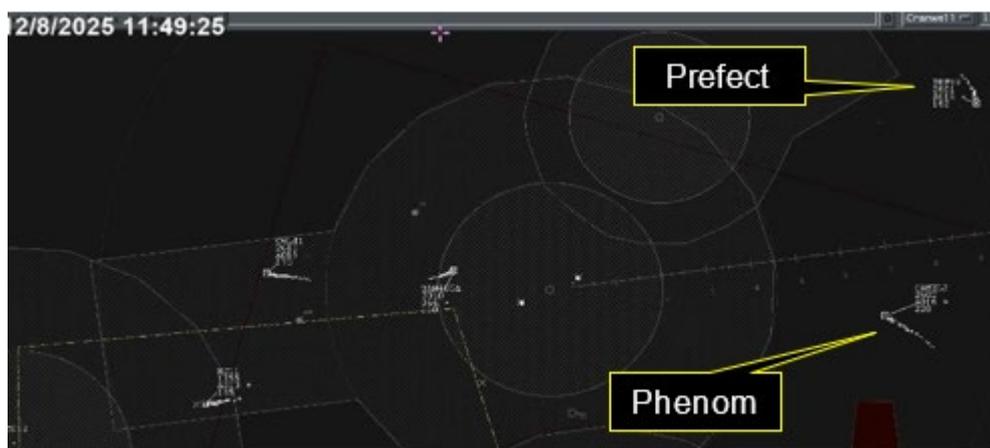
At 1149:25 the [lead pilot of the] pair of Phenoms reported "*field in sight to tower*" and changed to the Cranwell Tower frequency. At this same time, the Prefect was turning onto the base-leg of the radar pattern.

Figure 1- location of the Prefect and the Phenom formation at 1149:25.

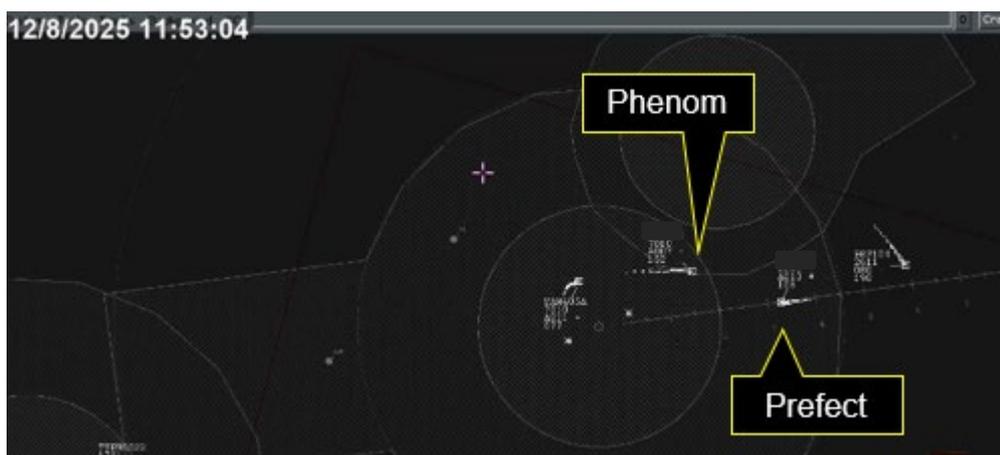
At 1152:59, Cranwell Tower transmitted *"...Confirm visual with the radar traffic at three miles?"*, however the callsign was slightly clipped and could have been unintelligible by the Phenom pilot.

Figure 2 - location of the Prefect and Phenom formation at 1153:04 when the clearance was issued to the formation.

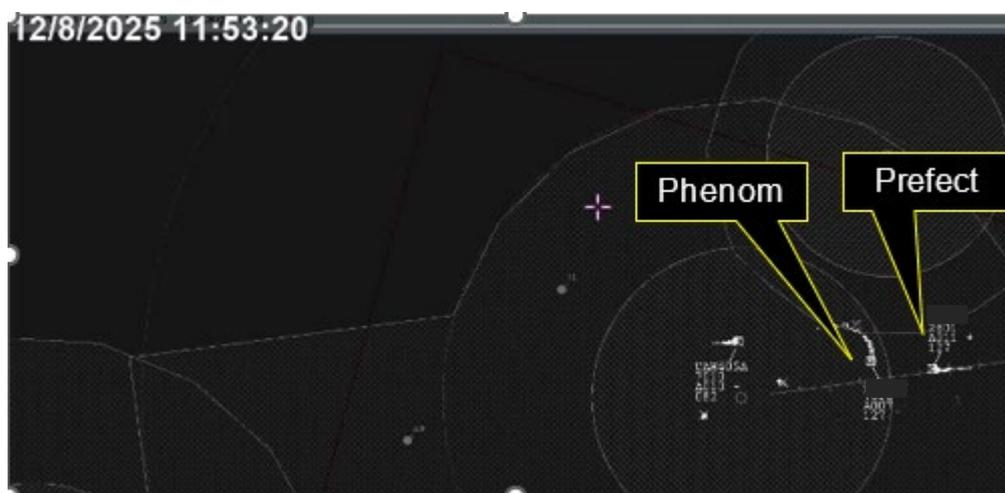
Figure 3 - radar picture at 1153:20, 6sec before the Airprox was declared by the Prefect pilot. The formation was indicating 700ft and the Prefect indicating 1100ft with ~ 1NM separation.

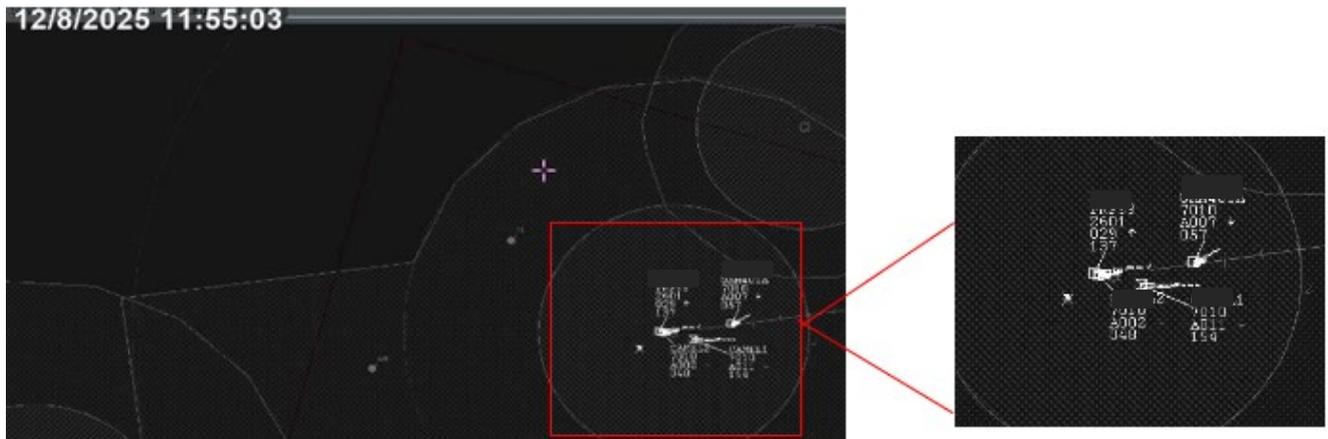
CPA occurred at 1155:03, with a separation of 0.1NM laterally and approximately 2800ft vertically. CPA occurred over a minute after the Airprox was declared and therefore is not accurate to the Airprox.

Figure 4 - radar picture at the point of CPA. This shows the Prefect conducting a Missed Approach and the lead Phenom landing.

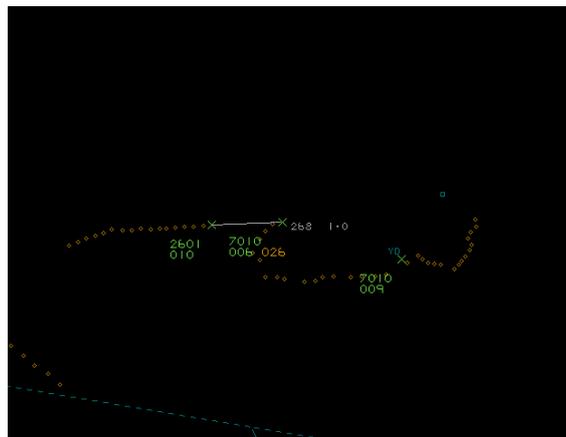
An analysis of the NATS radar replay was undertaken and both aircraft could be seen and identified using Mode S data with altitude shown in Flight Levels. The diagram at the top of the report was compiled using this data. The Phenom formation was visible in SSR only, probably due to their height and range from the NATS radar; this was not the picture available to the Cranwell controllers. As mentioned in the BM report, CPA was shortly after the Airprox was reported (see Figure 4), but by this time the Prefect pilot had been visual and established in the go-around, therefore, for analysis purposes, the Airprox separation was deemed to be at the point at which the Prefect pilot broke off the PAR with the Phenom turning final ahead of them (Figure 5).

Figure 5 – 11153:26, the time at which the Prefect pilot reported the Airprox
