**AIRPROX REPORT No 2025195**

Date: 05 Sep 2025 Time: 1123Z Position: 5054N 00000E Location: 1NM N Lewes

**PART A: SUMMARY OF INFORMATION REPORTED TO UKAB**

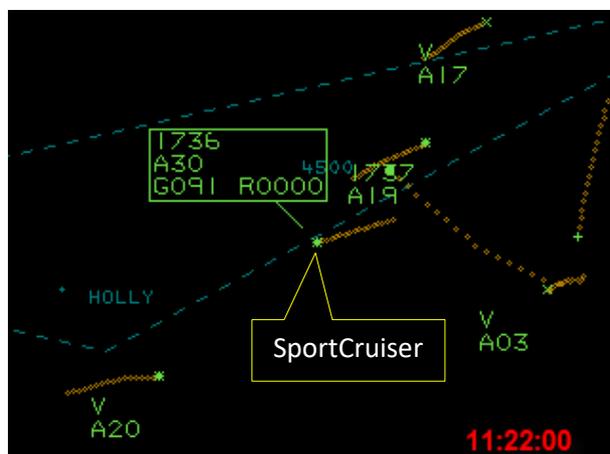
Figure 1 – NODE radar  
(1122 – 1min 4sec before CPA)

The Airprox report from the paraglider pilot stated the confliction occurred overhead Hamsey which was approximately 1.5NM north of Lewes at time 1122 (Figure 1).

The paraglider pilot's reported position correlated with the positioning and altitude of [the SportCruiser], however, NODE radar displayed no primary contacts in the vicinity of Hamsey. Farnborough radar did however display a number of primary targets on radar in the vicinity of [the SportCruiser], although none could be associated with the paraglider. Therefore, a closest point of approach was not attainable from NATS available data.

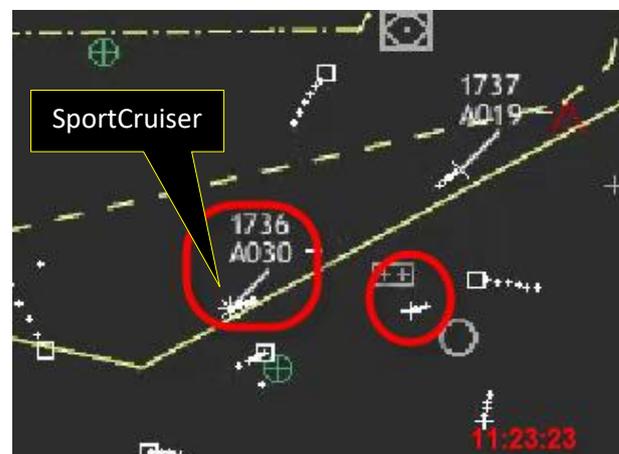
Figure 2 – Farnborough radar  
(1123:23 – 19sec after CPA)

At time 1123:23, a primary-only contact appeared 1/4 of a mile behind the aircraft for one sweep and then faded (there was no trail data as it appeared and then faded). The pilot [of the SportCruiser] did not report anything on the RT and called to leave the frequency at 1134, thanking the controller for their service before they transferred to [an en-route frequency].

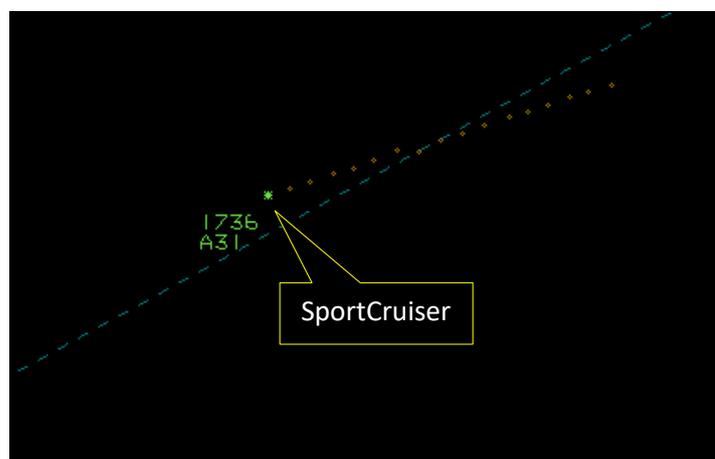
Figure 3 - 1123:02

An analysis of the NATS radar replay was undertaken and the SportCruiser could be positively identified from Mode S data. The paraglider was not observed on the replay. The pilot of the paraglider kindly supplied GPS track data for their flight. It was by combining the data sources that the diagram was constructed and the separation at CPA determined. The moment of CPA was assessed to have occurred between the radar sweeps at 1123:02 (Figure 3) and 1123:06.
