AIRPROX REPORT No 2025197

Date: 05 Sep 2025 Time: 1520Z Position: 5210N 00006E Location: 3.5NM SW Cambridge Airport

PART A: SUMMARY OF INFORMATION REPORTED TO UKAB

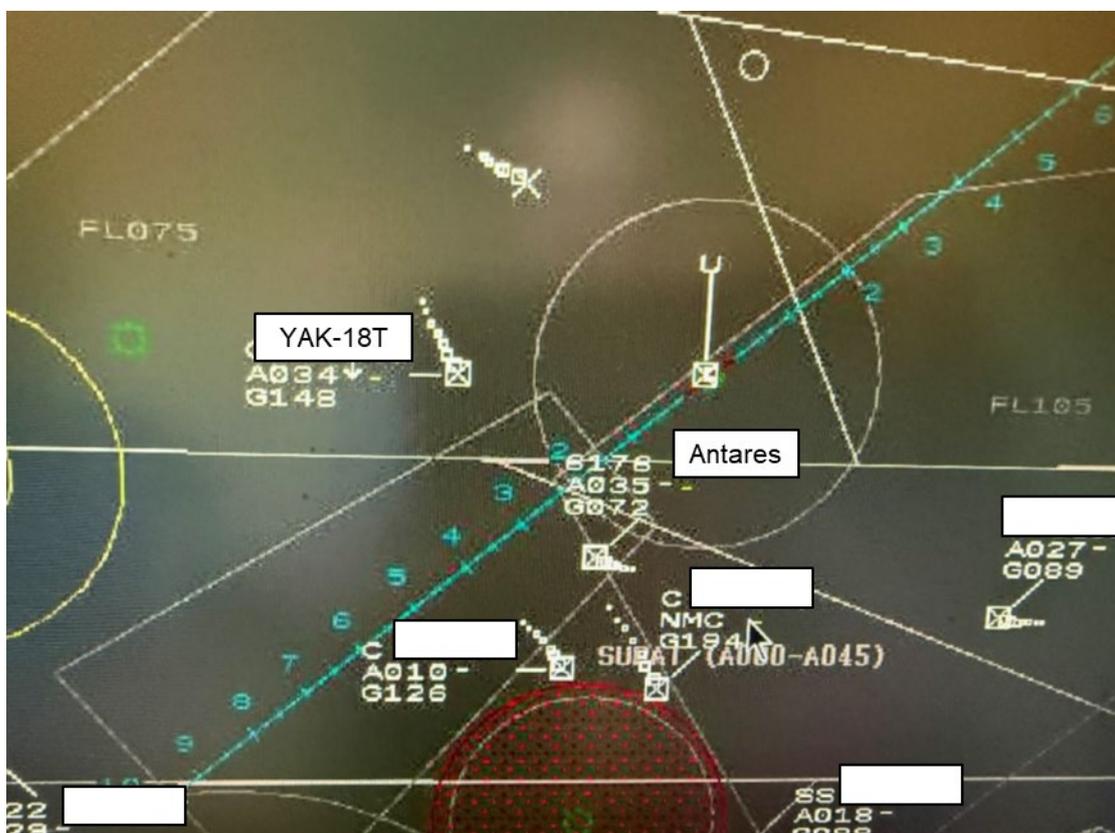
Figure 1: Cambridge Radar picture at 1519:24

At 1519:24, [The Antares'] position [could] be seen approximately 3 miles to the southwest of Cambridge (see [Figure 1]) tracking towards the west. [Yak-18T C/S] [could] also be seen heading south towards Duxford. [The Yak-18T pilot was] not in contact with Cambridge Radar.

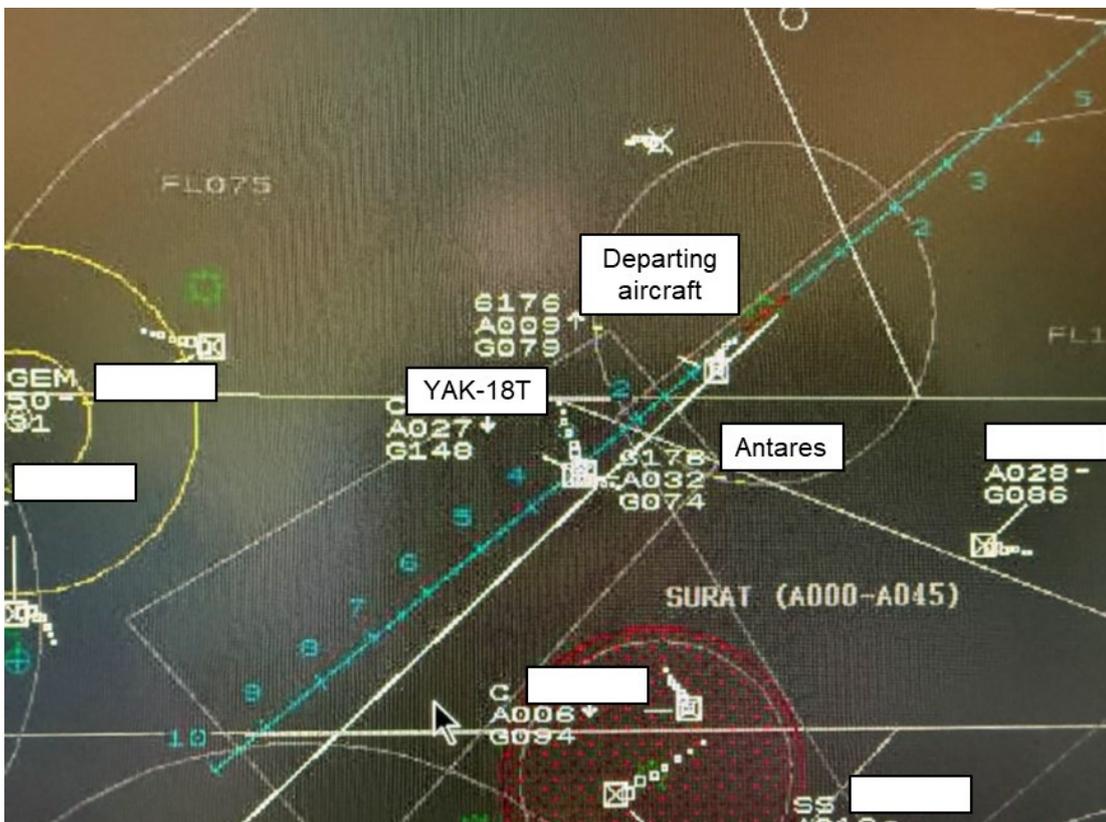
Figure 3: Cambridge Radar picture at 1520:22

At 1520:22, the radar contacts appear[ed] to merge, with the Mode C showing approximately 500ft in vertical separation (see [Figure 3]). The aircraft [were] approximately 3 miles to the southwest of Cambridge. At this time, [another pilot] made contact with Cambridge Radar following departure from Cambridge.

As the Mode C of [Yak-18T C/S had] not been verified it [was] difficult to ascertain the exact vertical separation, however, it [could] be determined that the actual vertical separation could be 200ft lower based on [Antares C/S] Mode C readout [A038] when the altitude report was made [4000ft] at 1502:16.³
