AIRPROX REPORT No 2025200

Date: 10 Sep 2025 Time: 1418Z Position: 5248N 00042W Location: 2NM SE Saltby

PART A: SUMMARY OF INFORMATION REPORTED TO UKAB

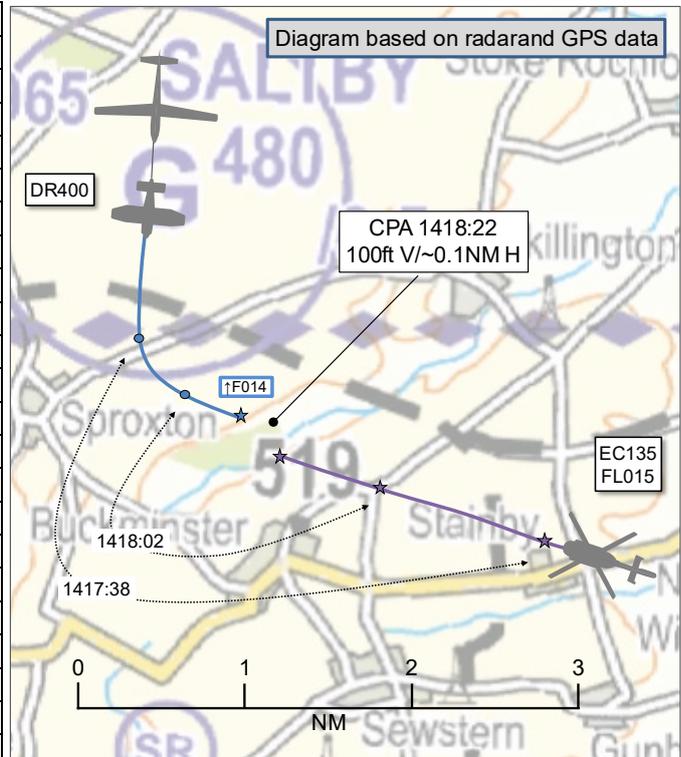
Recorded	Aircraft 1	Aircraft 2
Aircraft	DR400	EC135
Operator	Civ FW	Civ Comm
Airspace	London FIR	London FIR
Class	G	G
Rules	VFR	VFR
Service	None	Listening Out
Provider	N/A	Wittering/E Mids
Altitude/FL	FL014	FL015
Transponder	A, C	A, C, S
Reported		
Colours	Blue, White	Yellow
Lighting	Nav, Landing	Landing, Nav, HISL
Conditions	VMC	VMC
Visibility	5-10km	5-10km
Altitude/FL	1400ft	1770ft (740ft agl)
Altimeter	QFE (980hPa)	QNH
Heading	110°	284°
Speed	75kt	120kt
ACAS/TAS	SkyEcho	SkyEcho, TAS
Alert	Information	None
Separation at CPA		
Reported	0ft V/0.5NM H	30ft V/500ft H
Recorded	100ft V/0.1NM H

Fortunately, the DR400 pilot provided GPS track data for their flight and the diagram at the top of the report could be compiled by using the radar replay data and the GPS data. CPA was between data points and was therefore just after 1418:22, at this point the radar data indicated 100ft and 0.1NM separation. Comparing the GPS data with the radar data for the EC135 gave a similar CPA of approximately 0.15NM and approximately 100ft.

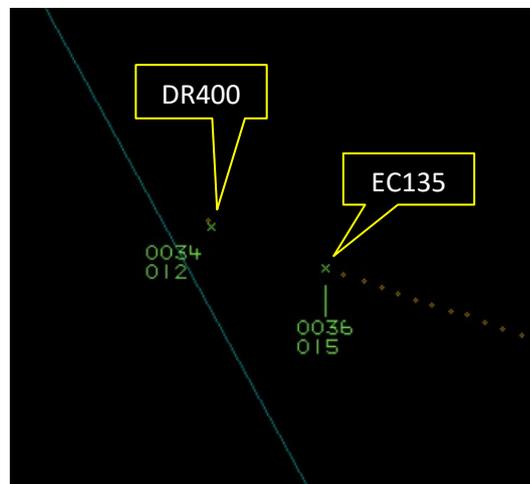
An analysis of the NATS radar replay was undertaken, the EC135 could be seen and identified using Mode S data, squawking 0036 (powerline inspection) and indicating FL015. The DR400 did not appear on the radar until just before the Airprox at 1418:06, but could be identified using Mode S data, and was squawking 0034 (glider towing) and indicating FL012, see Figure 1. When assessing ADS-B data sources, information on the EC135 was available throughout, however the DR400 did not show on ADS-B until after the event.

Figure 1 – 1408:06, the DR400 first appeared on the NATS radar replay.

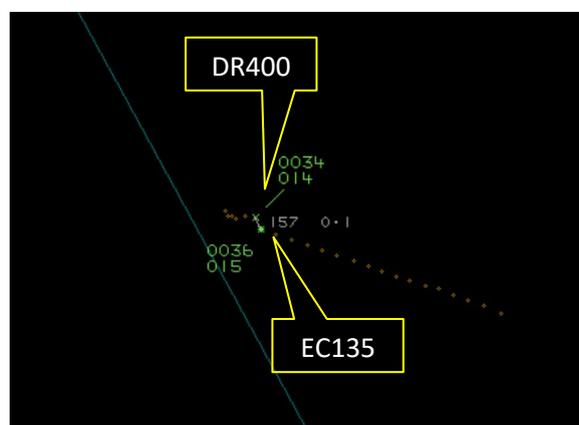
Figure 2 – CPA 1418:22

When determining the risk, the Board considered the reports from both pilots together with the radar replay and GPS data. They unanimously agreed that the DR400 pilot had taken early action to avert the risk of collision, but assessed that the final separation, at around 100ft and 0.1NM, meant that safety had been degraded, Risk Category C.
