**AIRPROX REPORT No 2025201**

Date: 11 Aug 2025 Time: 1323Z Position: 5217N 00058E Location: ivo Wyverstone

**PART A: SUMMARY OF INFORMATION REPORTED TO UKAB**

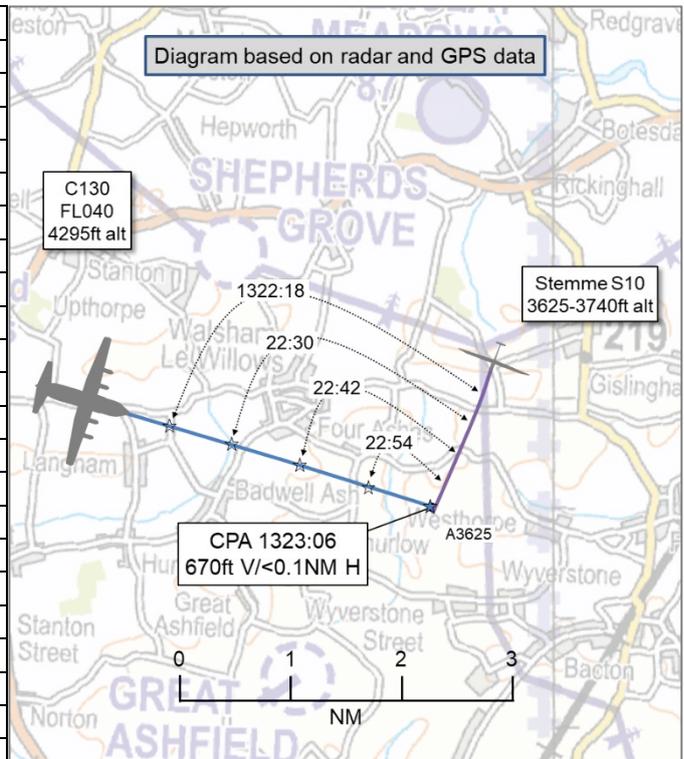
Recorded	Aircraft 1	Aircraft 2
Aircraft	C130	Stemme S10
Operator	Foreign Mil	Civ Gld
Airspace	London FIR	London FIR
Class	G	G
Rules	IFR	VFR
Service	Traffic	None
Provider	Lakenheath	N/A
Altitude/FL	FL040 (~4295ft <sup>1</sup> )	~3625ft
Transponder	A, C, S	Off <sup>2</sup>
<b>Reported</b>		
Colours	Grey	White
Lighting	Nav, anti-coll	Not fitted
Conditions	VMC	VMC
Visibility	>10km	>10km
Altitude/FL	FL040	~3700ft
Altimeter	SPS (29.29inHg)	QNH (1025hPa)
Heading	NR	~180°
Speed	NR	~75kt
ACAS/TAS	TCAS II	FLARM
Alert	None	None
	<b>Separation at CPA</b>	
Reported	NR	Not seen
Recorded	~670ft V/<0.1NM H
