AIRPROX REPORT No 2025203

Date: 09 Sep 2025 Time: 1641Z Position: 5110N 00013E Location: 2.5NM NW Tunbridge Wells

PART A: SUMMARY OF INFORMATION REPORTED TO UKAB

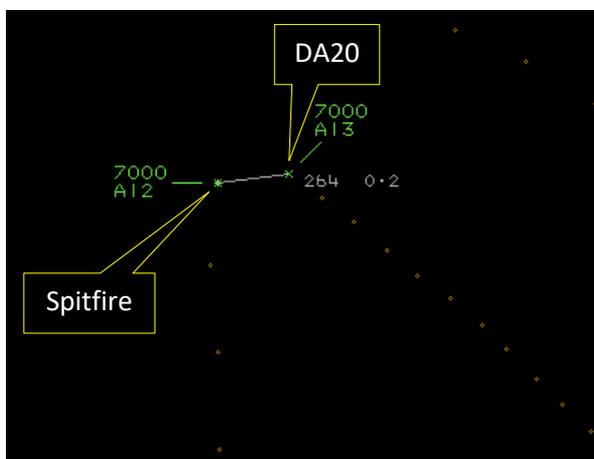
Figure 1 – 1641:10

An analysis of the NATS radar replay was undertaken and both aircraft could be positively identified from Mode S data. Both aircraft were observed by reference to ADS-B data sources. The pilot of the Spitfire kindly supplied GPS track data for their flight. CPA was determined to have occurred between the radar sweeps at 1641:10 and 1641:14. The altitude of the Spitfire has been shown as an approximate value as it had been at 1200ft on the radar sweep before CPA and at 1400ft on the sweep after CPA. The diagram was constructed and the separation at CPA determined by combining the data sources.
