AIRPROX REPORT No 2025205

Date: 18 Sep 2025 Time: 1322Z Position: 5158N 00113W Location: Souldern

PART A: SUMMARY OF INFORMATION REPORTED TO UKAB

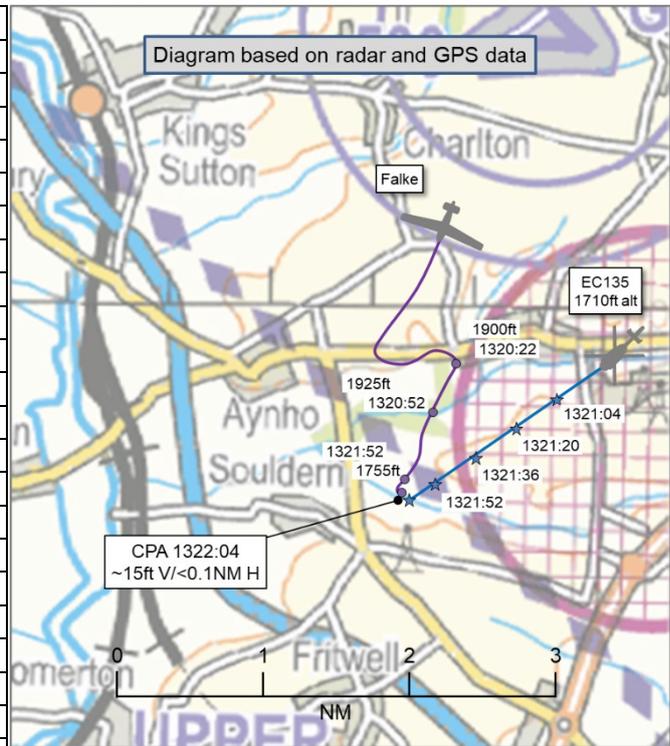
Recorded	Aircraft 1	Aircraft 2
Aircraft	EC135	Falke
Operator	Civ Comm	Civ Gld
Airspace	London FIR	London FIR
Class	G	G
Rules	VFR	VFR
Service	AGCS	None
Provider	Turweston	N/A
Altitude/FL	1710ft	~1695ft
Transponder	A, C, S	Not fitted
Reported		
Colours	Yellow	Red and white
Lighting	Position, ldg, HISL	White strobe
Conditions	VMC	VMC
Visibility	>10km	>10km
Altitude/FL	1675ft	1300ft AGL
Altimeter	QNH	QFE
Heading	233°	NK
Speed	120kt	45kt
ACAS/TAS	TAS, SkyEcho	FLARM
Alert	None	None
	Separation at CPA	
Reported	0ft V/100ft H	NR
Recorded	~15ft V/<0.1NM H

The EC135 was tracked via radar and identified through Mode S data. The Falke was not carrying a transponder and was not captured by radar as a primary return, but the pilot kindly provided a GPS log file which was used to create the diagram at page 1 and allowed a comparison of relative altitudes.

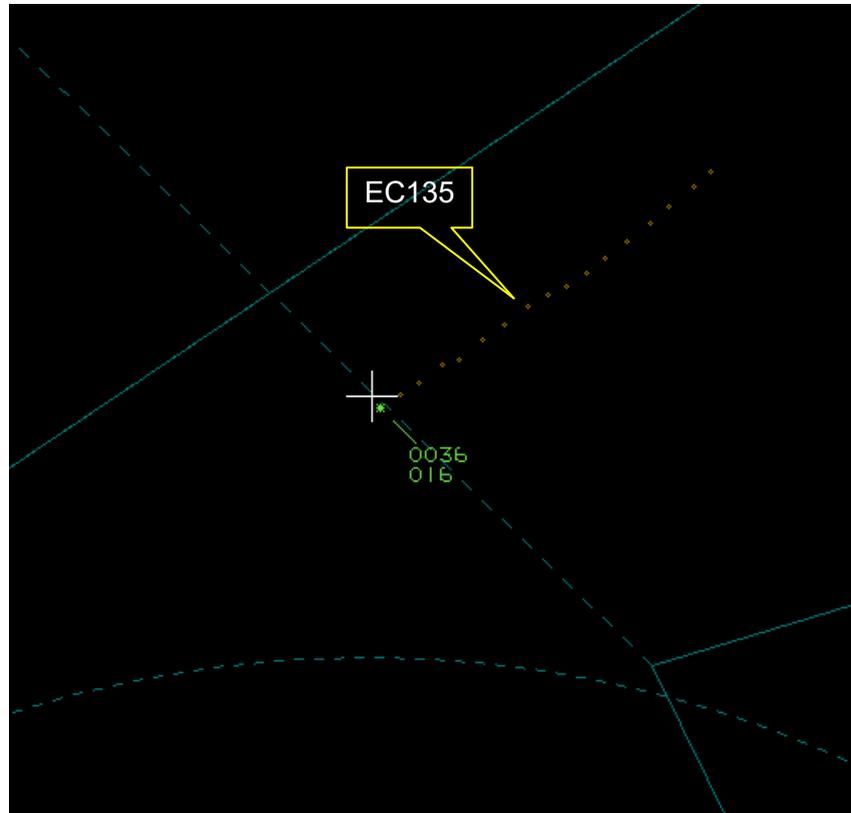
Figure 1: At CPA (1322:04). White cross marks reported CPA.
