**AIRPROX REPORT No 2025206**

Date: 13 Sep 2025 Time: 1821Z Position: 5132N 00309W Location: Cardiff

**PART A: SUMMARY OF INFORMATION REPORTED TO UKAB**

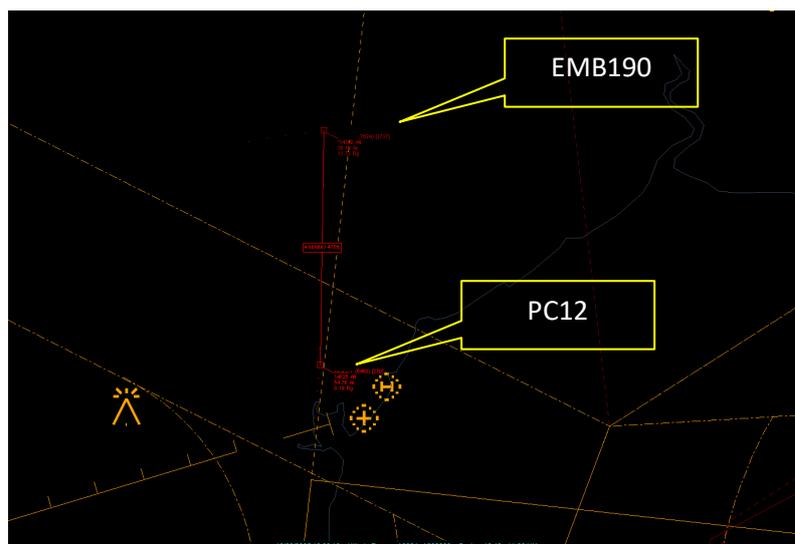
Figure 1 – Separation 4.8NM

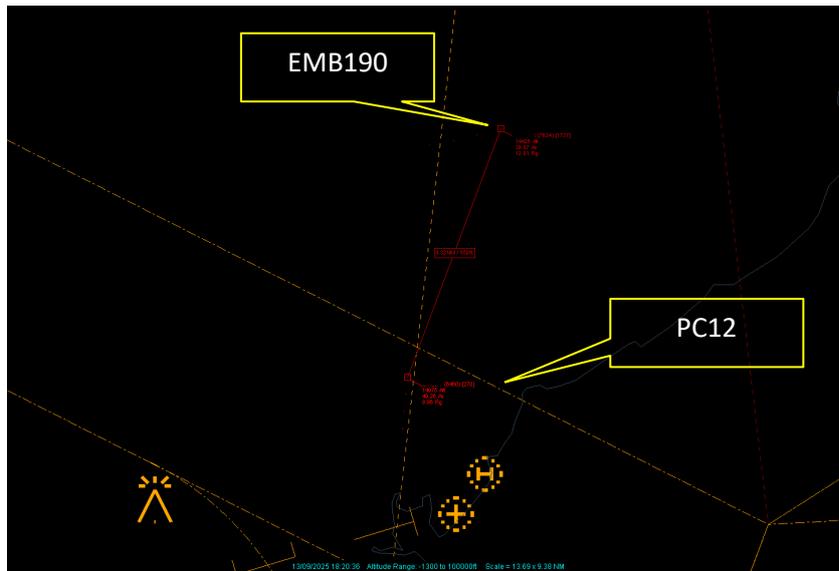
Figure 2 – 1820:36 Separation 4.32NM and 550ft

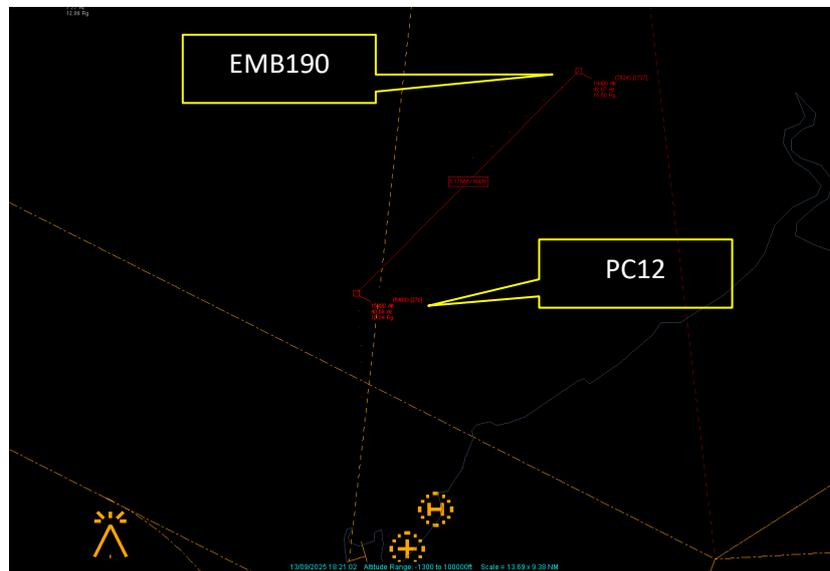
Figure 3 – Standard Separation regained at 1821:02
