**AIRPROX REPORT No 2025207**

Date: 23 Sep 2025 Time: 0920Z Position: 5150N 00217W Location: 3NM SW Gloucester

**PART A: SUMMARY OF INFORMATION REPORTED TO UKAB**

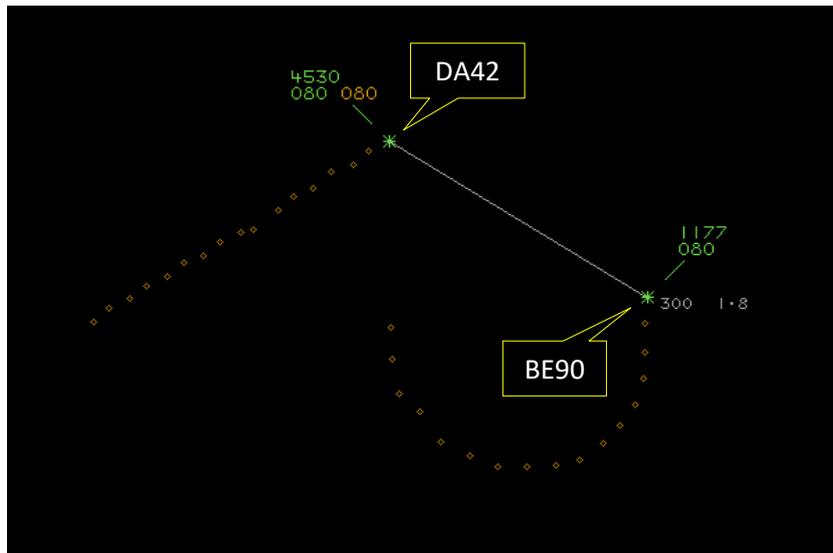
Figure 1 – 0918:55 (1min before CPA)

An analysis of the NATS radar replay was undertaken and both aircraft could be positively identified from Mode S data (Figure 1). The BE90, but not the DA42, was observed by reference to ADS-B data sources.

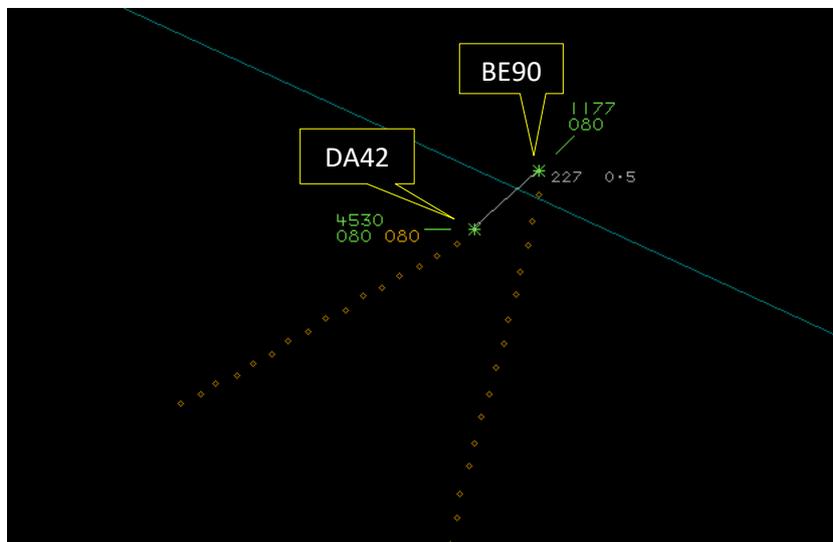
Figure 2 – CPA at 0919:55

**THE LONDON INFORMATION FISO** reports that [the pilot of the BE90] was in receipt of a Basic Service from them, squawking 1177. The other aircraft was approximately 5NM south-west of Gloucestershire Airport, squawking 4530. It is reported that [the BE90] flew 0.6NM ahead of [the DA42]. An Airprox was not reported to them at the time or subsequently. They were not in contact with [the pilot of the DA42].

An Airprox was reported when a BE90 and a DA42 flew into proximity 3NM south-west of Gloucester at 0920Z on Tuesday 23<sup>rd</sup> September 2025. The BE90 pilot was operating under IFR in VMC in receipt of a Basic Service from London Information. The DA42 pilot was operating under IFR in VMC in receipt of a Procedural Service from Gloster Approach.
