AIRPROX REPORT No 2025208

Date: 19 Sep 2025 Time: 1127Z Position: 5119N 00005W Location: ivo Kenley Airfield

PART A: SUMMARY OF INFORMATION REPORTED TO UKAB

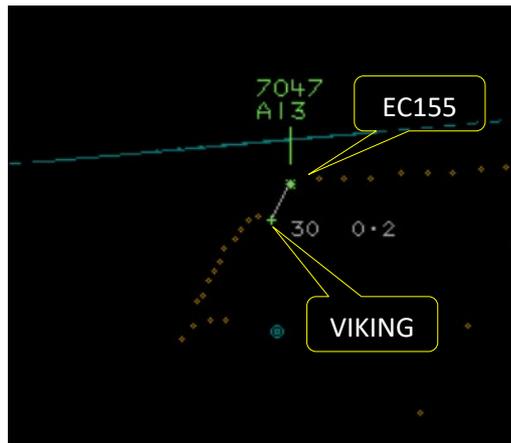
Figure 1 - Time 1126:42

Analysis of the NATS radar replay was undertaken and the EC155 was positively identified using Mode S data while the glider was identified by its flightpath and was seen displayed as a primary track only (Figure 1).

CPA was assessed to have occurred at 1126:42 with 0.2NM lateral and approximately 390ft vertical separation by use of combined radar and interpolated ADS-B data.

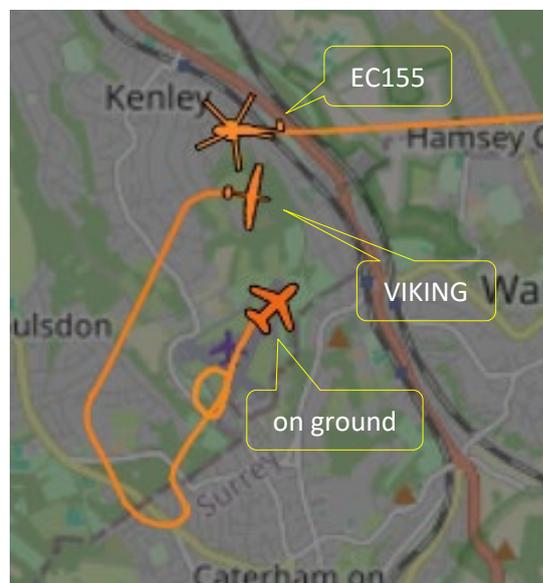
Figure 2 - Time ~1126:40

Further analysis was undertaken of third-party tracking sources and the EC155 was not visible using ADS-B sources but was seen utilising MLAT sources, while the Viking was visible using ADS-B data (Figure 2).
